NORTH HAMPTON LIBRARY

Foley Buhl Roberts & Associates
Preliminary Structural Review and Assessment

2014 Aug 29

Re: North Hampton Library, 237A Atlantic Avenue, North Hampton, NH
Preliminary Structural Review and Assessment

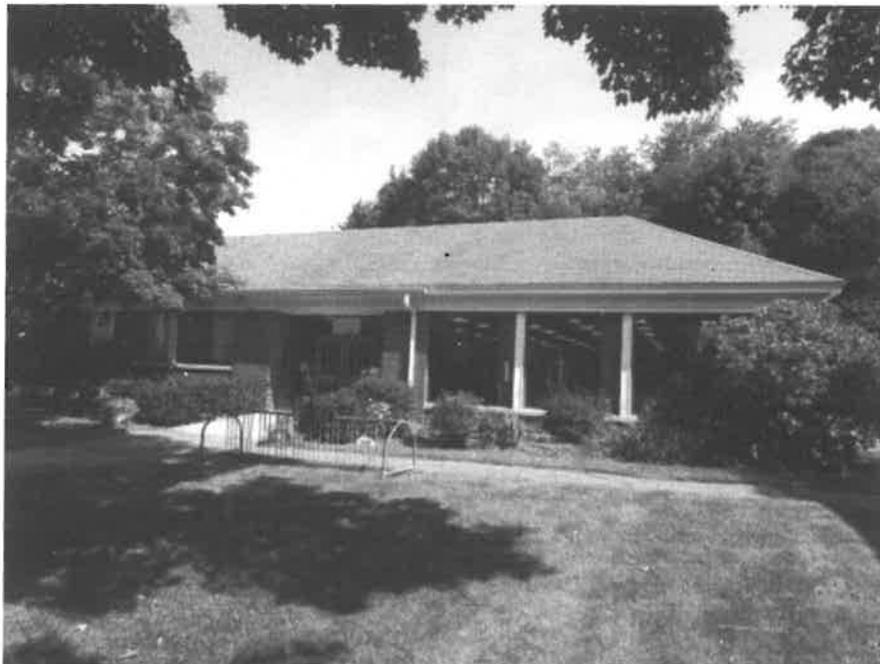
The windows on the east, north and west elevations extend across 40% to 60% of the length of those walls. However window and door openings on the south elevation extend across approximately 90% of that elevation (those window openings include the tall windows in the reading area, the entry vestibule, the director's office and the meeting room). This is a significant observation that will be commented on later in this report with regard to wind and seismic loads.

Photo 1: South Elevation, main entry, reading room windows.

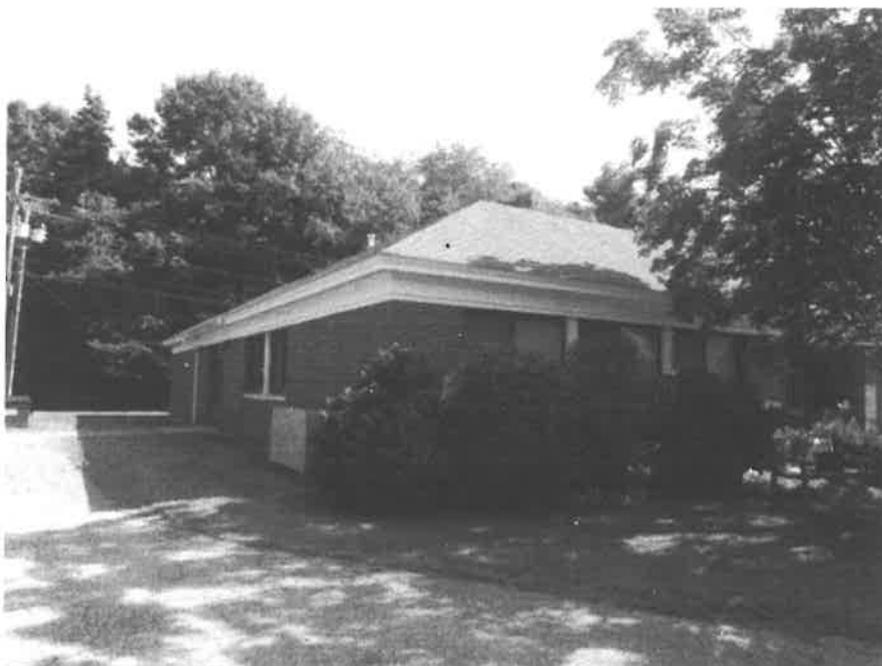
Photo 2: Southwest corner.

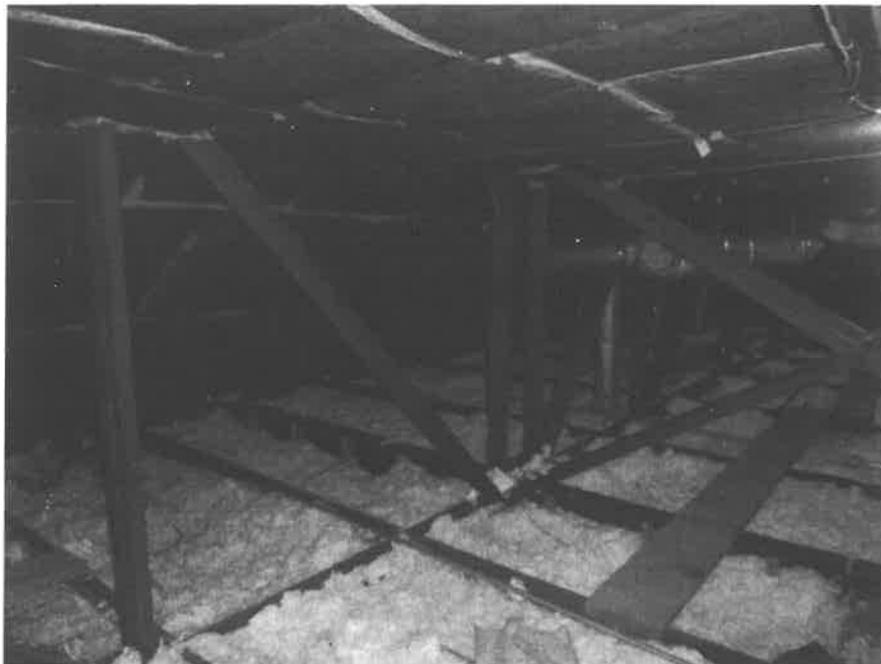
Analysis of the steel trusses is beyond the scope of this preliminary assessment. The visible components of the steel trusses were observed to be in good condition, with no deficiencies noted.

Photo 3: Attic space within the steel roof trusses.

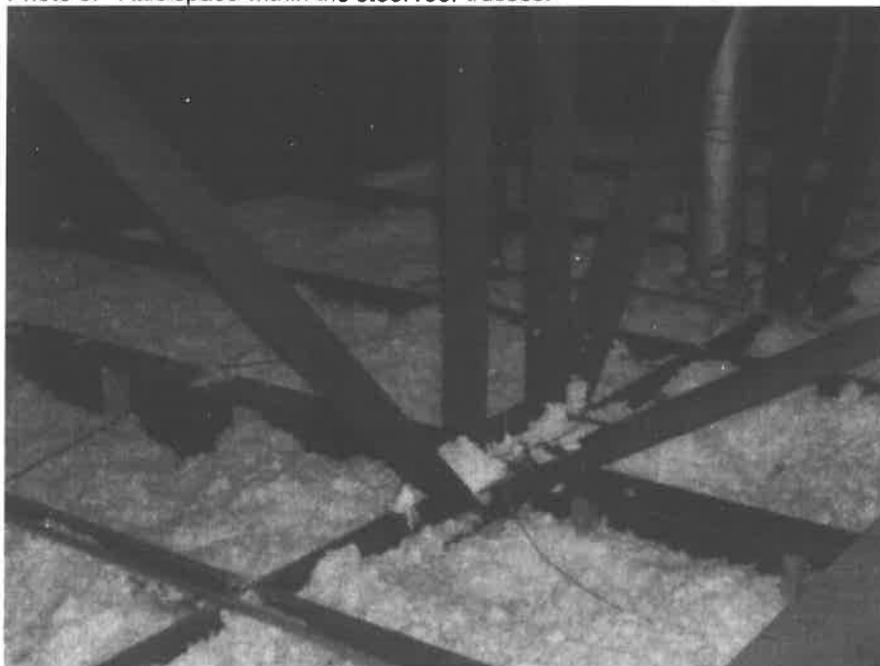
Photo 4: Steel trusses bearing on interior steel beam line.

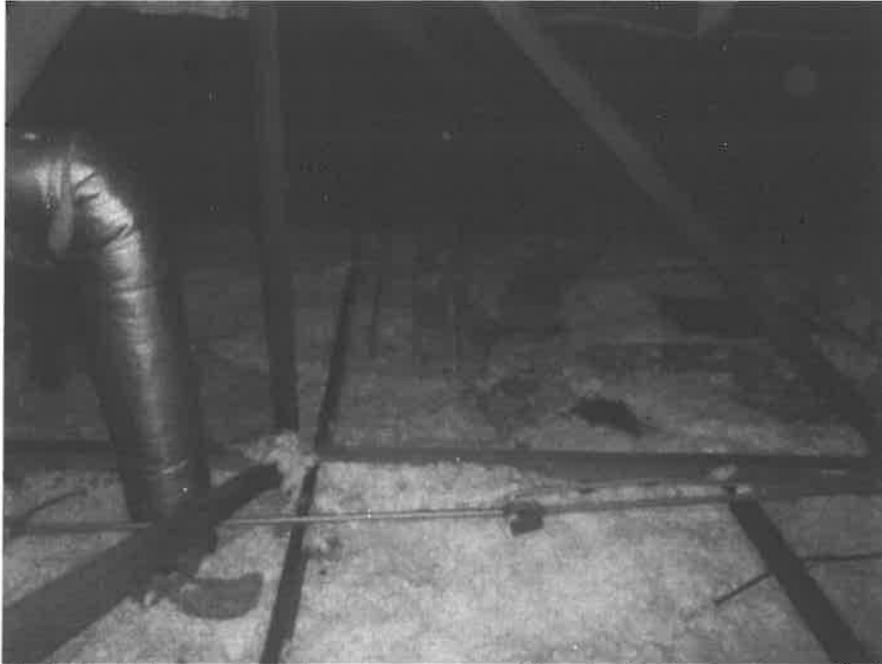
A second seismic vulnerability exists in connection with the interior non-load bearing masonry walls. The tops of these partitions are not effectively restrained to the roof structure, leaving them vulnerable to overturning in a seismic event.

Photo 5: Note top of unrestrained masonry wall (east wall of main entry vestibule).

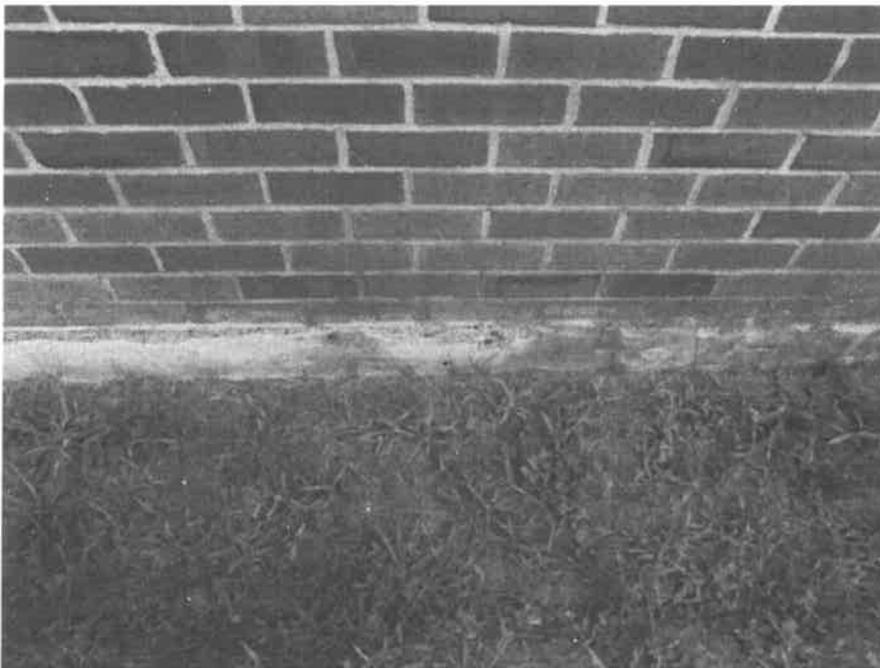
The top outer faces of the perimeter foundation walls are visible above grade and below the brick veneer. There has been some scaling and delamination of the concrete immediately below the brick shelf (see photo). This damage appears to be superficial and may be due to segregation of the concrete during placement.

Photo 6: Spalled concrete surface on exterior foundation wall, west side.
