Energy Audit Report

Town of North Hampton Facilities

North Hampton Energy Committee

North Hampton Town Facilities Energy Audit

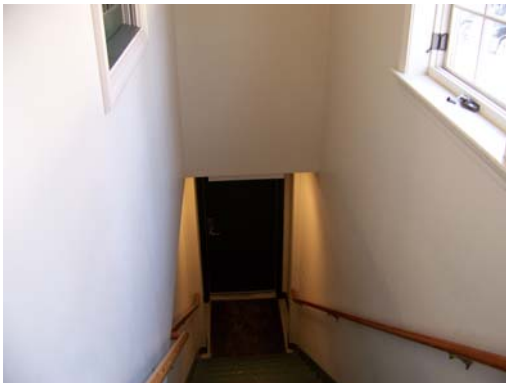
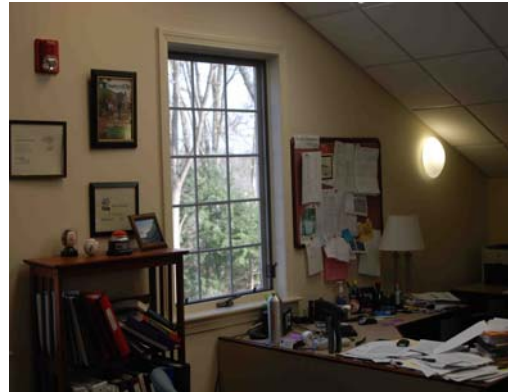
During the daylight inspection we found that the lights were left on in the North (employee only) staircase which employees use to enter and exit the 2nd floor town offices. These lights should be shut off when not in use. We would recommend installing occupancy sensors in this stairwell area. Unoccupied areas should also have all lights turned off.

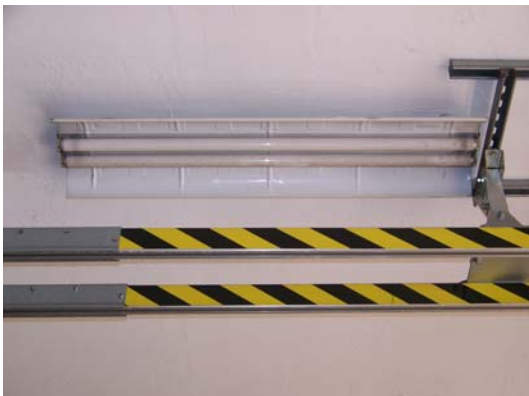
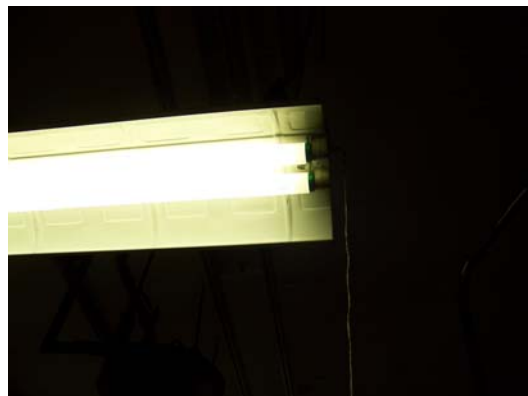
Fluorescent Lights - Retrofitting T12 overhead fluorescent lamps with modern T8 lamps and electronic ballasts can reduce lighting energy consumption by 35%. Adding specular reflectors, new lenses, and occupancy sensors or timers can double the savings. Paybacks of one to three years are common. This retrofit or replacement would be highly recommended for the overhead lighting in the Fire Department truck bays.

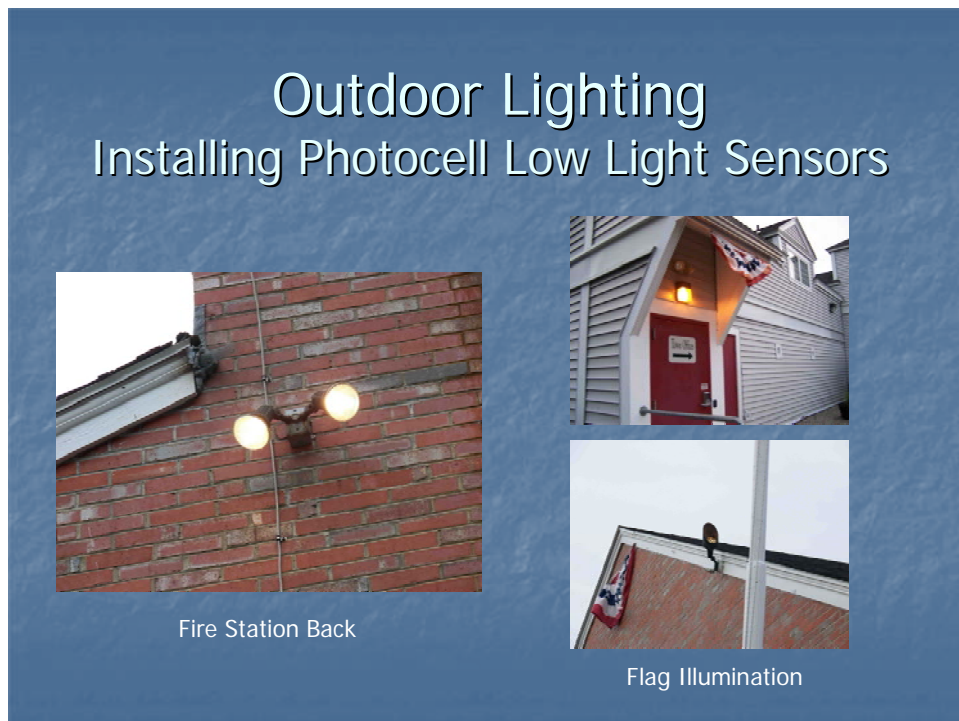
- A.) Single incandescent floodlight which illuminates the flag in the front of the building was on during daylight hours, this should be on a timer or photovoltaic operated switch.
- B.) Lights along the east side of the building appear to be on a timer system.
- C.) Single light above the stairway of the employee's entrance, was on during daytime hours. This light apparently is on constantly and should be on a timer or photovoltaic operated switch.
- D.) Double (pair) incandescent floodlights above the rear entrance of the fire department were on during daytime hours, and should be on a timer or photovoltaic operated switch.
- E.) Incandescent floodlights should be replaced with CFL bulbs.

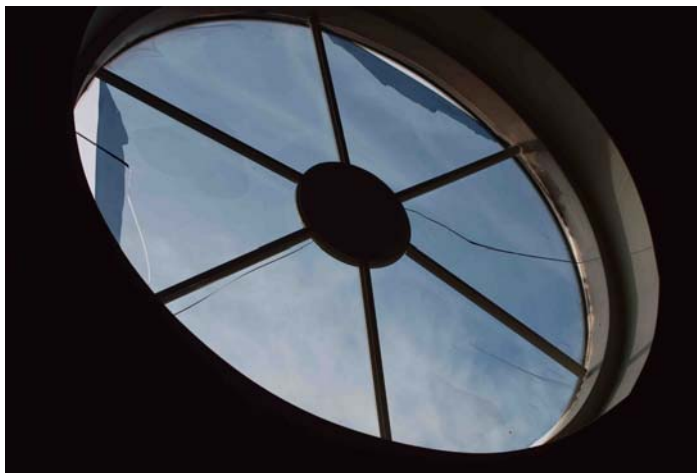
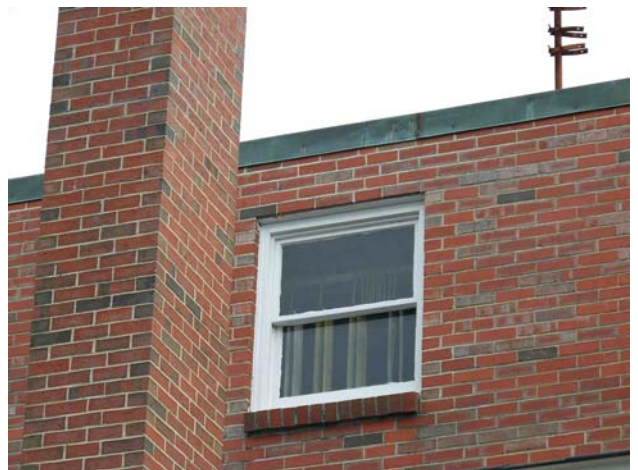
The five windows in the fire department truck bay on the west side of the facility and the two windows in the front are old inefficient single pane windows with outer storms. The windows in the truck bay were covered inside with clear plastic shrink film insulation. Thermal readings from our infrared thermometer showed that the plastic covering does help, however we recommend replacing these with high energy efficient windows. The rating or U-Factor (rate of heat loss) for windows in New Hampshire is listed as $U \leq 0.35$. An argon gas filled vinyl/wood frame double glazing Low-E replacement would meet this requirement and save significant energy. A fact sheet "Selecting Energy Efficient Windows in New Hampshire" is included at the end of the report.

The hose tower window located at the top of the tower is also a single pane window without a storm and should be replaced with the above rated window.

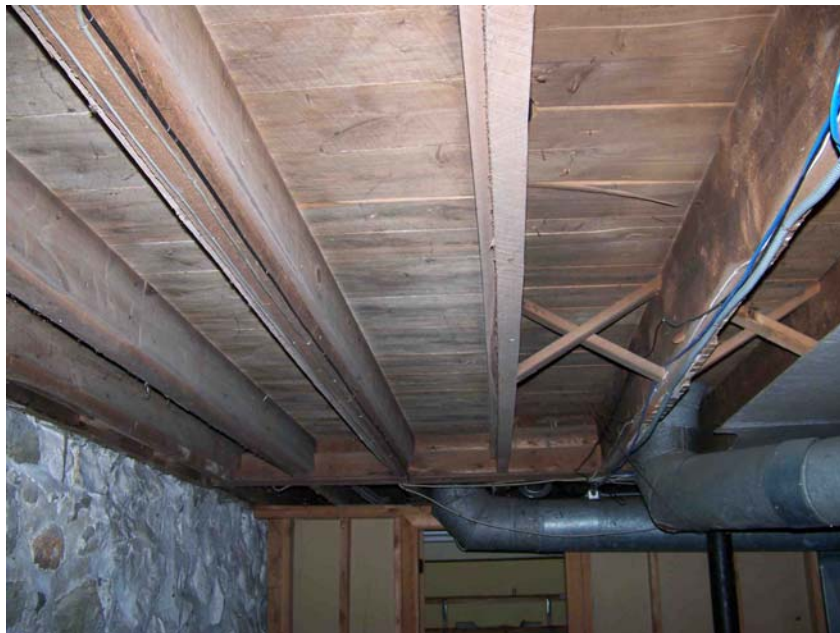
The Tax Collectors Office has an older oil burning forced hot air (FHA) furnace in the basement. Although the system appeared to be in good condition a more efficient modern system would certainly realize energy savings. The biggest low cost opportunity for energy savings in this building would be insulating the FHA ducting and basement ceiling or floor joists.

Tax Collectors Office Basement - Needs Insulation (Ceiling and FHA Ducts)

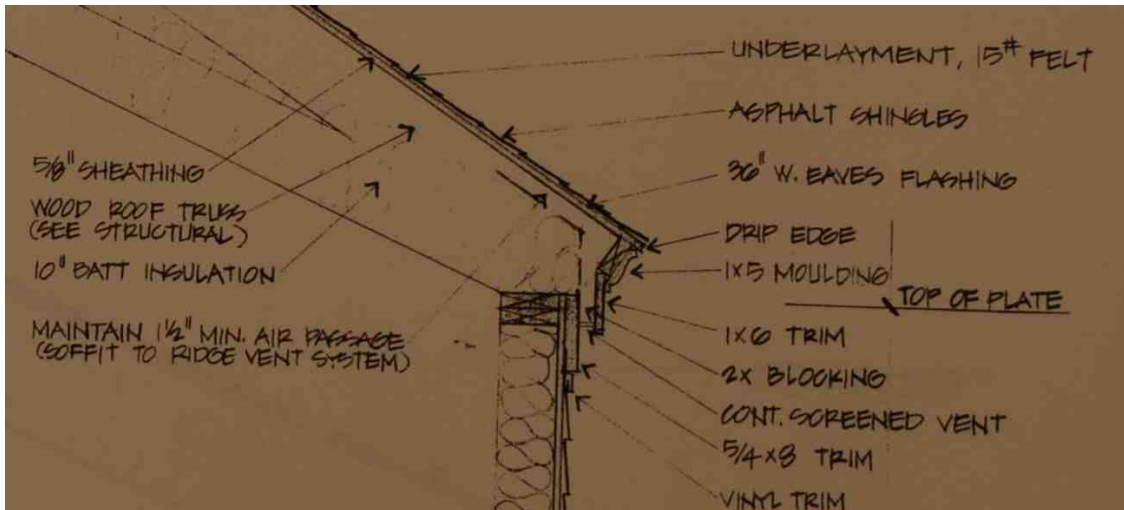
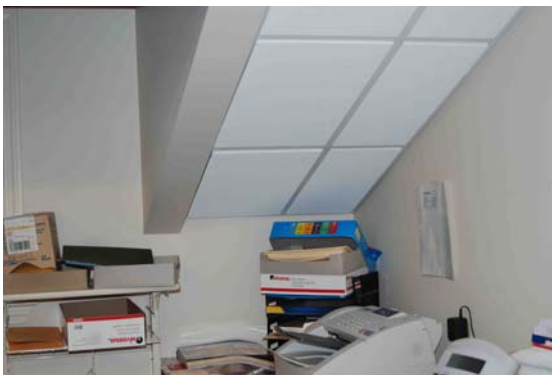
Ceiling / Wall Interface

Indoor thermal readings of the ceiling/wall interface in the town offices indicated heat loss. Outdoor scans, using a more sophisticated thermal imaging infrared camera, of the soffit area confirmed this finding. We pulled some of the office ceiling tiles away and discovered that the insulation along the roof line was pushed up allowing air direct access to the indoor office area. It appeared that the insulation had either been pulled away for electrical work or had been installed incorrectly in the first place. Regardless, this deficiency should be a top priority for corrective action as this breach affects the efficiency of both the heating and air conditioning systems. A blow up of the building plans below shows the problem area. The 10" Batt insulation is lifted away from the top plate, this "lifting" may also be blocking the soffit to ridge vent air passage system.

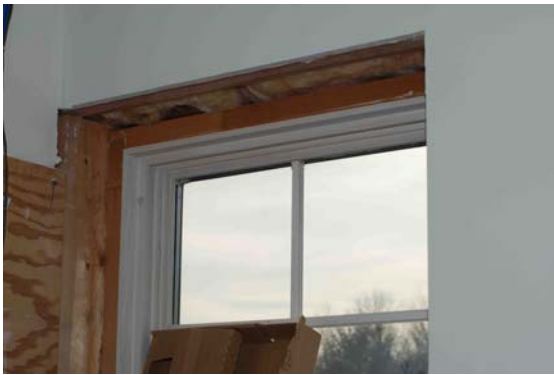
Computer Server Room Window

The computer server room which is located in a small space off of the storage room in the southwest side of the top floor has a separate cooling system plugged into a wall socket and directly vented to the outdoors through the wall. This unit was set to 55F. It is understood that the computer room needs to be maintained at a certain temperature, and that the room is prone to overheating. The room has a ~24" square opening in the ceiling where cable modifications were made. There is a fan hole in the shared storage wall, and the window in this room is unfinished and has no internal shades for sun protection. The room appears to have been hastily fabricated with no thought as to energy efficiency. There should be documentation from the computer manufacturer as to optimal operating temperatures of the computer server that resides in this space. The room temperature should be maintained as much as possible using the house HVAC system as the primary system and the secondary AC unit that is in the room should supplement cool air only when needed.

During our visit in December the air conditioning unit was on full with the temperature setting of 55⁰ F on the AC unit. In the winter months simply leaving the door open and using a floor fan to circulate air would most likely keep this room within correct operating temperature. The current configuration has the main HVAC heating the facility and the supplemental AC in the server room system cooling. These two systems are fighting each other and it is a very inefficient set-up. The holes in the ceiling should be repaired, the window should be finished, and a solar shade should be hung in the window which can be drawn during the summer months (south facing window).

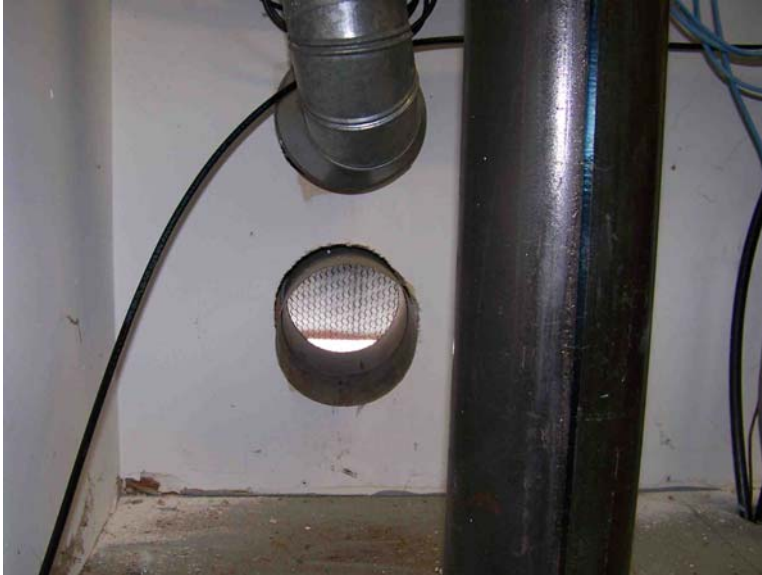
There were a number of openings in the town offices building where cold air intrusion was apparent. The majority of these openings were in the two furnace rooms located off the storage area. There is a ~6" intake hole directly below the smaller current air intake for the furnace that supplies the town offices.

It was unclear if this hole was required for make up air to the existing system or if it was simply a hole that was made mistakenly during installation of the existing furnace. This should be investigated with a furnace technician, to determine if it is necessary.

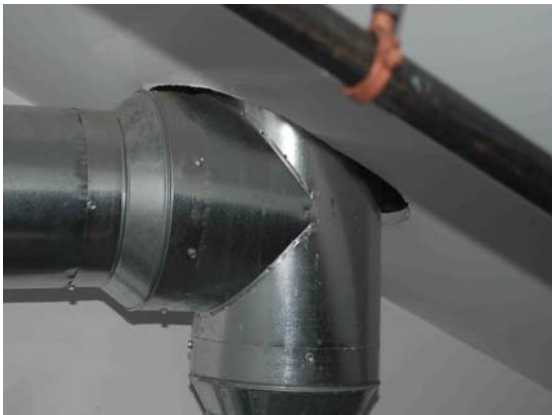
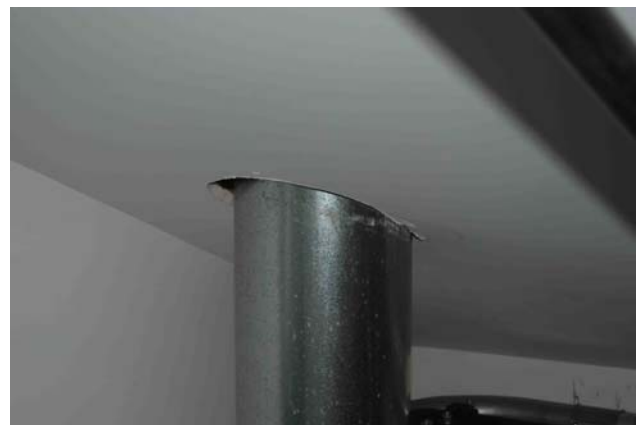
The exhaust ducting associated with the Police Dept furnace needs insulation around the openings to eliminate heat loss and cold air infiltration.

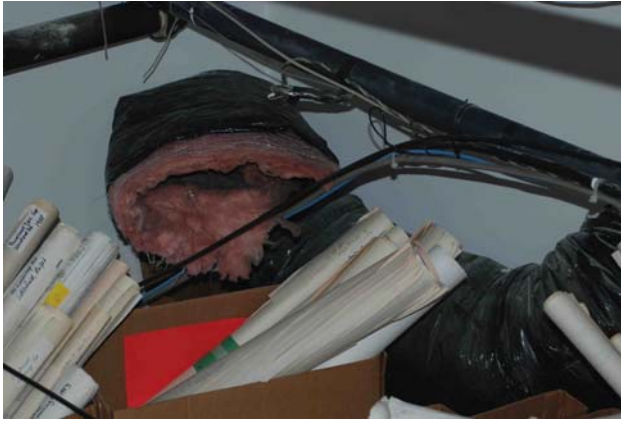
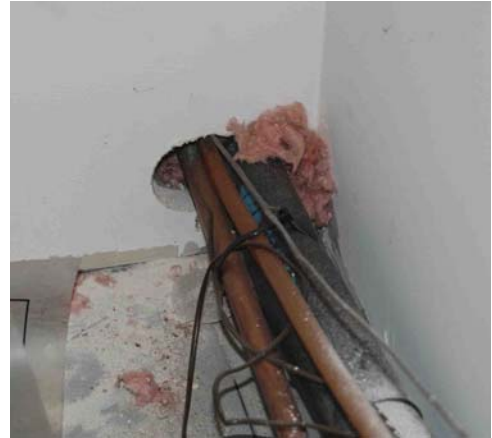
In the same room of the building there were two other areas of concern along the south wall. The first was an old insulated duct that should be removed and plugged, the other is an area where the insulation has been pulled away from some piping, perhaps to eliminate pipes from freezing. This should be investigated as well to determine whether appropriate insulation has been installed.

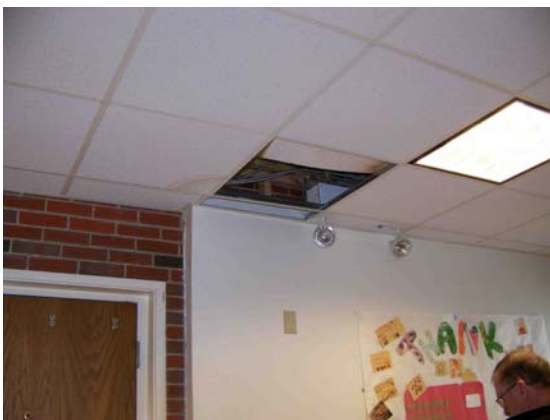
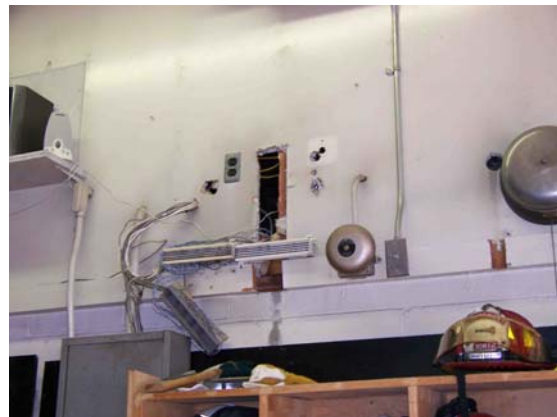
There were other instances of openings in the building associated with maintenance or fixing problems. The public entry to the tax collectors office had a ceiling panel removed apparently to check on a roof leak. The panel was never replaced, exposing this heated area to an uninsulated area above the ceiling. Another opening was found in the truck bay of the fire station. It should be a standard operating procedure that if a repair is initiated the affected area needs to be resealed as soon as possible after repair in order to conserve as much energy as possible.

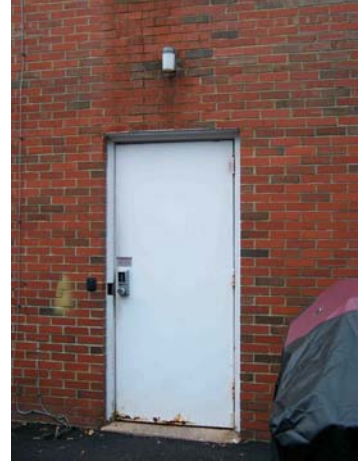
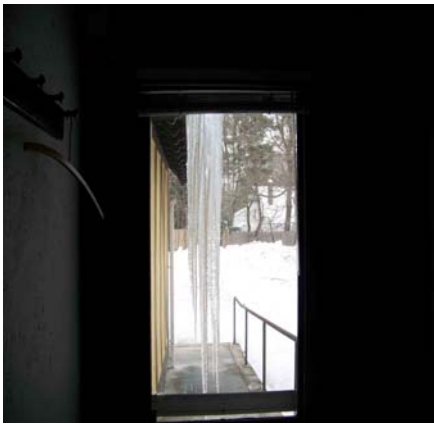
Both back doors to the fire department need to be replaced with energy efficient models. They are poorly weatherized, leaky, old, rusted, and damaged.

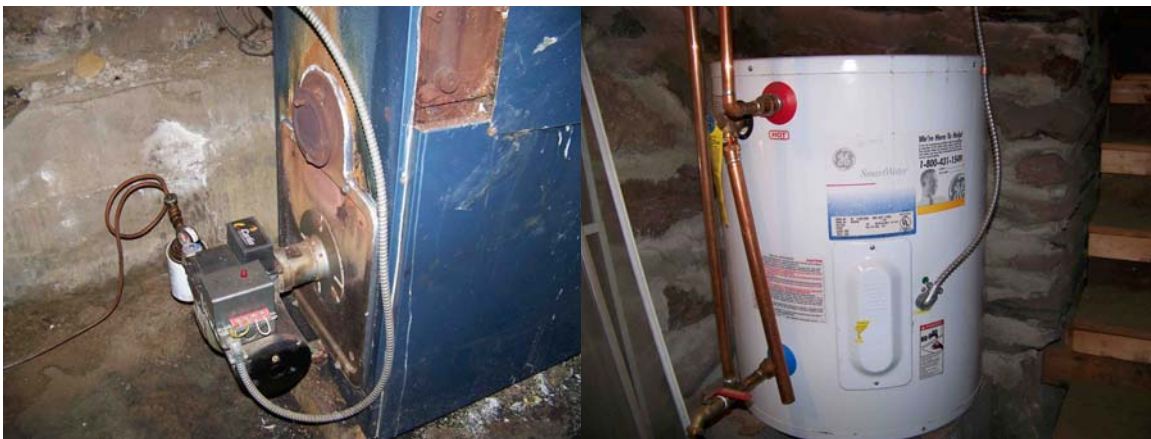
The Old Town Hall is a model of inefficiency. Simply said this building should not be open during the winter months. Although the thermostat was set at a reasonable 61°F the large single pane windows, poorly insulated walls, and uninsulated floors all add up to wasted energy and giant fuel costs. The oil furnace looked to be in fairly good condition however it is old and should be replaced with a more efficient model.

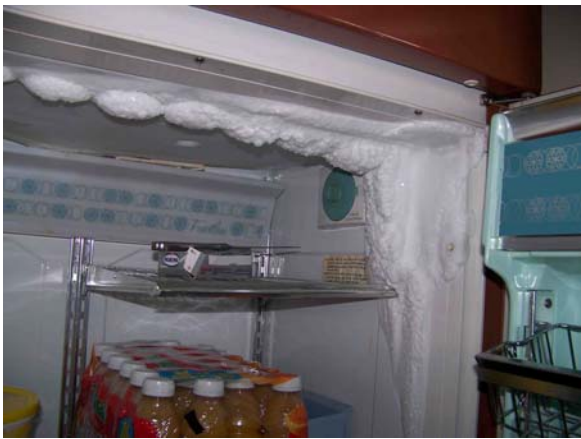
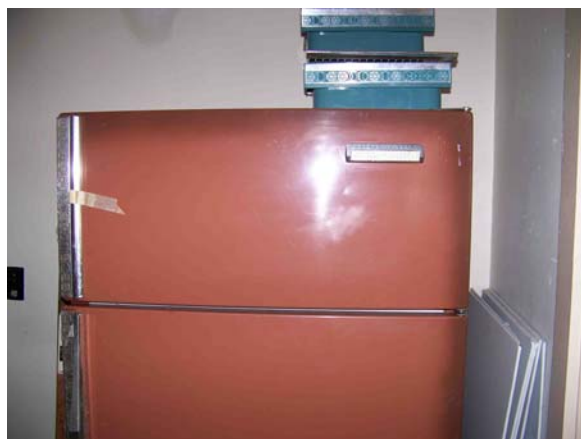
The refrigerator should be unplugged and removed as soon as possible. The unit is ancient and is very inefficient. There is evidence that the doors do not have a tight fit which wastes even more energy. We would highly recommend replacing this refrigerator with an Energy Star rated model.

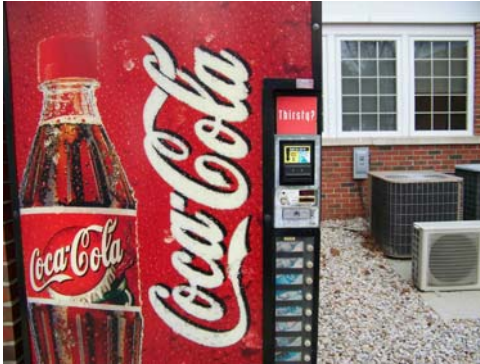
The refrigerated beverage vending (Coke) machine in the front of the fire department should be removed or, if deemed necessary, should be replaced with an energy efficient (Energy Star) rated model. Refrigerated vending machines consume five times more electricity than a typical home refrigerator. With an energy consumption rating of 7-16 kWh/day this machine alone costs the town over \$250/year for electricity.

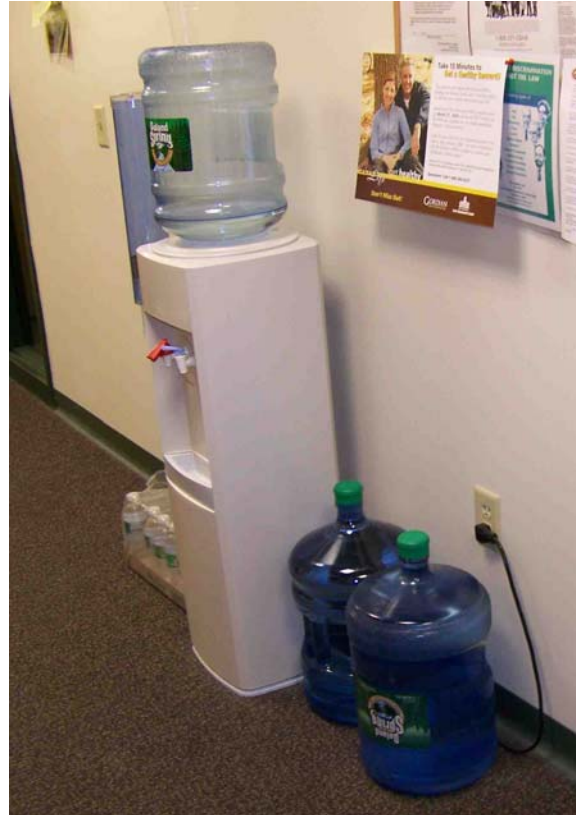
Office area refrigerated water dispensers (Poland Springs) should be eliminated; these systems are in constant cooling mode consuming electricity even when the office is closed. It would be more efficient and economical to have employees fill their own re-useable water bottles with our high quality town water. Individual bottles of water could also be stored in the office refrigerator for meetings and personal use.
