April 25, 2014

Re: North Hampton Fire Department, 235 Atlantic Avenue, North Hampton, NH
Preliminary Structural Review and Assessment

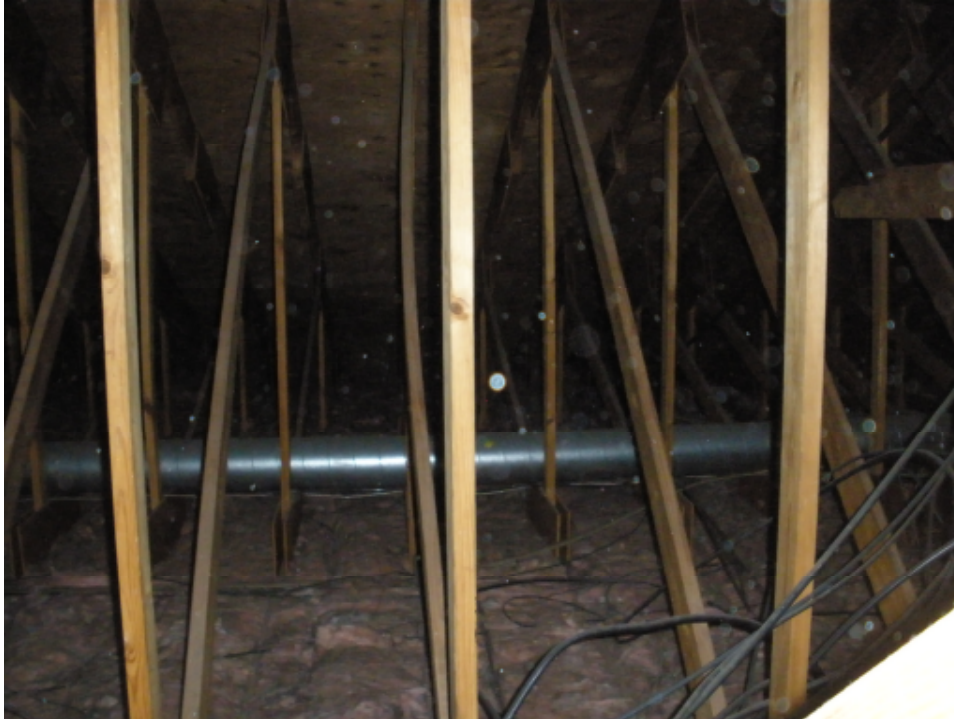
1. Bowed diagonal web members, absence of Continuous Lateral Bracing (CLB), also called "Through Truss Bracing": Wood trusses often require installation of additional wood framing through (i.e., perpendicular to) the trusses in order to reduce the buckling

length of compression web members. The CLB resists the tendency for the compression member to buckle out of plane, thereby increasing the load capacity of those members. While it is possible to design truss installations that do not require this type of bracing, doing so would be unusual for trusses of this size and configuration. This roof structure has no CLB on any of the web members. Furthermore, I noted several 2x6 web diagonal members that are permanently bowed out-of-plane (see photo 3). This is an indication that the roof has been overloaded in the past and that these web member should have had CLB installed on them when the building was first constructed in order to allow these web members to be fully effective. The absence of CLB and the resulting observed buckling of web members significantly reduces the snow load capacity of this roof. This finding should be confirmed by a quantitative structural analysis of the trusses. An analysis of this type is beyond the scope of this initial assessment. This observation (i.e., the absence of CLB thru-truss bracing and the observed bowing of web members out-of-plane) is the most serious deficiency noted during this assessment.

Photo 3: Bowed truss web diagonals, no thru-truss bracing.

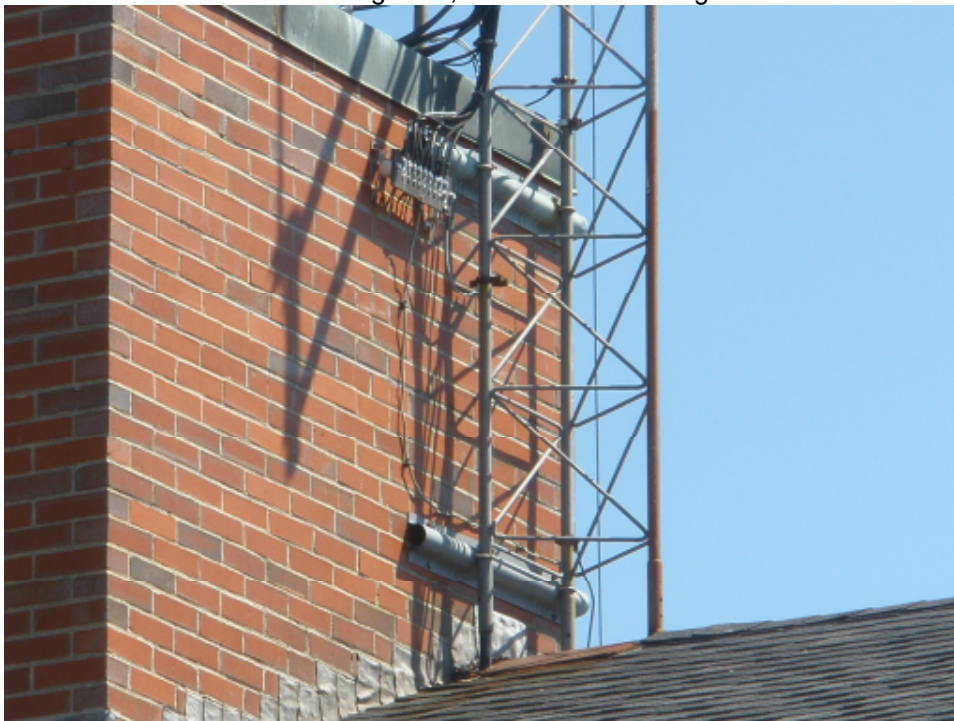
The tower itself has three vertical legs. The two northerly legs are secured to the masonry of the hose tower. Those attachments appear adequate for resisting lateral wind loads on the tower. However they do not serve to support the vertical weight of the tower or to resist the downward thrust of the resulting from wind loads acting on the tower. Those vertical loads are transmitted to the plywood roof deck at the base of the tower via a bearing plate. No supplemental framing or reinforcement has been added beneath the roof deck to support the vertical loads imposed by this tower.

Photo 4: Radio antenna tower and hose tower.

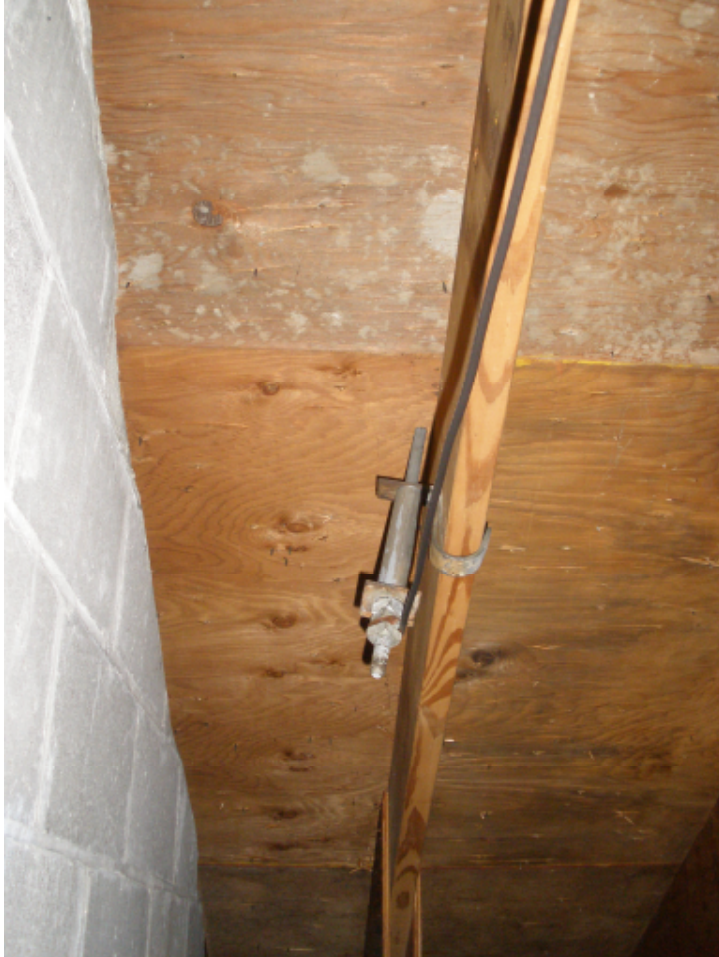
All of the tower guy wires are secured to the building roof. The anchorages for the guy wires include a hooked bolt that penetrates the roofing and roof deck and hooks under a truss top chord (see photo). These anchorages appear to be inadequate and should be reviewed by a qualified antenna installation firm.

Photo 5: Antenna guy anchorage to truss top chord.

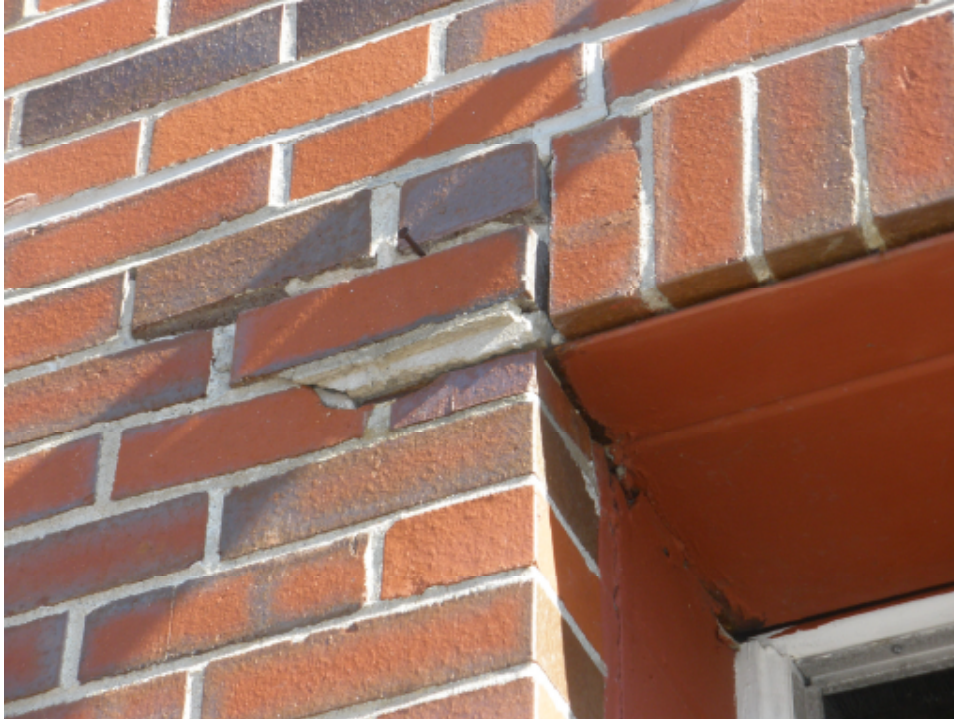
Damaged, displaced, or "step-cracked" masonry was observed at the upper corners of two of the apparatus bay overhead doors. Specifically, this damage is visible at the east corner of the east door and the west corner of the west door. At the east door, this damage is likely related to the outward movement of this wall noted in the preceding paragraph. At the west door, the damage is more localized and was likely caused by a vehicular impact.

Photo 6: Damaged exterior masonry, west overhead door.

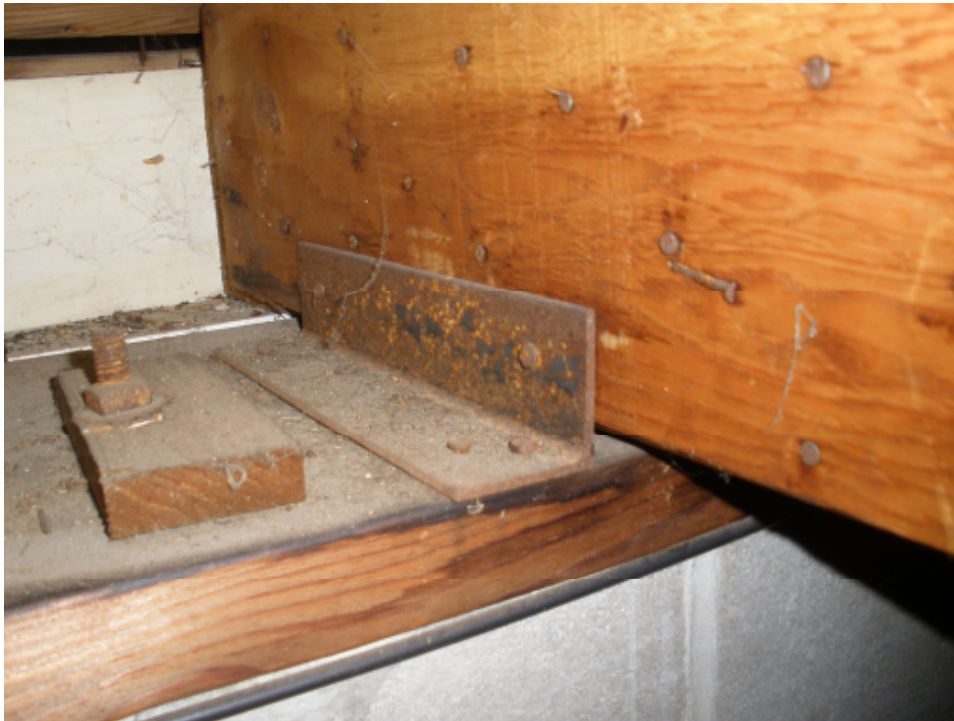
2. Anchorage at bearing points: The trusses are secured to the bearing plates at the tops of the masonry walls with an angle on one side of the truss. In my opinion, this connection is inadequate to resist the wind uplift loads found in the current Building Code.

Photo 7: Truss bearing, clip angle, wall plate

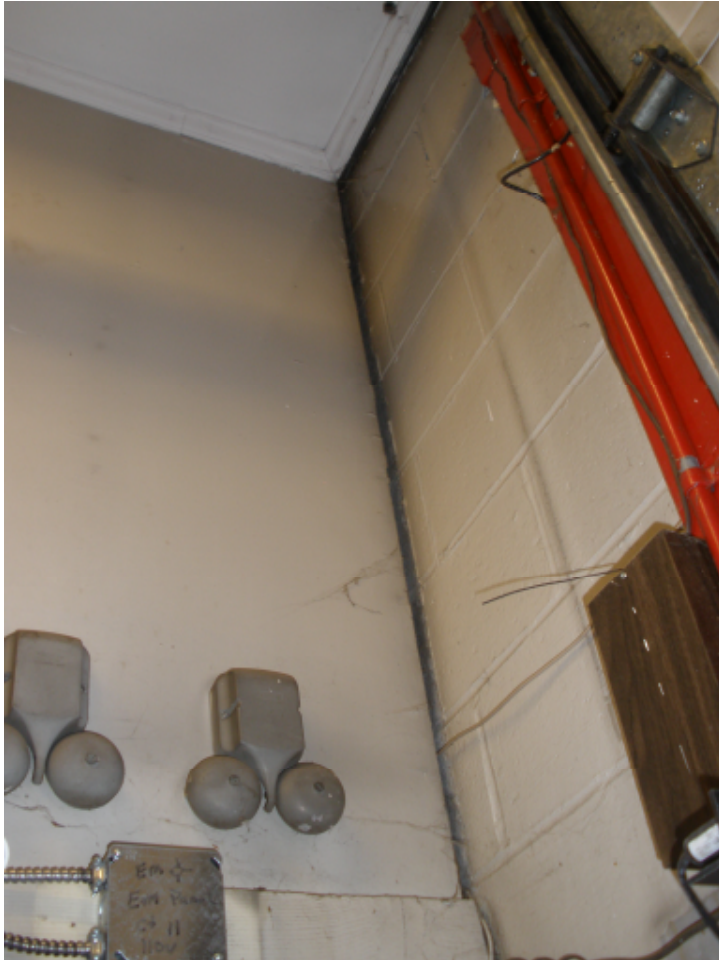
The south gable end wall of the building appears to be separating from the interior partition wall that separates the apparatus bay from the office area. This separation is of varying width and is

approximately $\frac{3}{4}$ " wide near the ceiling line. This condition appears to be due to an outward "lean" or rotation of the south gable end wall.

Photo 8: separation of south gable end wall (at right) from intersecting interior wall (left).
