1844 Town Hall

North Hampton, NH

Exterior Conditions Assessment Report

February 2018

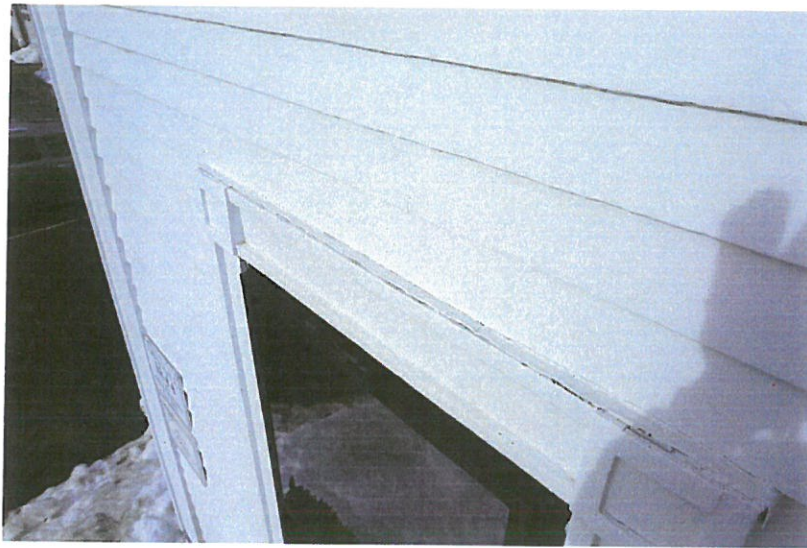
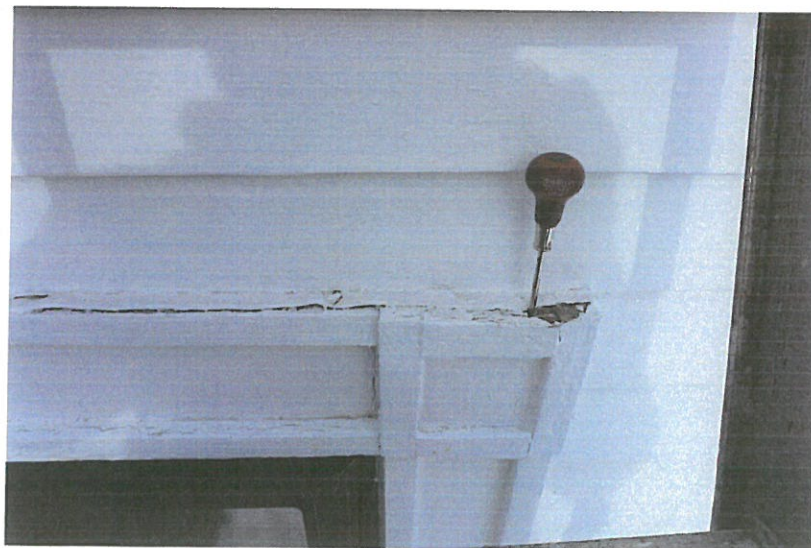
1. Checked lead flashing on two windows and on the front door.

These flashings are cracked need to be changed to include an overhang; they need to extend out further.

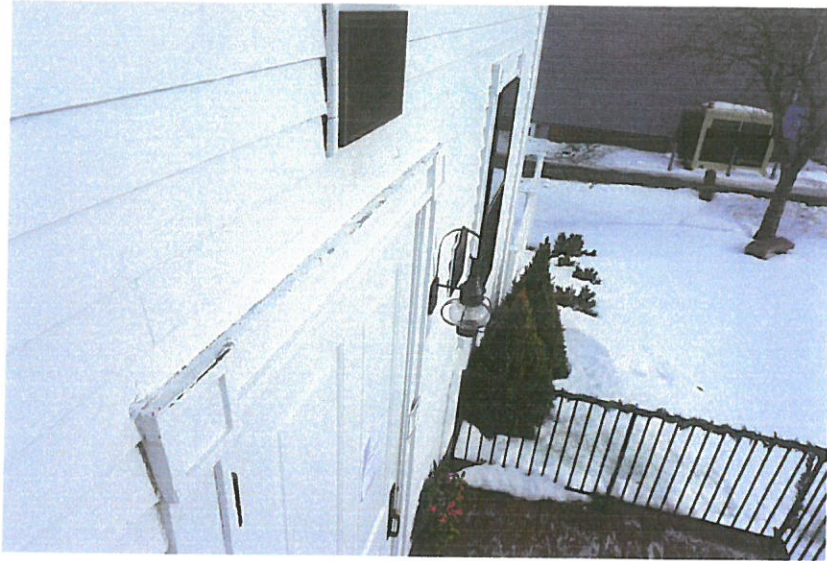
2. Checked condition of all front woodwork – trims, casings, doorway upper woodwork.

The left and right corner pilasters require minor re-nailing at the bottoms; nails are rusting and loose. Use galvanized cut nails.

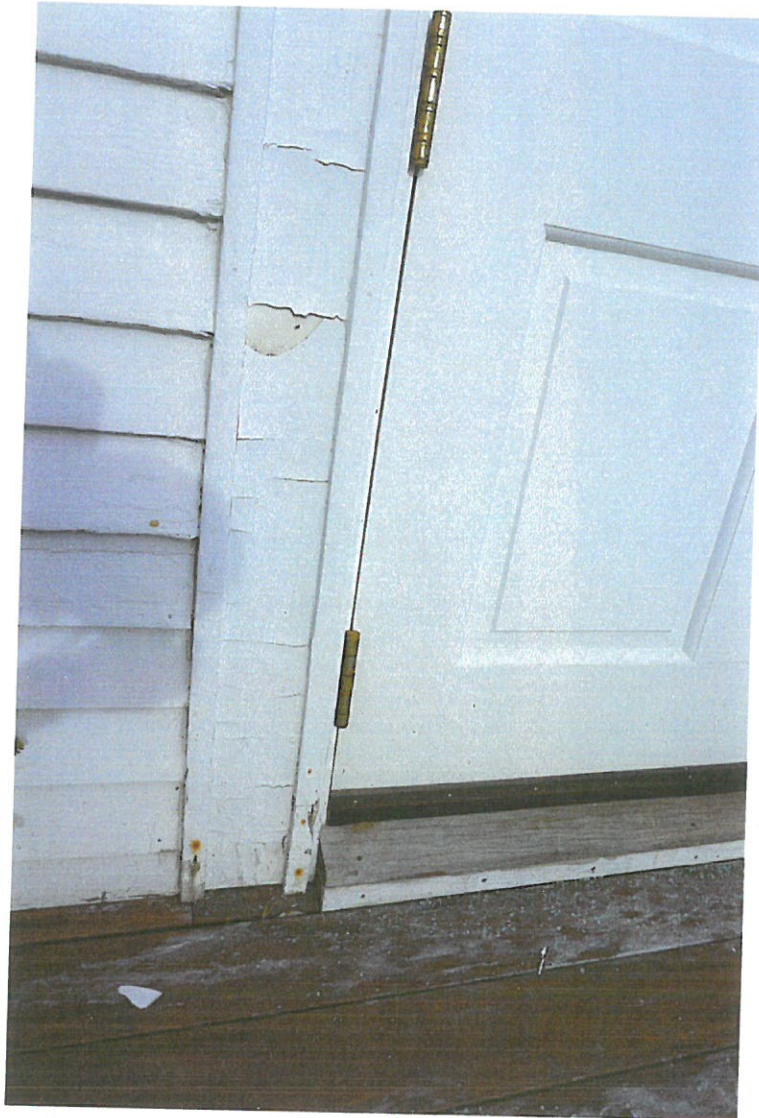
3. The window frames are fine; the door frame is okay. The door casing has an applied material plaster that is cracking and falling off. It's either hiding a problem or is a poor covering treatment.

It needs to come off and casings should be re-painted.

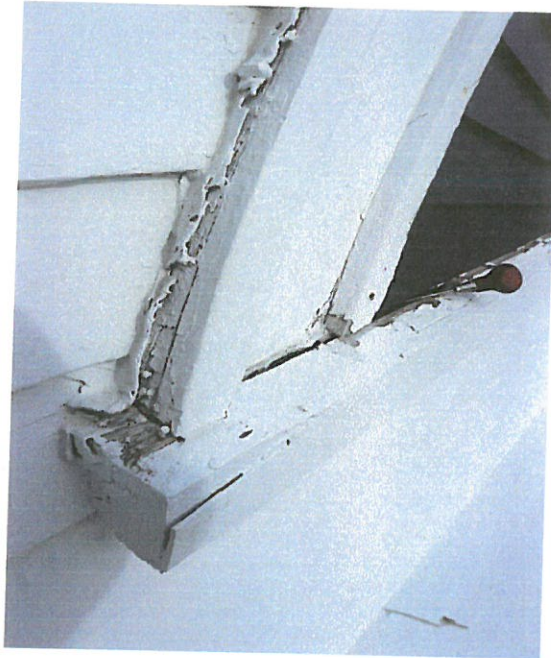
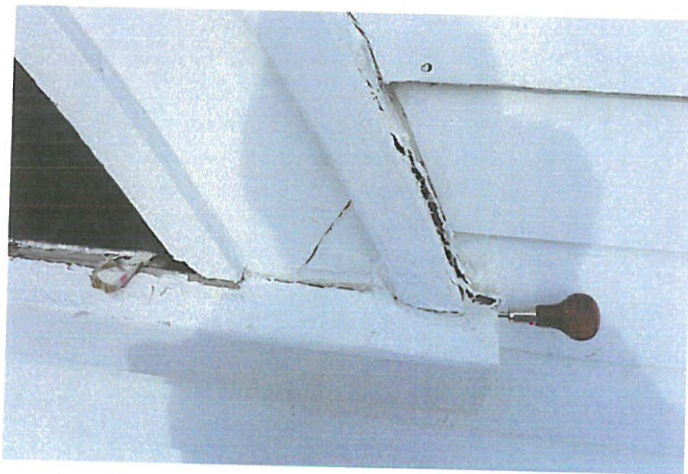
4. The fan light clapboard siding is new, however the window frame itself is original. The sill has dropped substantially. Overall, with a gap of $\frac{3}{8}$ inches from the right to left corner. The sill is very loose; no doubt that the fasteners are rusted out. Casing corners, where they meet the sill, are broken.

The sill needs to be removed and then re-positioned and re-fastened. Casing needs repairs. Curve header should be flashed.

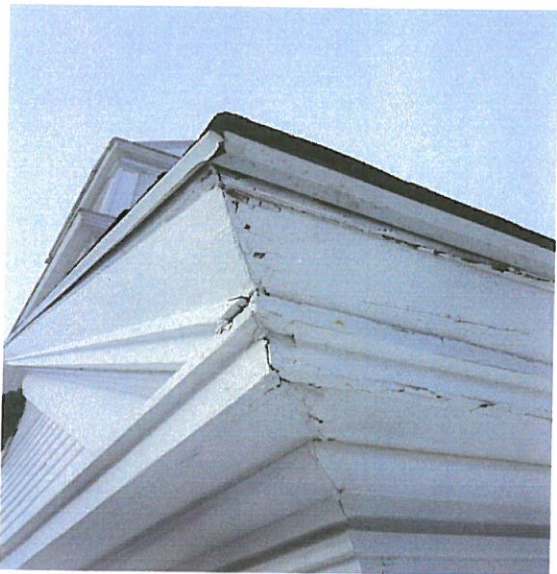
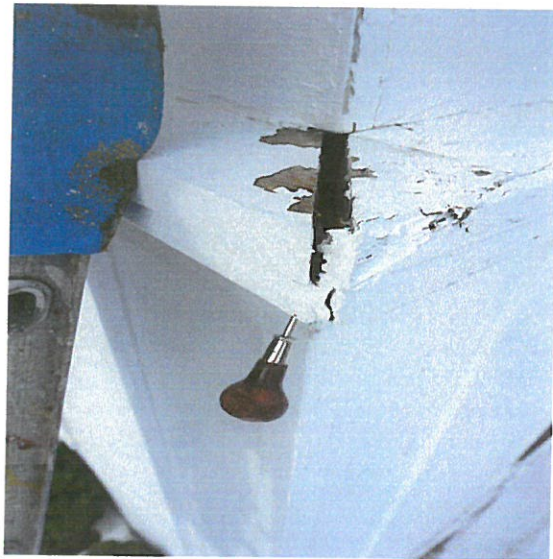
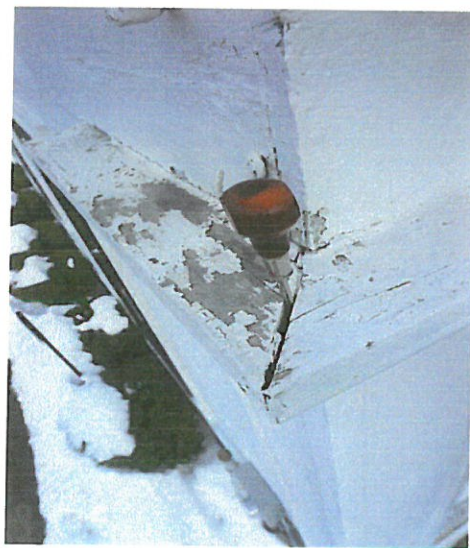
5. The lead flashing installed on the top of the water table is good.
6. The returns and miters are sound but many are gapping and opening.

They require re-nailing while others need better fillers in the open-mitered gaps and then paint. You may want to consider flashing the tops of the mitered pilaster capitals.

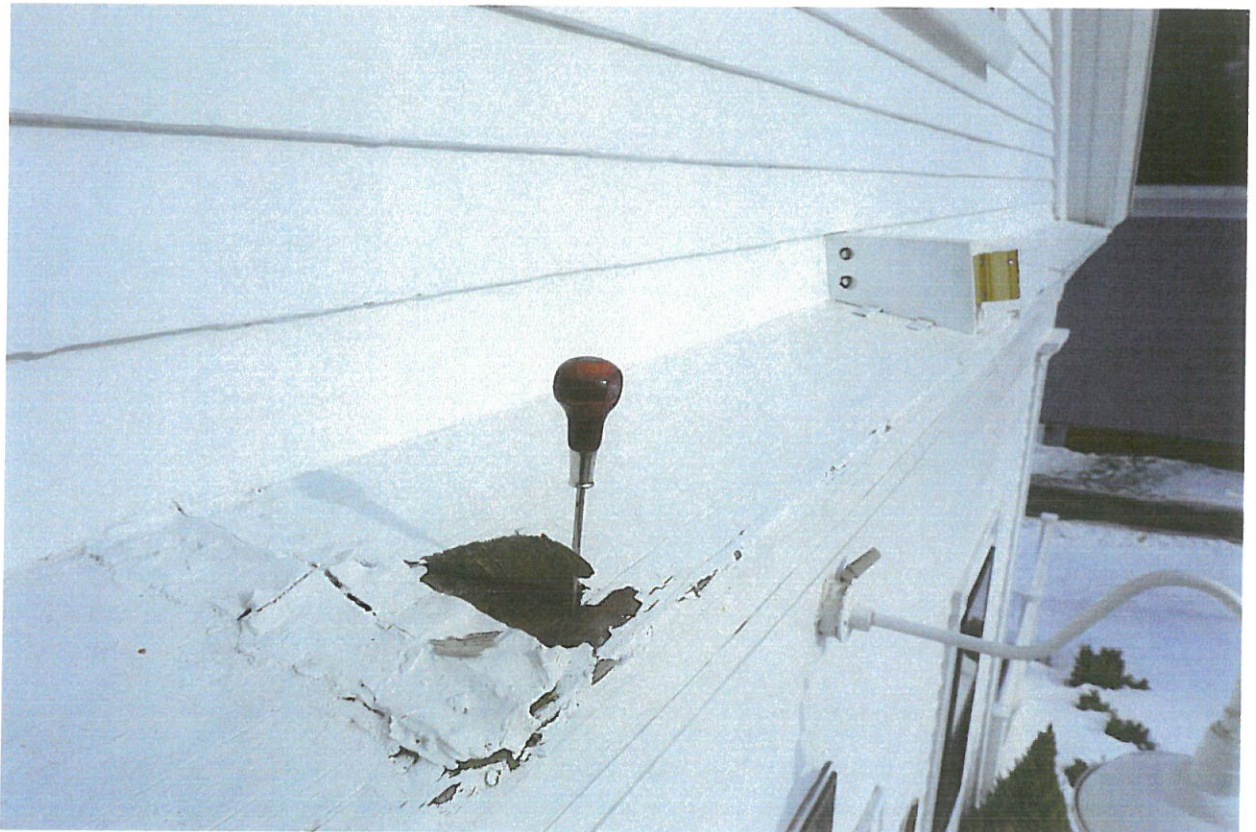
7. Inspection of the roof front gable, rakes and soffits revealed that both raking cornice mouldings are good with no obvious problems. The horizontal soffit cover board displays good wood though it is showing signs of wear and age.

A leaded copper flashing over the entire length would extend the life of this element.

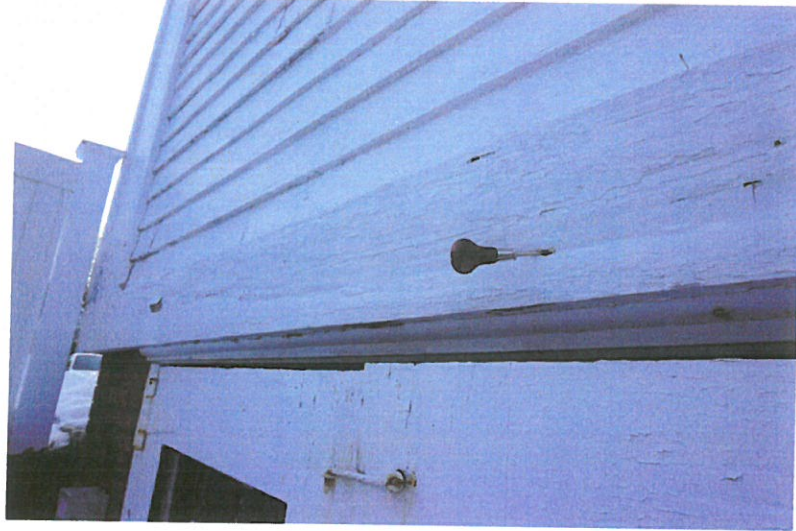
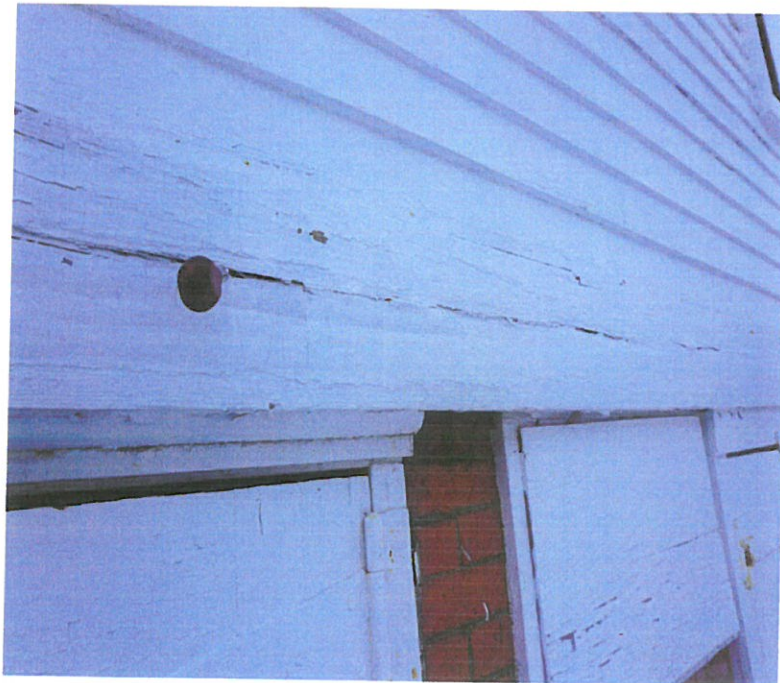
1. On the left side bottom of the building, above the basement double doors with sashes, there's approximately 22 feet of water table that is completely rotted out; 2 x 9 x 22 feet.

What is behind this rot? Does it go through to the sheathing and/or the building sill?

Inspection could not determine this condition.

Replace this section of water table, matching profile and sizing. Lead flash top of entire length of water table.

Recommend cutting out a foot-long window into the water table – three or four of them. To see what's behind them and to see how deep the rot goes and repair accordingly.

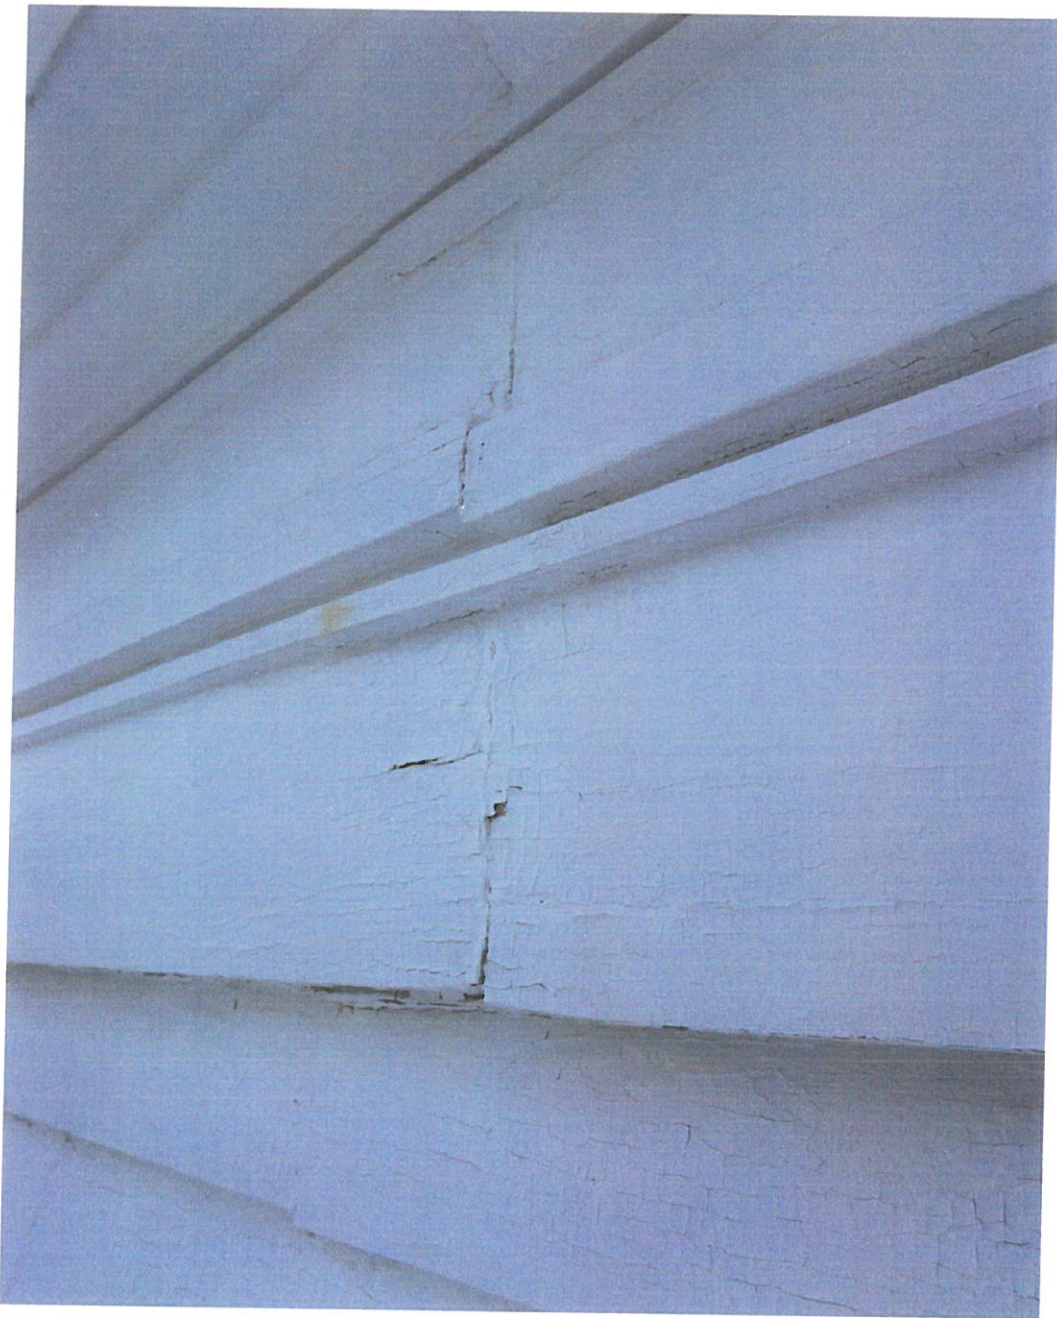
2. In the lower, right hand section, above the other pair of tongue and groove board doors there's an obvious sag in the building. All the woodwork, including the roof eave-line, has shifted. The window headers are pitched out of level. The clapboards have compressed and/or the claps have popped loose.

After further review this condition appears to be an old movement. Possibly caused by the construction of the back bay addition to the building (not the new ell) and the removal of the north rear stone foundation and gable wall. All of these observations suggest that the building sills in the northeast corner may be poorly supported and/or are rotting out. Inspection of sills could not determine their condition.

Recommend creating windows from exterior into the water table to check exterior sill façade.

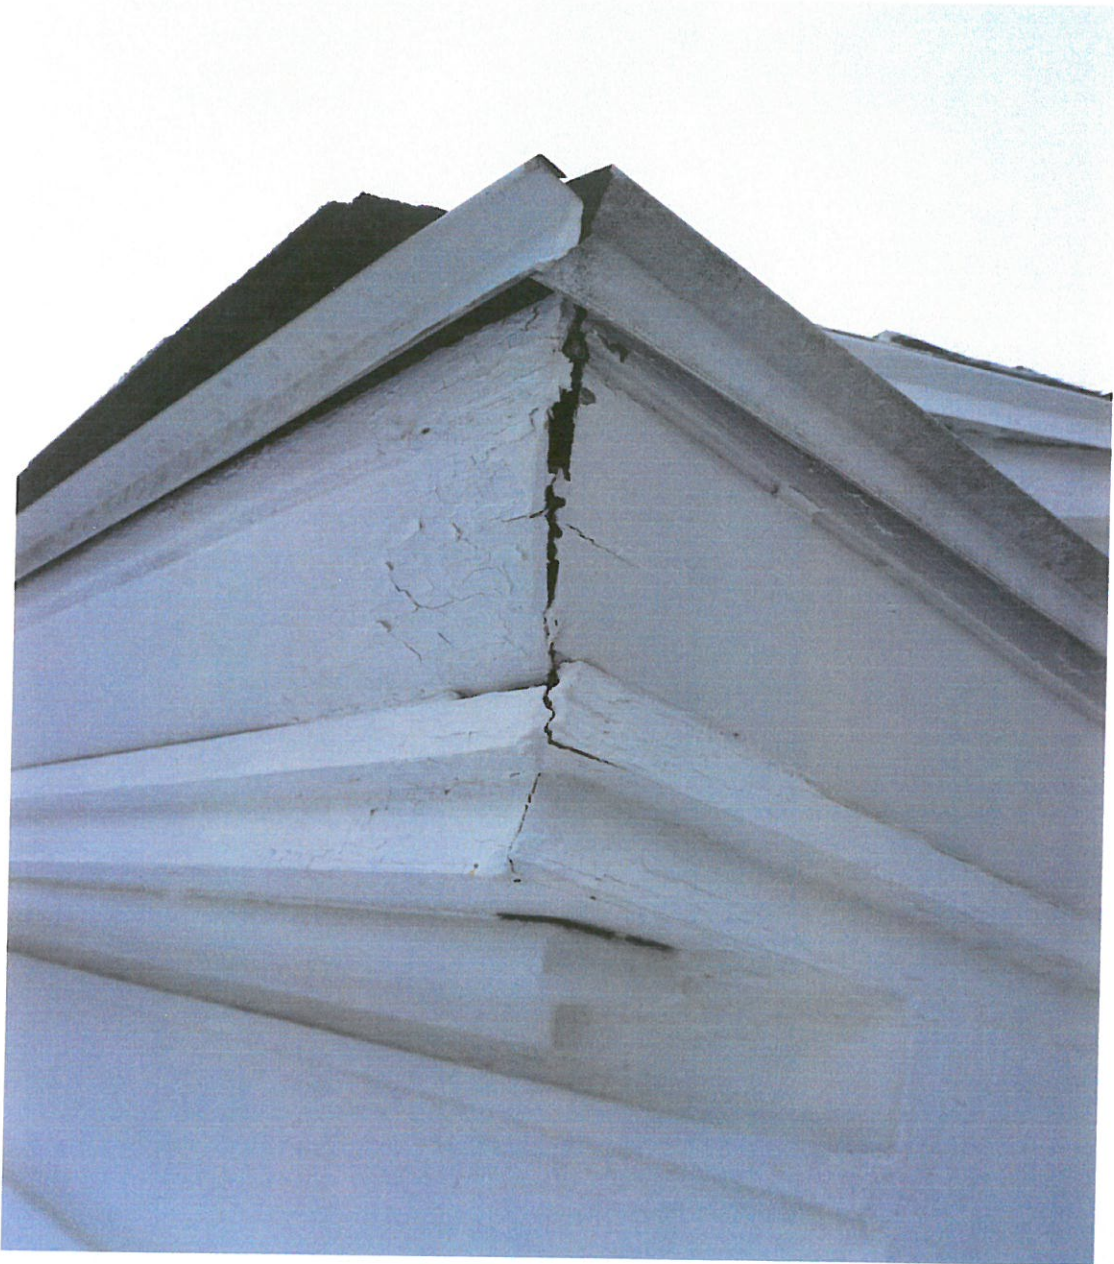
5. Right hand side corner return is falling off.

Re-attach corner return.

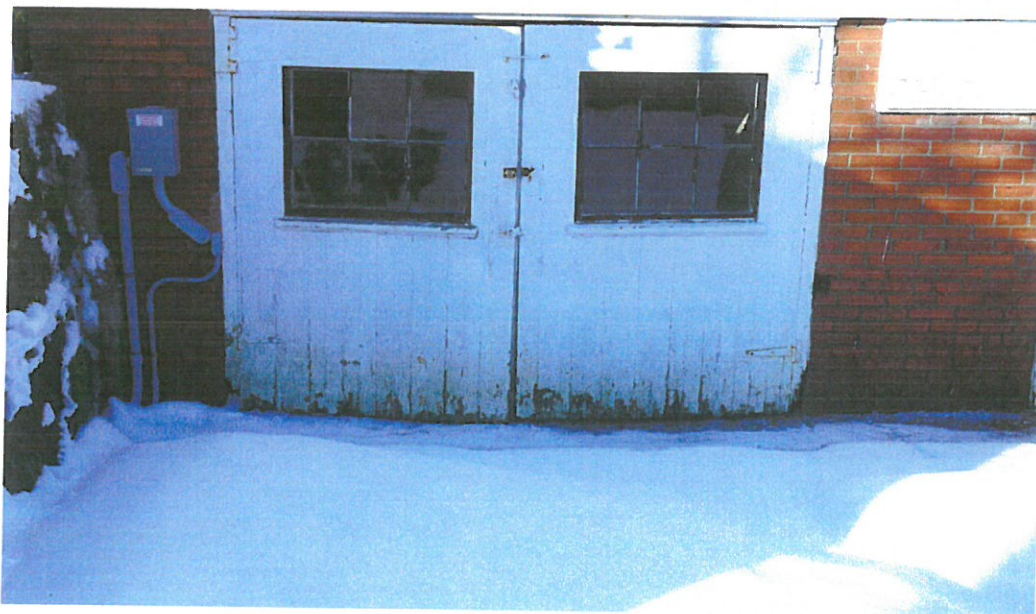
7. The middle pair of doors exhibit the same issues and the hinges are rusted out.

Repair or replace in-kind.

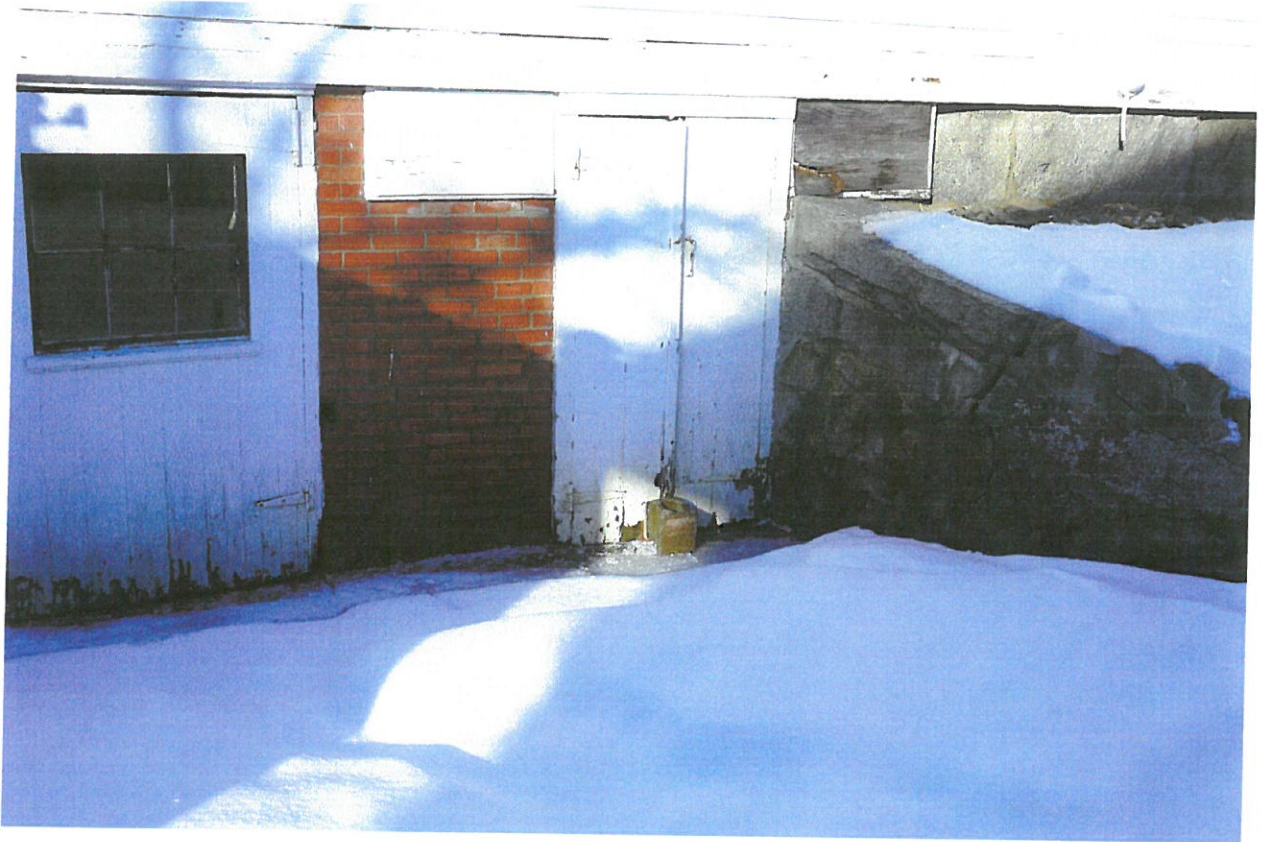
8. The third pair are new and function though they do not conform to the building's historic period. The right hand door has sagged and is not in alignment.

Consider replacement to match the historic period or re-hang right side door.

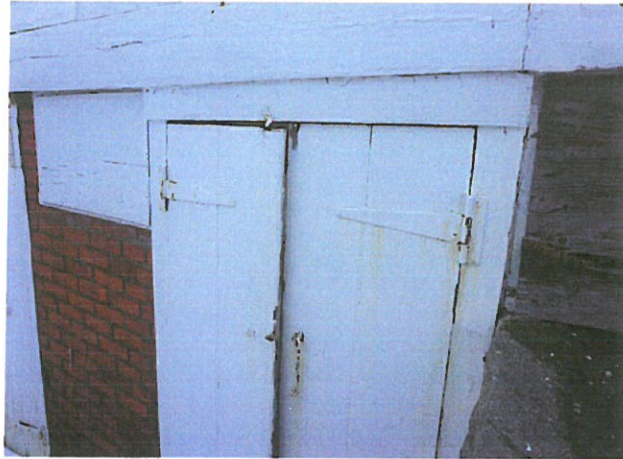
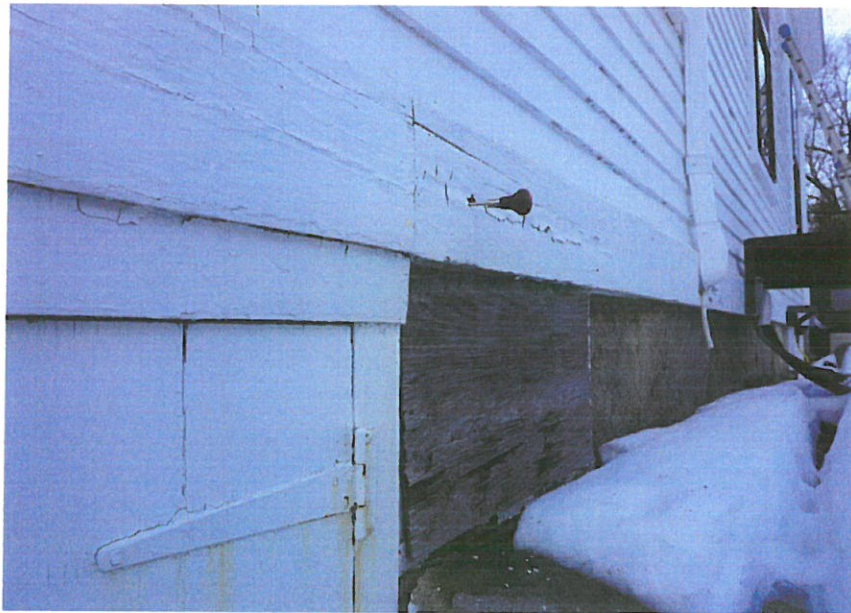
9. Two cellar windows are covered with rotting plywood.

Re-cover or uncover them and repair/restore those windows. Replace missing sash glass.

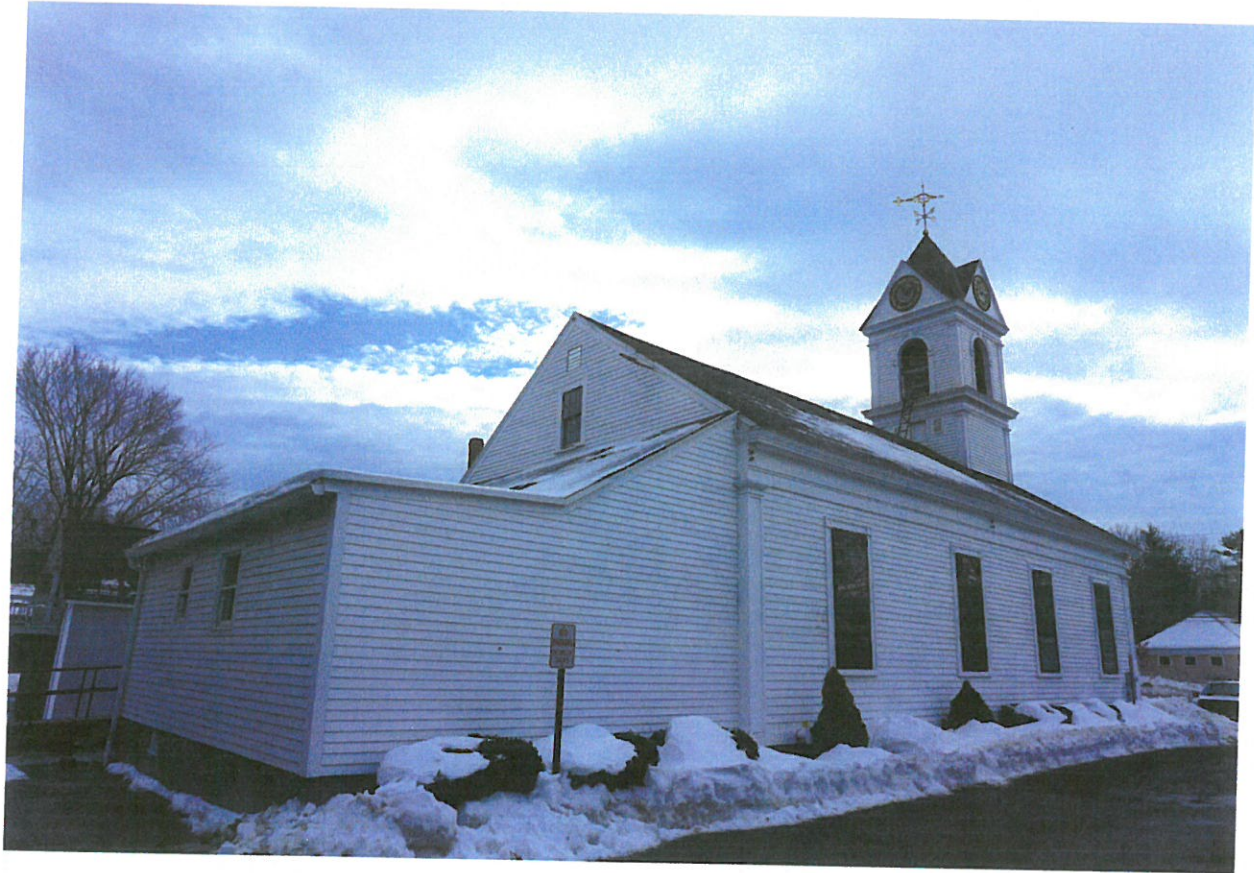
10. Approximately 80-feet of clapboards need replacing on the façade due to breaks and splits.

Repair accordingly with proper-sized clapboards. Spot re-nail northeast half of the building.

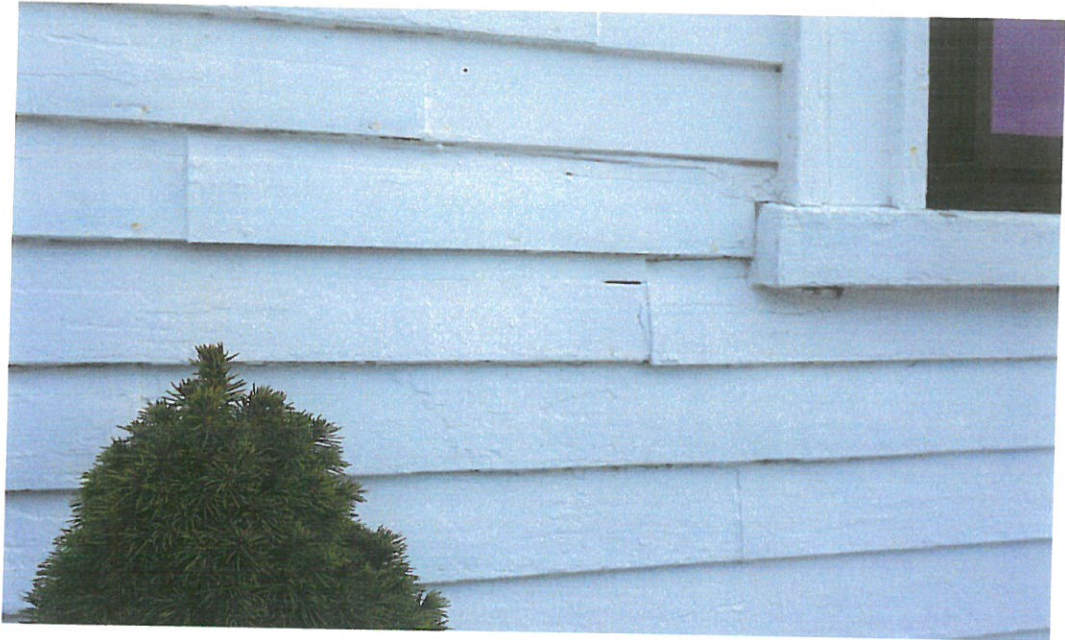
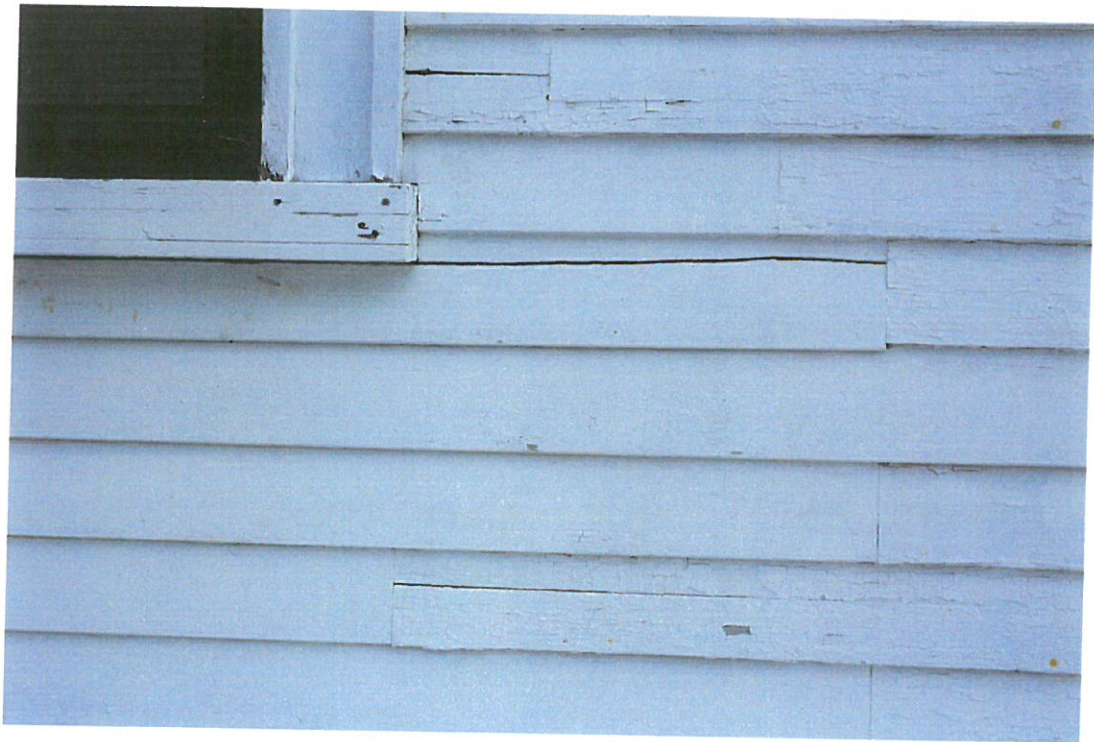
1. There is approximately 150 linear feet of considerably damaged clapboards. Many are split and broken. (See next page)

Replace in kind with appropriate materials.

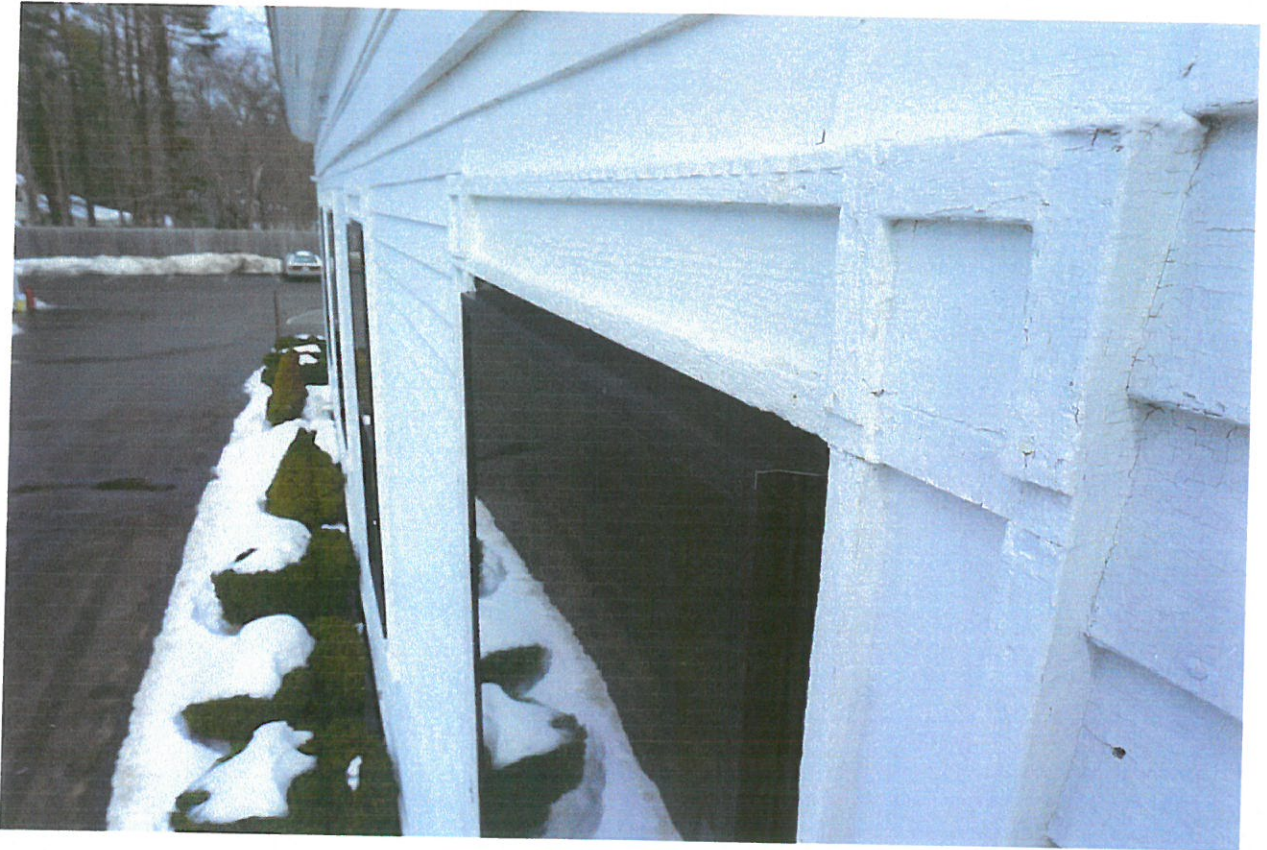
2. Some of the window block headers are loose. Three are missing trim.

*Remove and clean edges then re-fasten all headers and repair square trim.
All window headers should be flashed with overhang.*

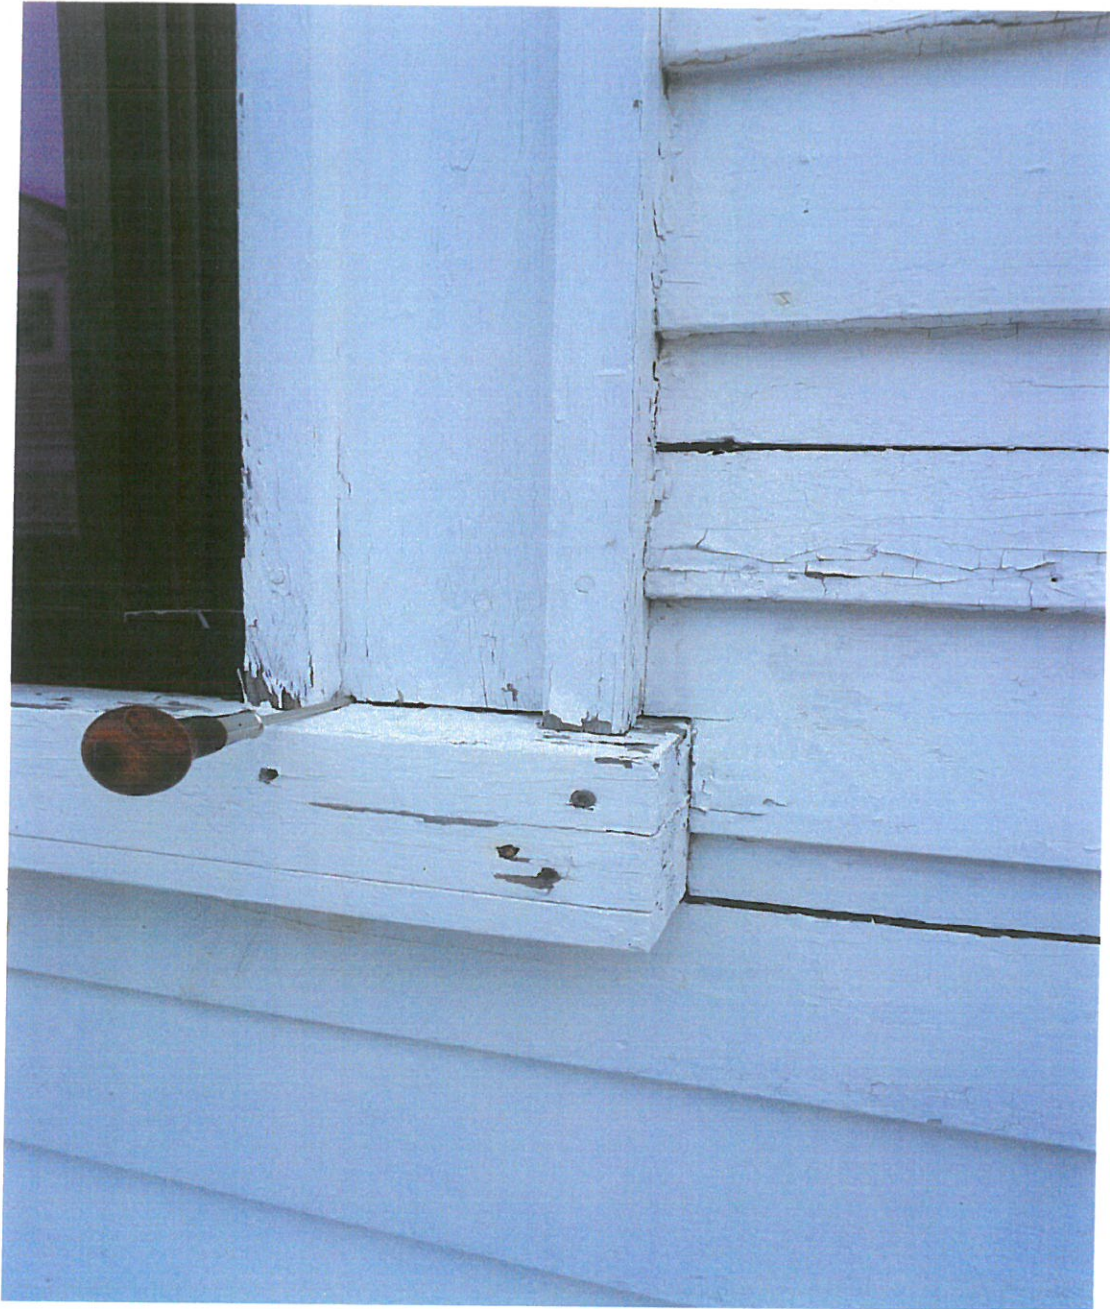
3. A new window located on the far left side is a reproduction. The sill is a three-piece laminate and the fasteners are exposed and cracking.

Recommend installation of a better quality, reproduction window sill that matches the others.

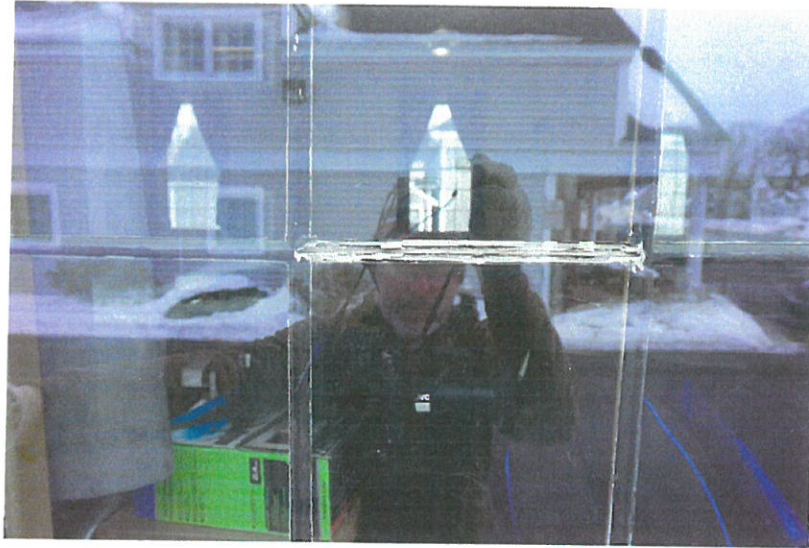
4. In one middle window, the sash bar is broken and missing.

The sash bar needs replacing.

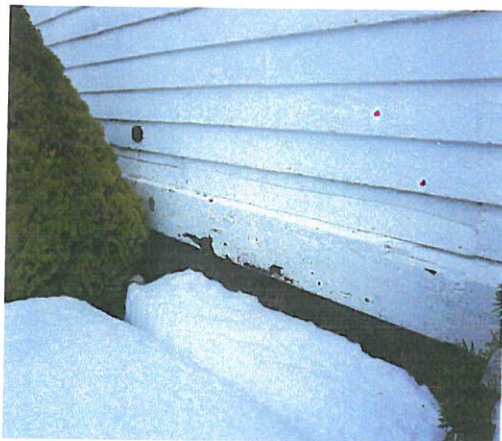
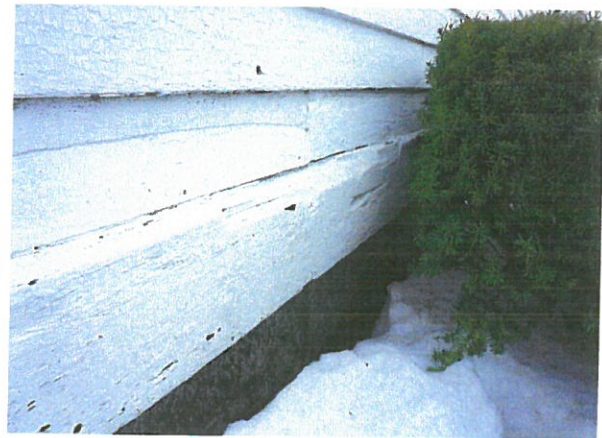
5. Water table has damage in the middle section; a large area is broken and missing a section.

Dutchman repair in-kind with a new section. All water tables need flashing.

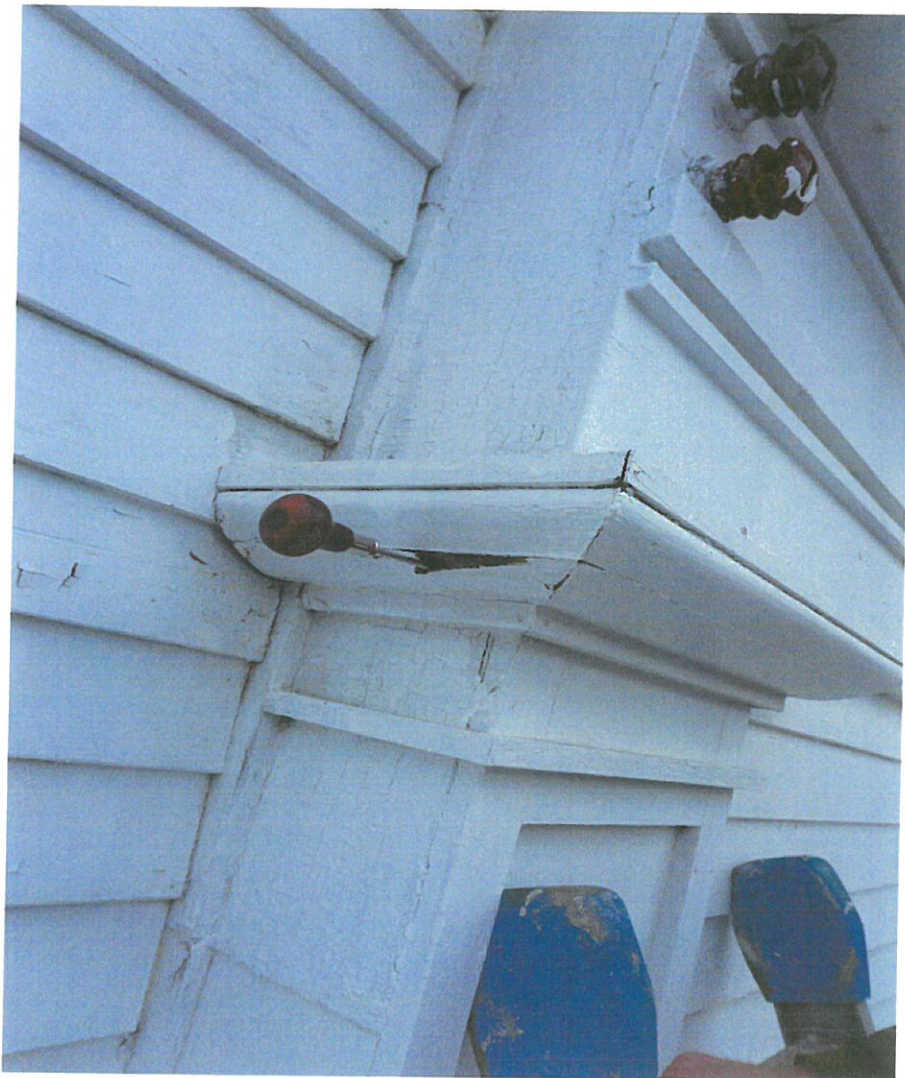
7. Northwest corner column return rotted. Northwest 20th century two-piece repair.

Replace with one piece of moulding, sized accordingly.

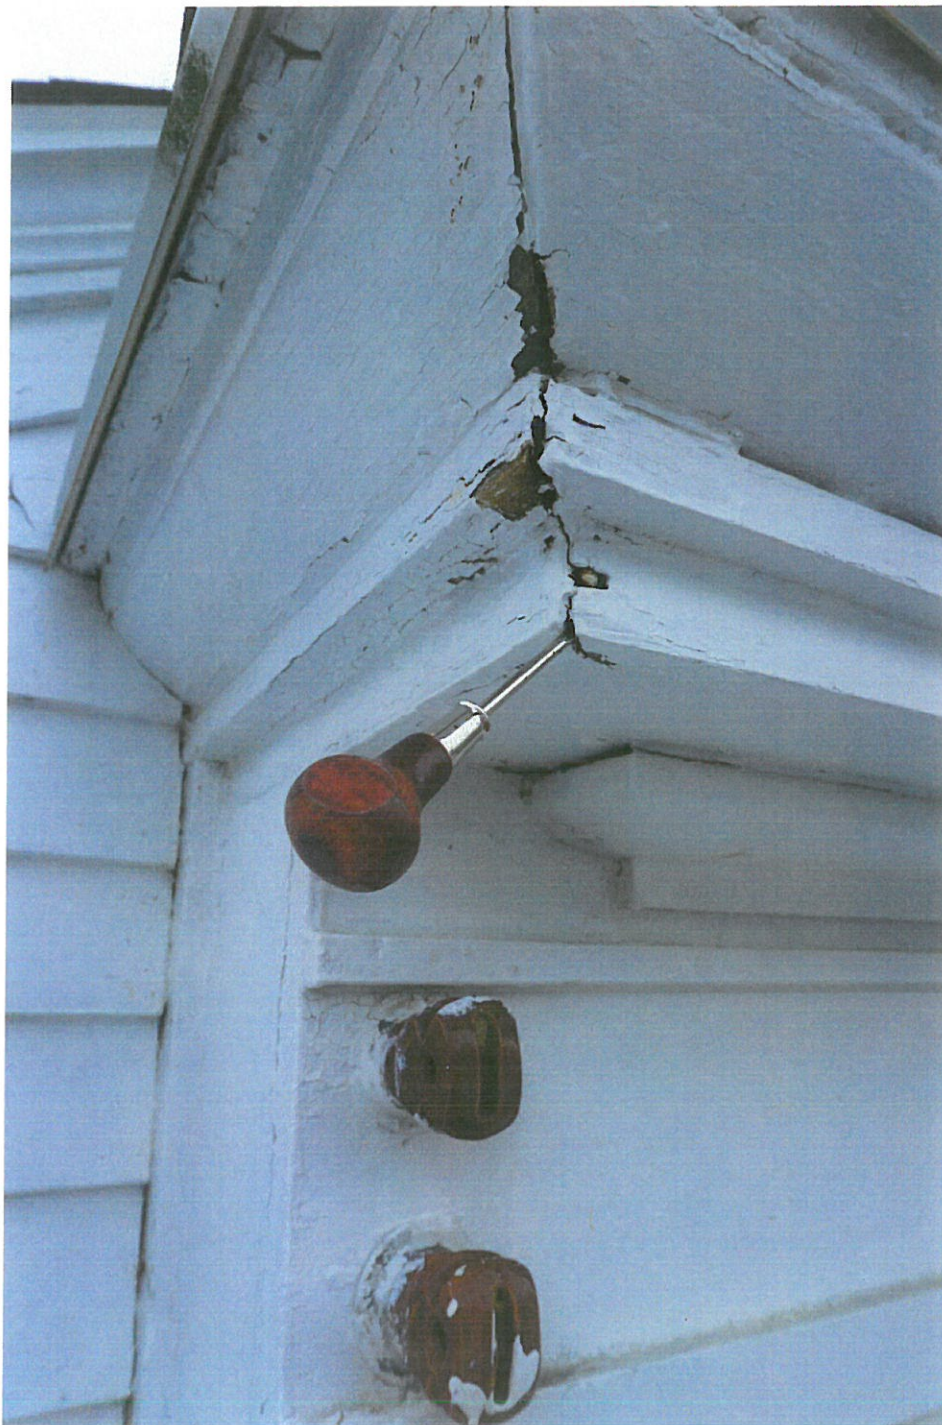
8. Open roof frieze and crown. Some rot in edge.

Cut and fill gap with Dutchman wood patch putty and paint.

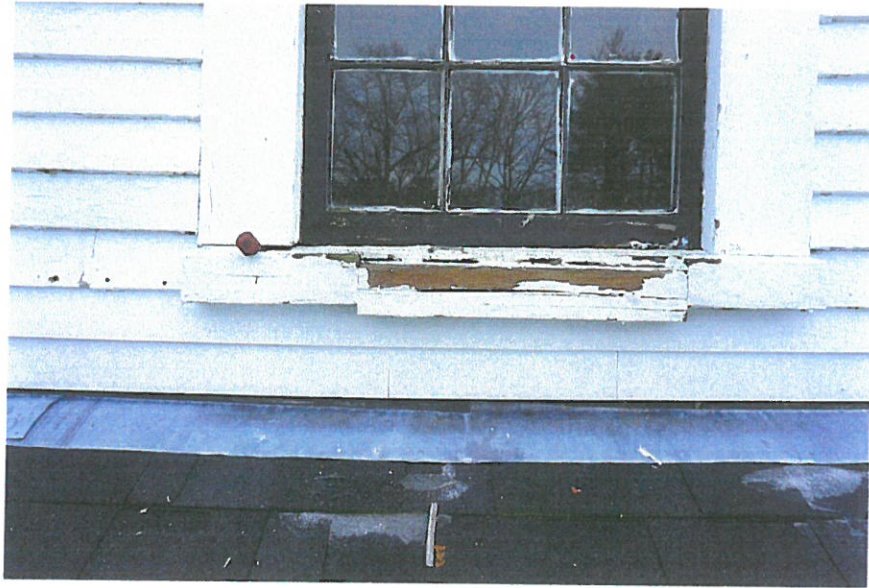
2. Gable sash and window frame have issues.

The window frame needs a new sill. A large portion of it is missing and very loose, dropping out of frame due to rusted fasteners.

The lower sash bottom rail is rotten and sash glazing is falling out.

Replace in-kind.

Repair sash and re-glaze. Consider installing a storm window for protection of sash.

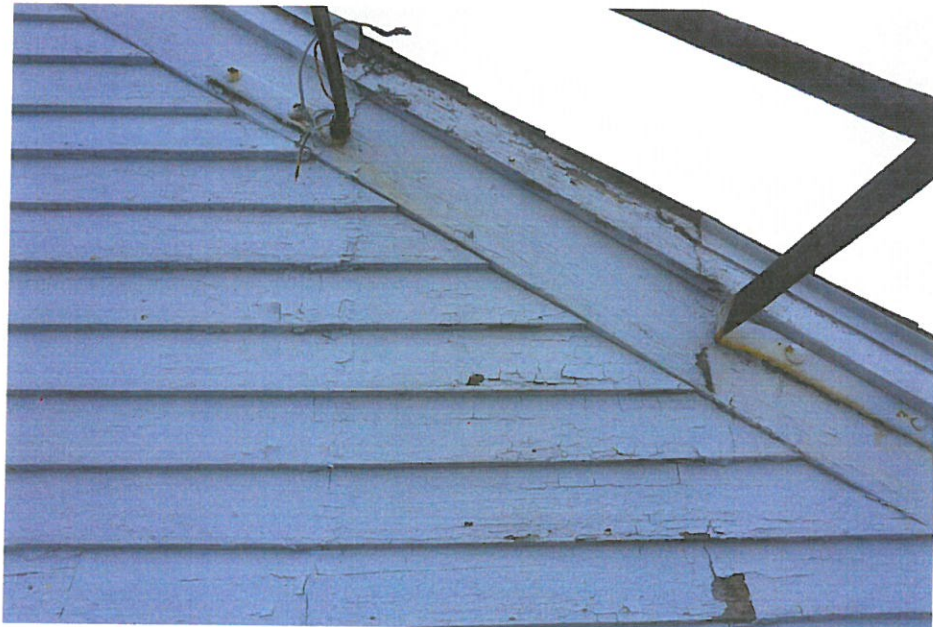
3. The metal chimney bracket should be removed.

Holes in the rake need to be filled where the bracket is and install missing flashing section along roof and chimney line.

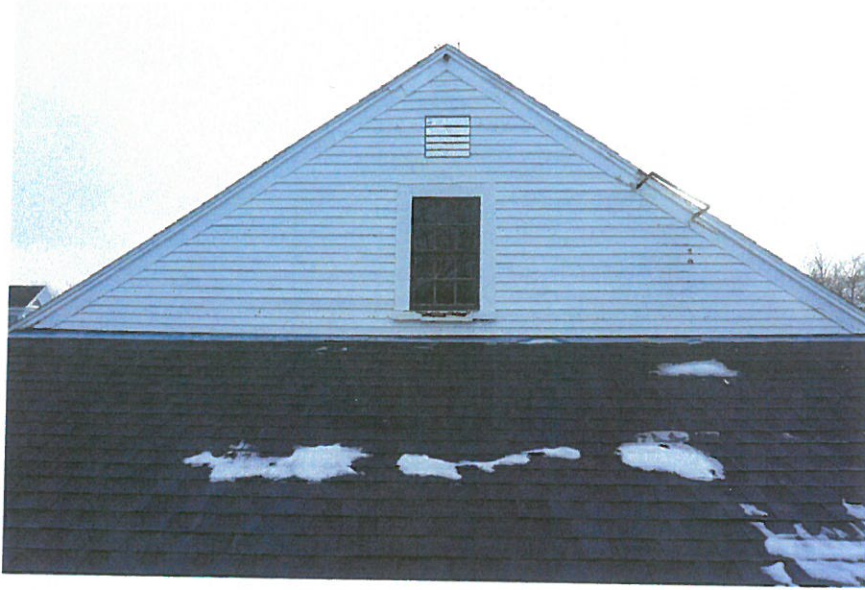
4. There is a section of approximately 30 linear feet of clapboards that need replacement on north façade gable due to splits and breakage.

Replace in-kind with appropriate material and re-nail all existing claps as they are very loose.

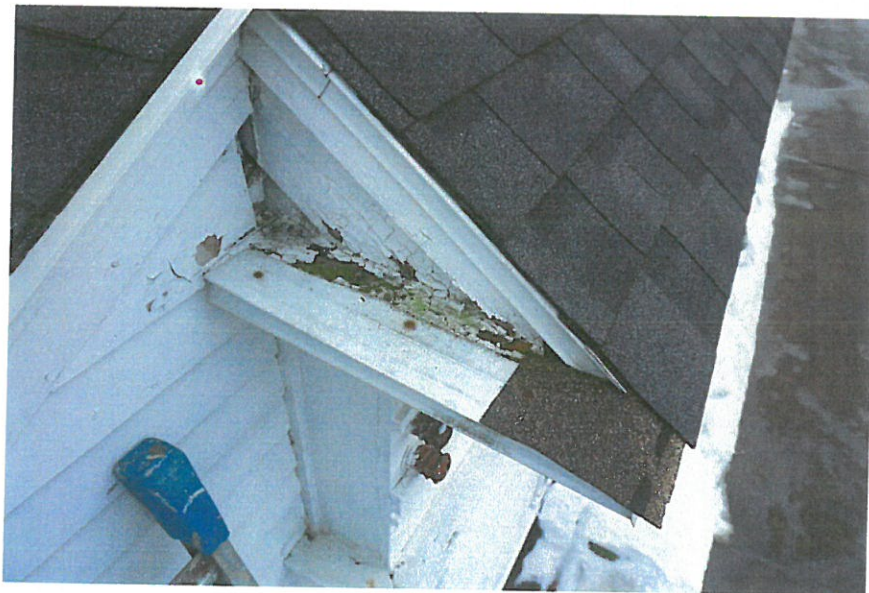
5. Roof returns need top flashing.

Install lead flashing.
