1844 Town Hall

North Hampton, NH

Exterior Conditions Assessment Report

February 2018

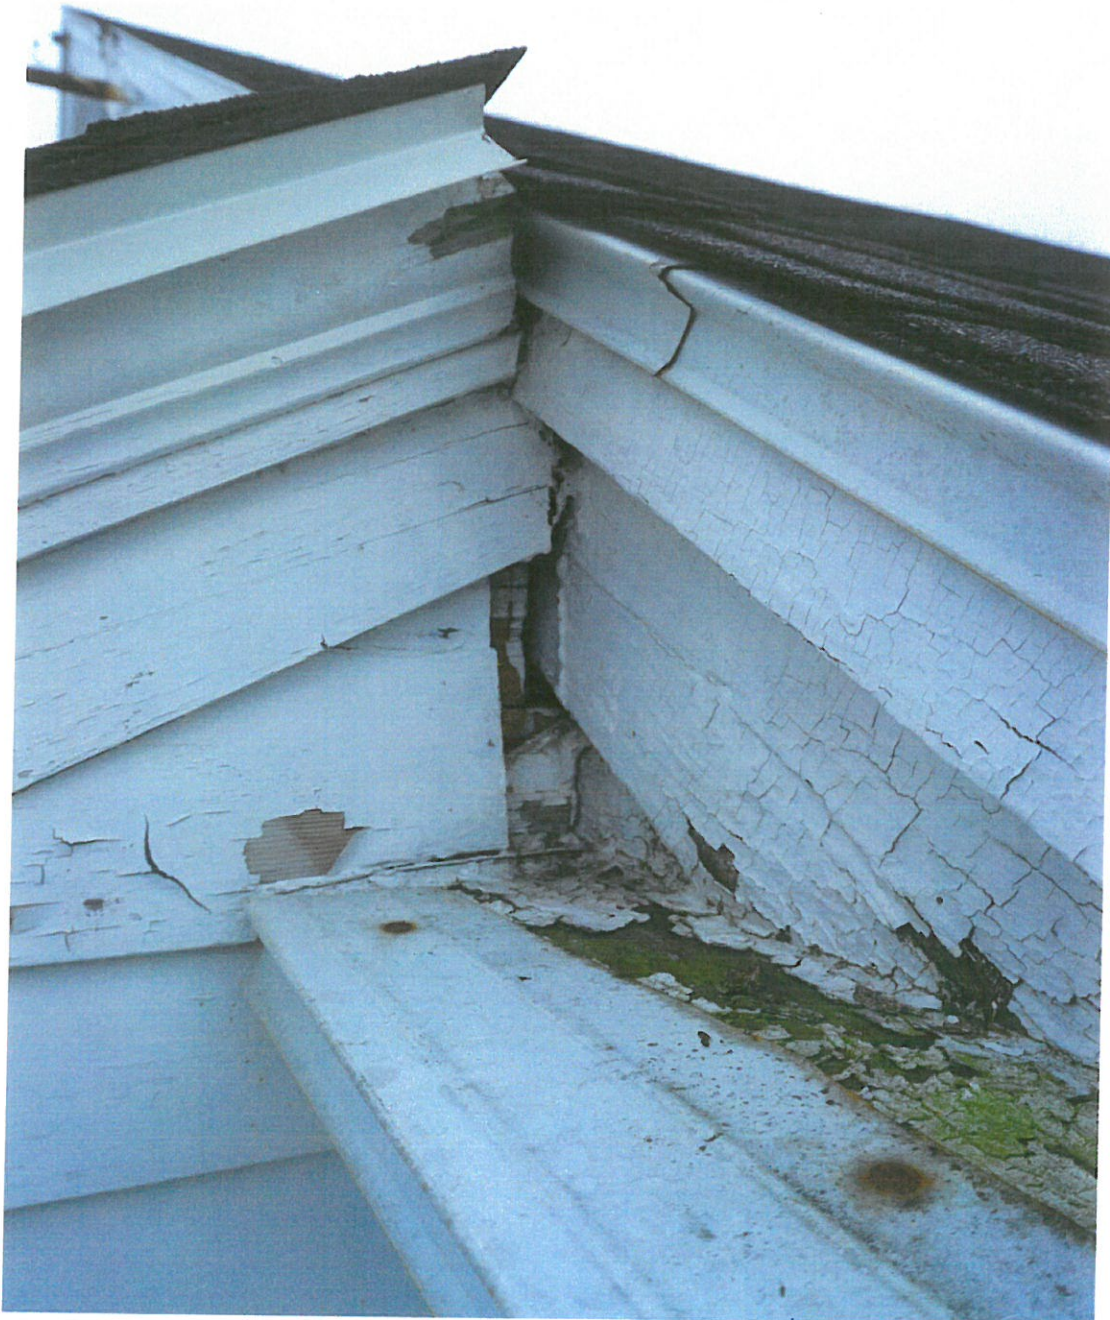
6. There needs to be improvement of flashing where the ell roof joins the gable of the main building. I can see daylight in the attic in this area.

Install flashing and fill gaps in this area.

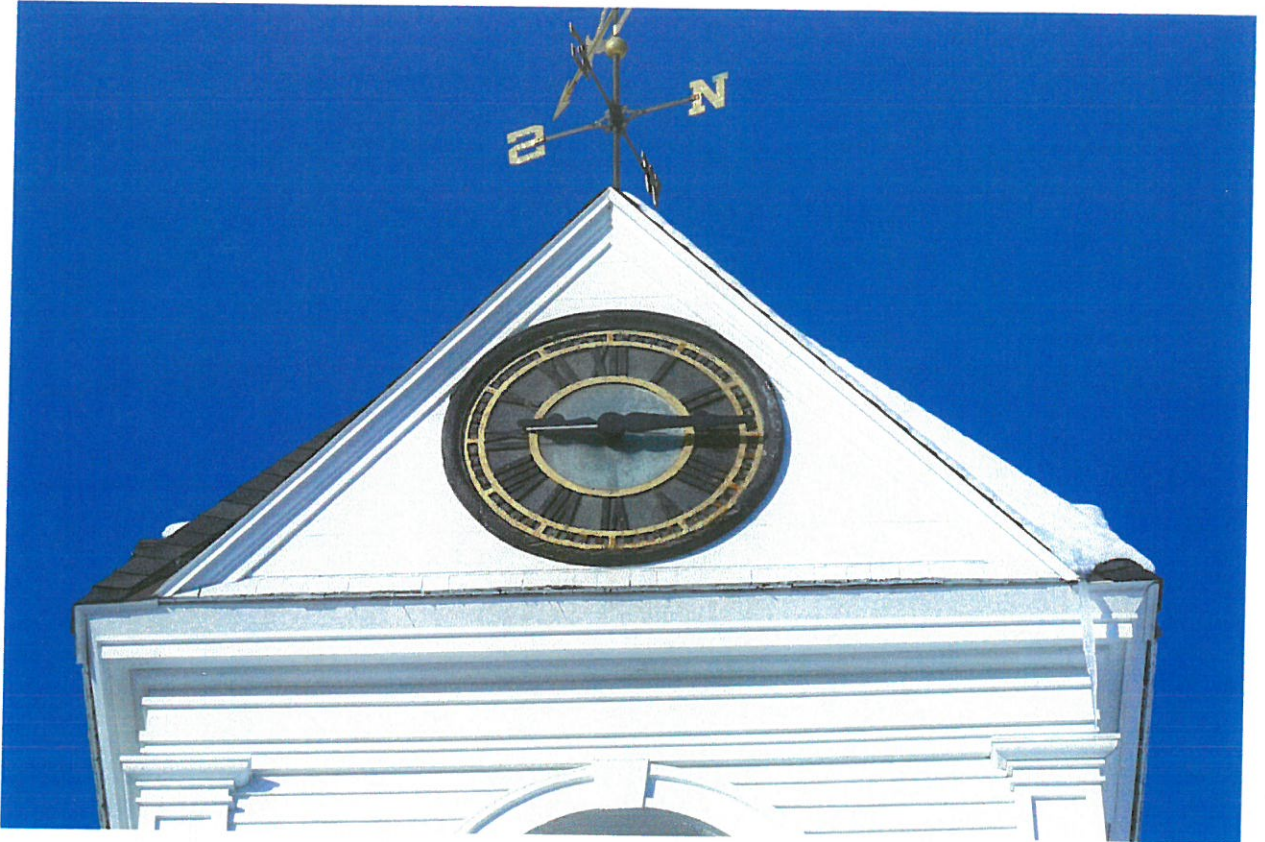
1. There are wood clock faces on all four sides. The one on the east side is really in rough shape. The mouldings have gapped and split and loosened.

Though the clock face has new hands, the east clock face dial face needs repair and conservation.

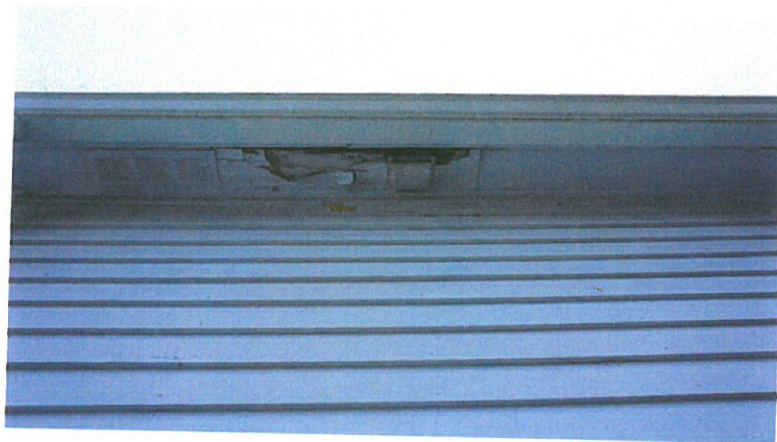
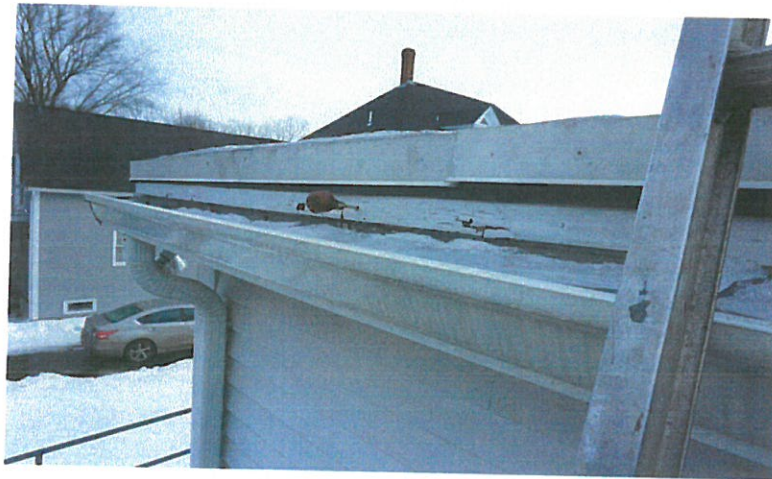
1. This side is more problematic. The soffit and frieze behind the gutter are rotted along its entire length.

These need to be replaced with new material. Install full-length soffit vents.

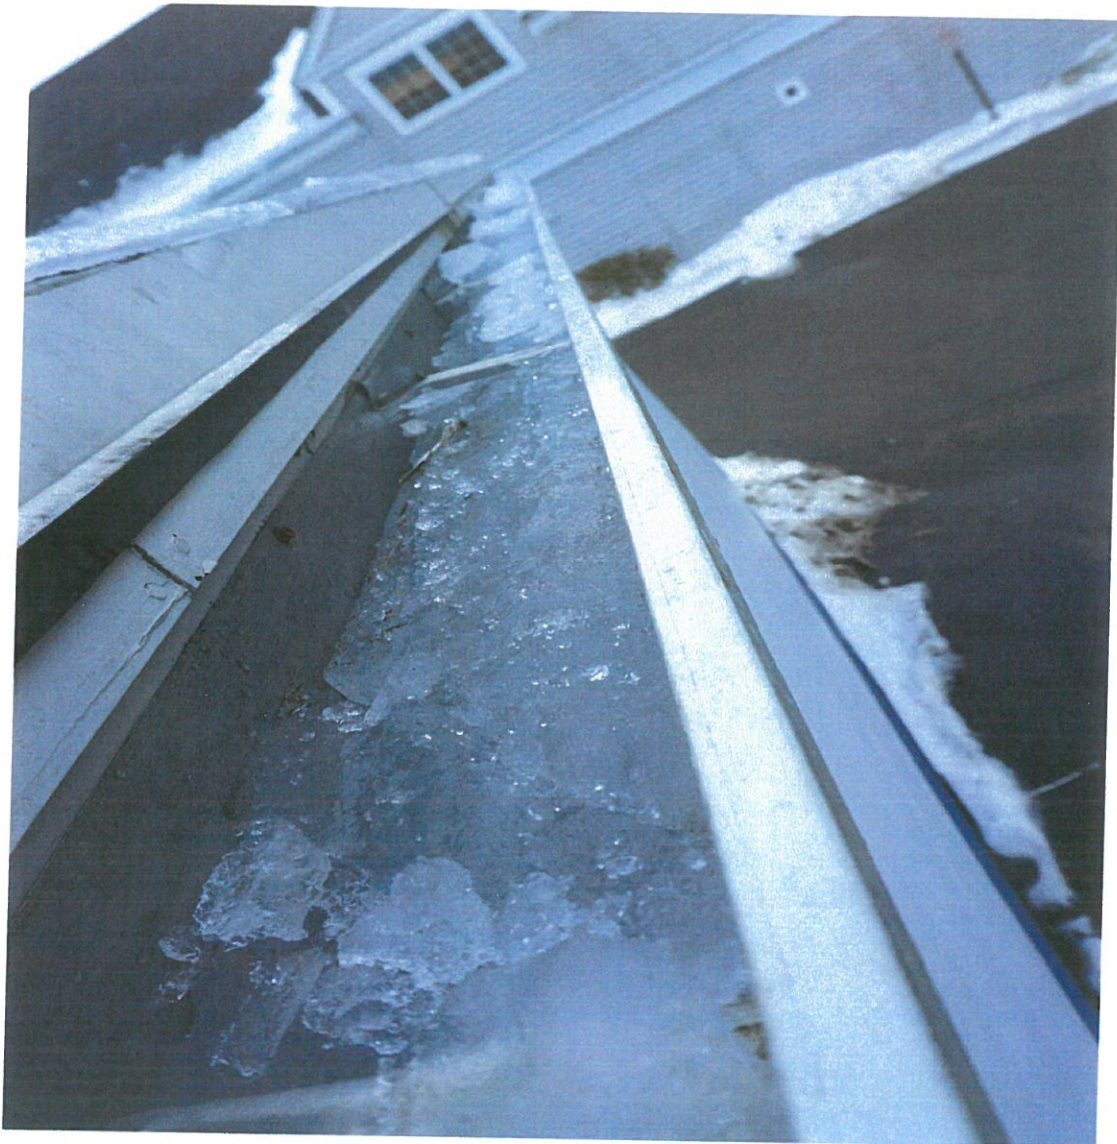
2. The gutter is sagging and not pitched properly.

Re-hang gutter for proper pitch and consider a second down spout as the existing downspout is blowing past its draining site. The down spout needs to be re-aligned so water drains down the pipe. The connector is broken and needs to be fixed or replaced. Consider second downspout as gutter length is quite long for just one.

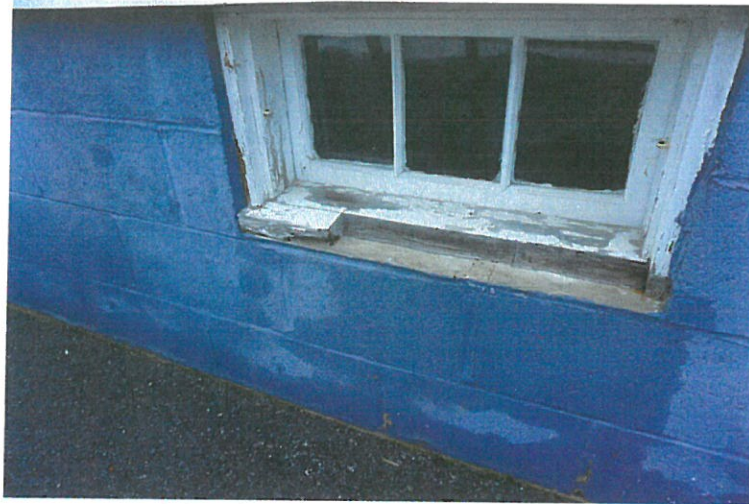
1. A portion of the cellar window sill is missing.

The sill needs replacement.

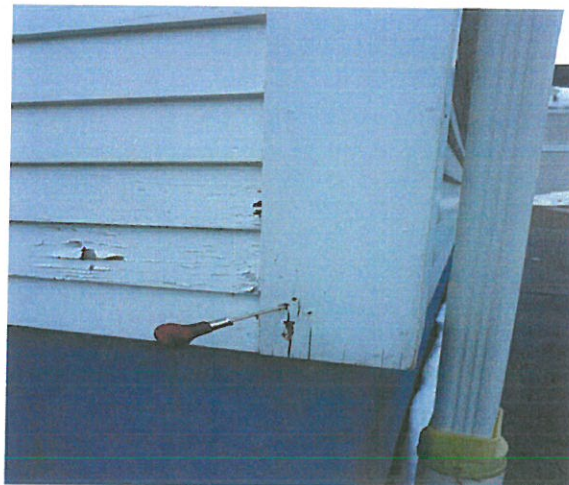
3. Northeast corner board rotten on ends.

Patch northeast corner boards with wood repair.
