Capital Improvements Plan (CIP) for FY2016-FY2021

Foley Buhl Roberts & Associates
Structural Report

April 25, 2014

Re: North Hampton Fire Department, 235 Atlantic Avenue, North Hampton, NH
Preliminary Structural Review and Assessment

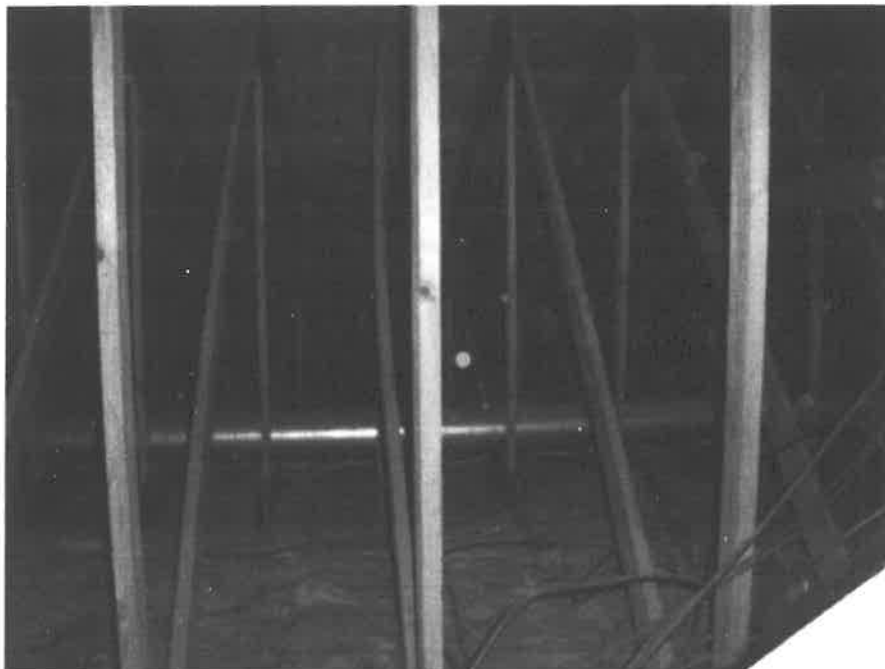
1. Bowed diagonal web members, absence of Continuous Lateral Bracing (CLB), also called "Through Truss Bracing": Wood trusses often require installation of additional wood framing through (i.e., perpendicular to) the trusses in order to reduce the buckling

length of compression web members. The CLB resists the tendency for the compression member to buckle out of plane, thereby increasing the load capacity of those members. While it is possible to design truss installations that do not require this type of bracing, doing so would be unusual for trusses of this size and configuration. This roof structure has no CLB on any of the web members. Furthermore, I noted several 2x6 web diagonal members that are permanently bowed out-of-plane (see photo 3). This is an indication that the roof has been overloaded in the past and that these web member should have had CLB installed on them when the building was first constructed in order to allow these web members to be fully effective. The absence of CLB and the resulting observed buckling of web members significantly reduces the snow load capacity of this roof. This finding should be confirmed by a quantitative structural analysis of the trusses. An analysis of this type is beyond the scope of this initial assessment. This observation (i.e., the absence of CLB thru-truss bracing and the observed bowing of web members out-of-plane) is the most serious deficiency noted during this assessment.

Photo 3: Bowed truss web diagonals, no thru-truss bracing.

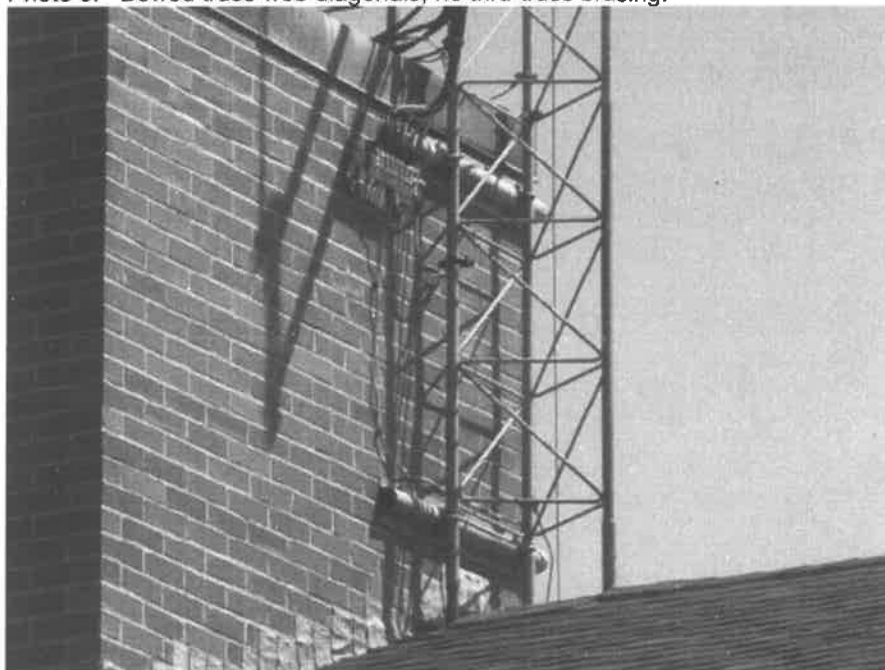
The tower itself has three vertical legs. The two northerly legs are secured to the masonry of the hose tower. Those attachments appear adequate for resisting lateral wind loads on the tower. However they do not serve to support the vertical weight of the tower or to resist the downward thrust of the resulting from wind loads acting on the tower. Those vertical loads are transmitted to the plywood roof deck at the base of the tower via a bearing plate. No supplemental framing or reinforcement has been added beneath the roof deck to support the vertical loads imposed by this tower.

Photo 4: Radio antenna tower and hose tower.

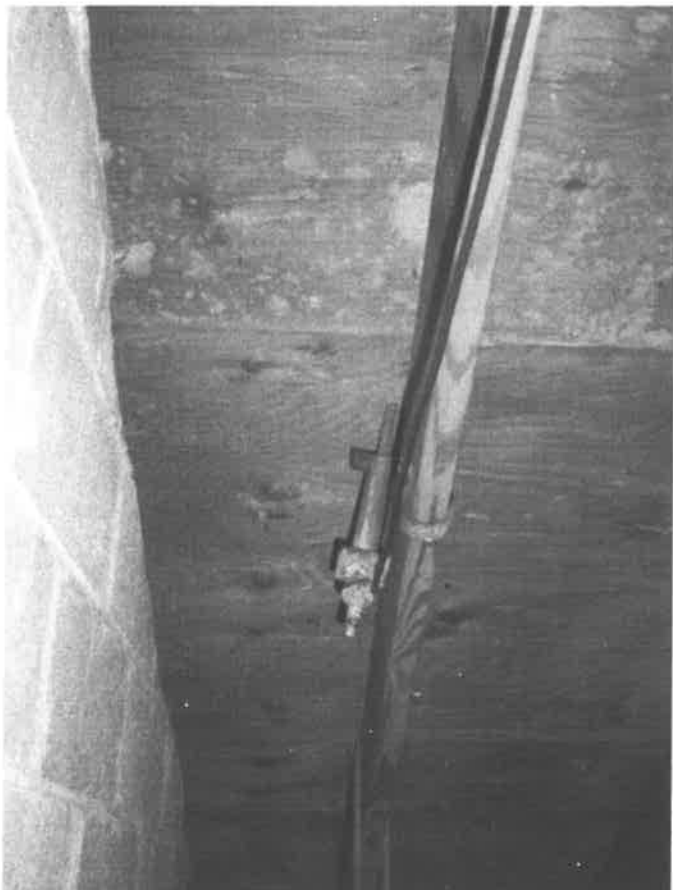
All of the tower guy wires are secured to the building roof. The anchorages for the guy wires include a hooked bolt that penetrates the roofing and roof deck and hooks under a truss top chord (see photo). These anchorages appear to be inadequate and should be reviewed by a qualified antenna installation firm.

Photo 5: Antenna guy anchorage to truss top chord.

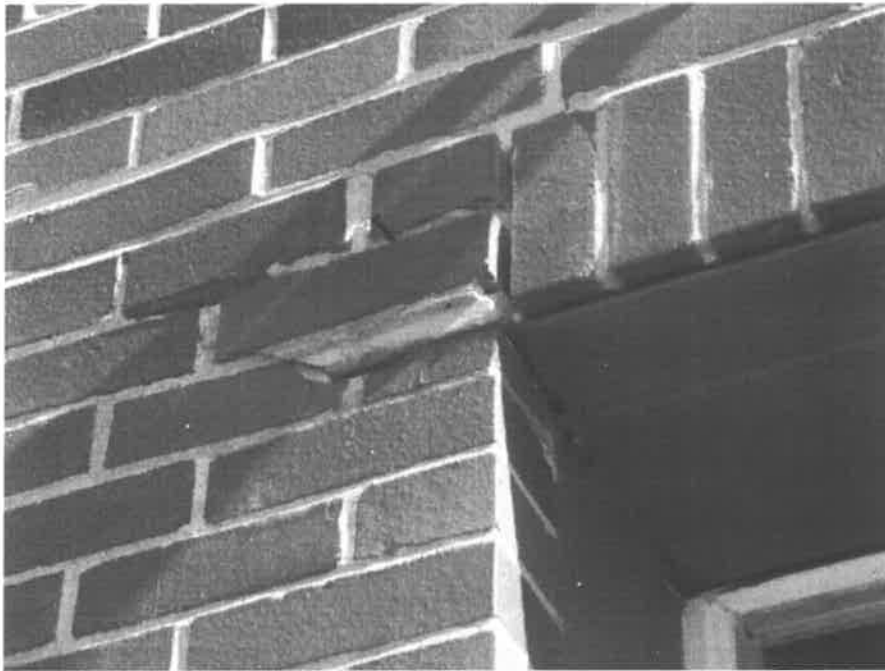
Damaged, displaced, or "step-cracked" masonry was observed at the upper corners of two of the apparatus bay overhead doors. Specifically, this damage is visible at the east corner of the east door and the west corner of the west door. At the east door, this damage is likely related to the outward movement of this wall noted in the preceding paragraph. At the west door, the damage is more localized and was likely caused by a vehicular impact.

Photo 6: Damaged exterior masonry, west overhead door.

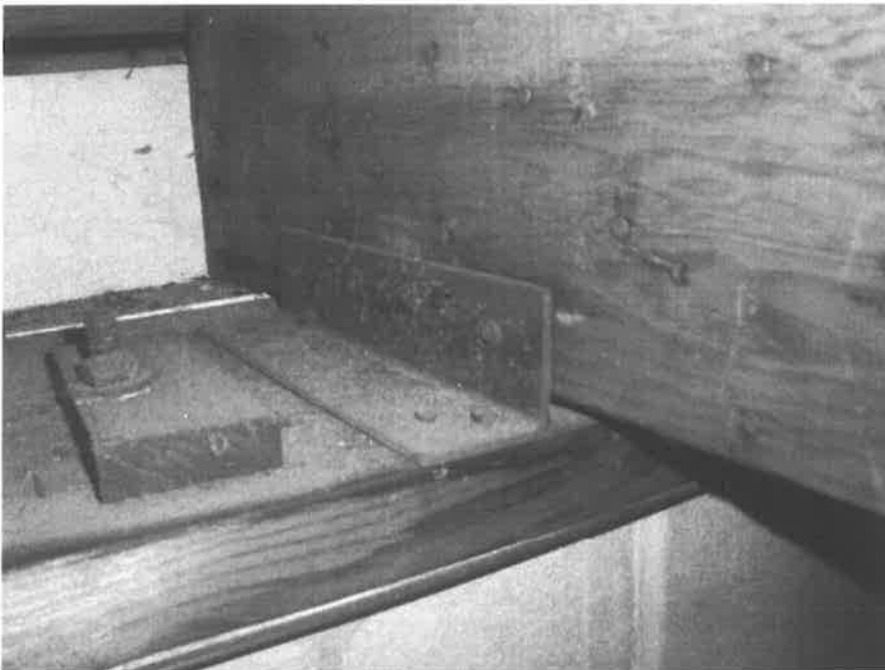
2. Anchorage at bearing points: The trusses are secured to the bearing plates at the tops of the masonry walls with an angle on one side of the truss. In my opinion, this connection is inadequate to resist the wind uplift loads found in the current Building Code.

Photo 7: Truss bearing, clip angle, wall plate

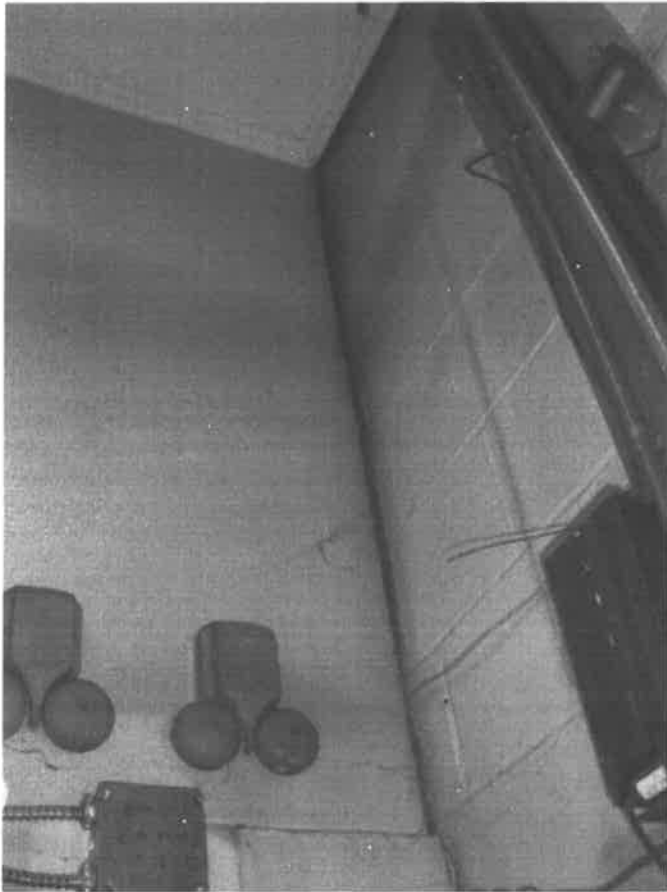
The south gable end wall of the building appears to be separating from the interior partition wall that separates the apparatus bay from the office area. This separation is of varying width and is

approximately $\frac{3}{4}$ " wide near the ceiling line. This condition appears to be due to an outward "lean" or rotation of the south gable end wall.

Photo 8: separation of south gable end wall (at right) from intersecting interior wall (left).
