CULVERT INSPECTION REPORT

**NHDOT 43937
NORTH HAMPTON**

**US ROUTE 1
OVER LITTLE RIVER**

Location: U.S. Route 1 (Lafayette Road) over Little River
Locale: North Hampton, NH
Purpose: Culvert Investigation

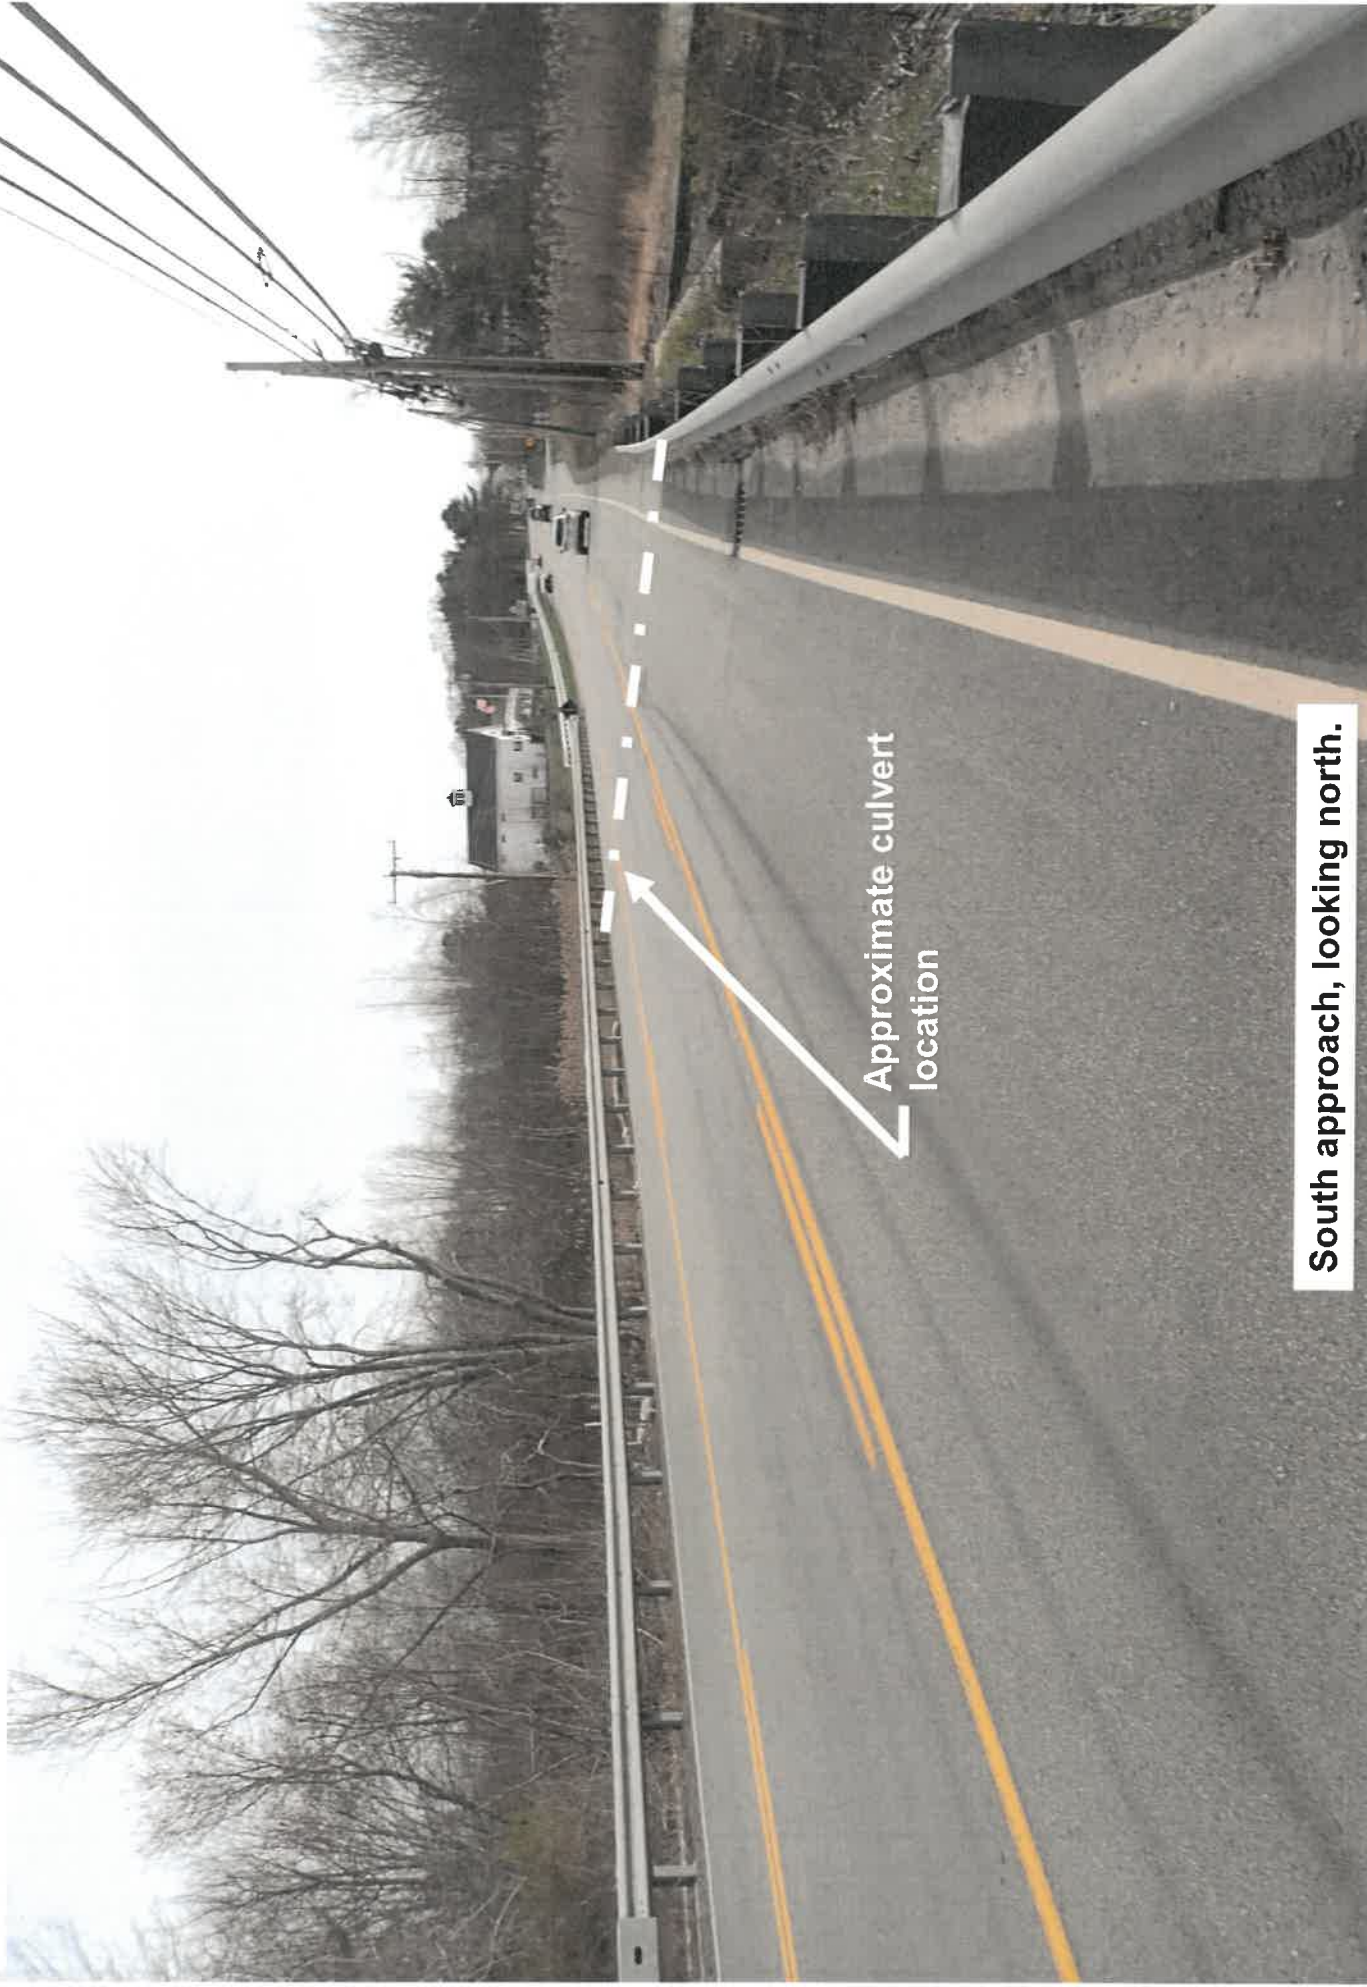
U.S. 1 over Little River
Photo: 2

The asphalt roadway over the structure was generally in good condition, displaying no evidence of settlement. There were a few areas of minor cracking most prevalent along the northbound edge of travel way line **(Photo 2)**. The rip rap placed between the west guardrail and the west headwall did not display any evidence of active settlement **(Photo 4)**.

(Areas of minor cracking)

Roadway over the culvert, looking southwest.

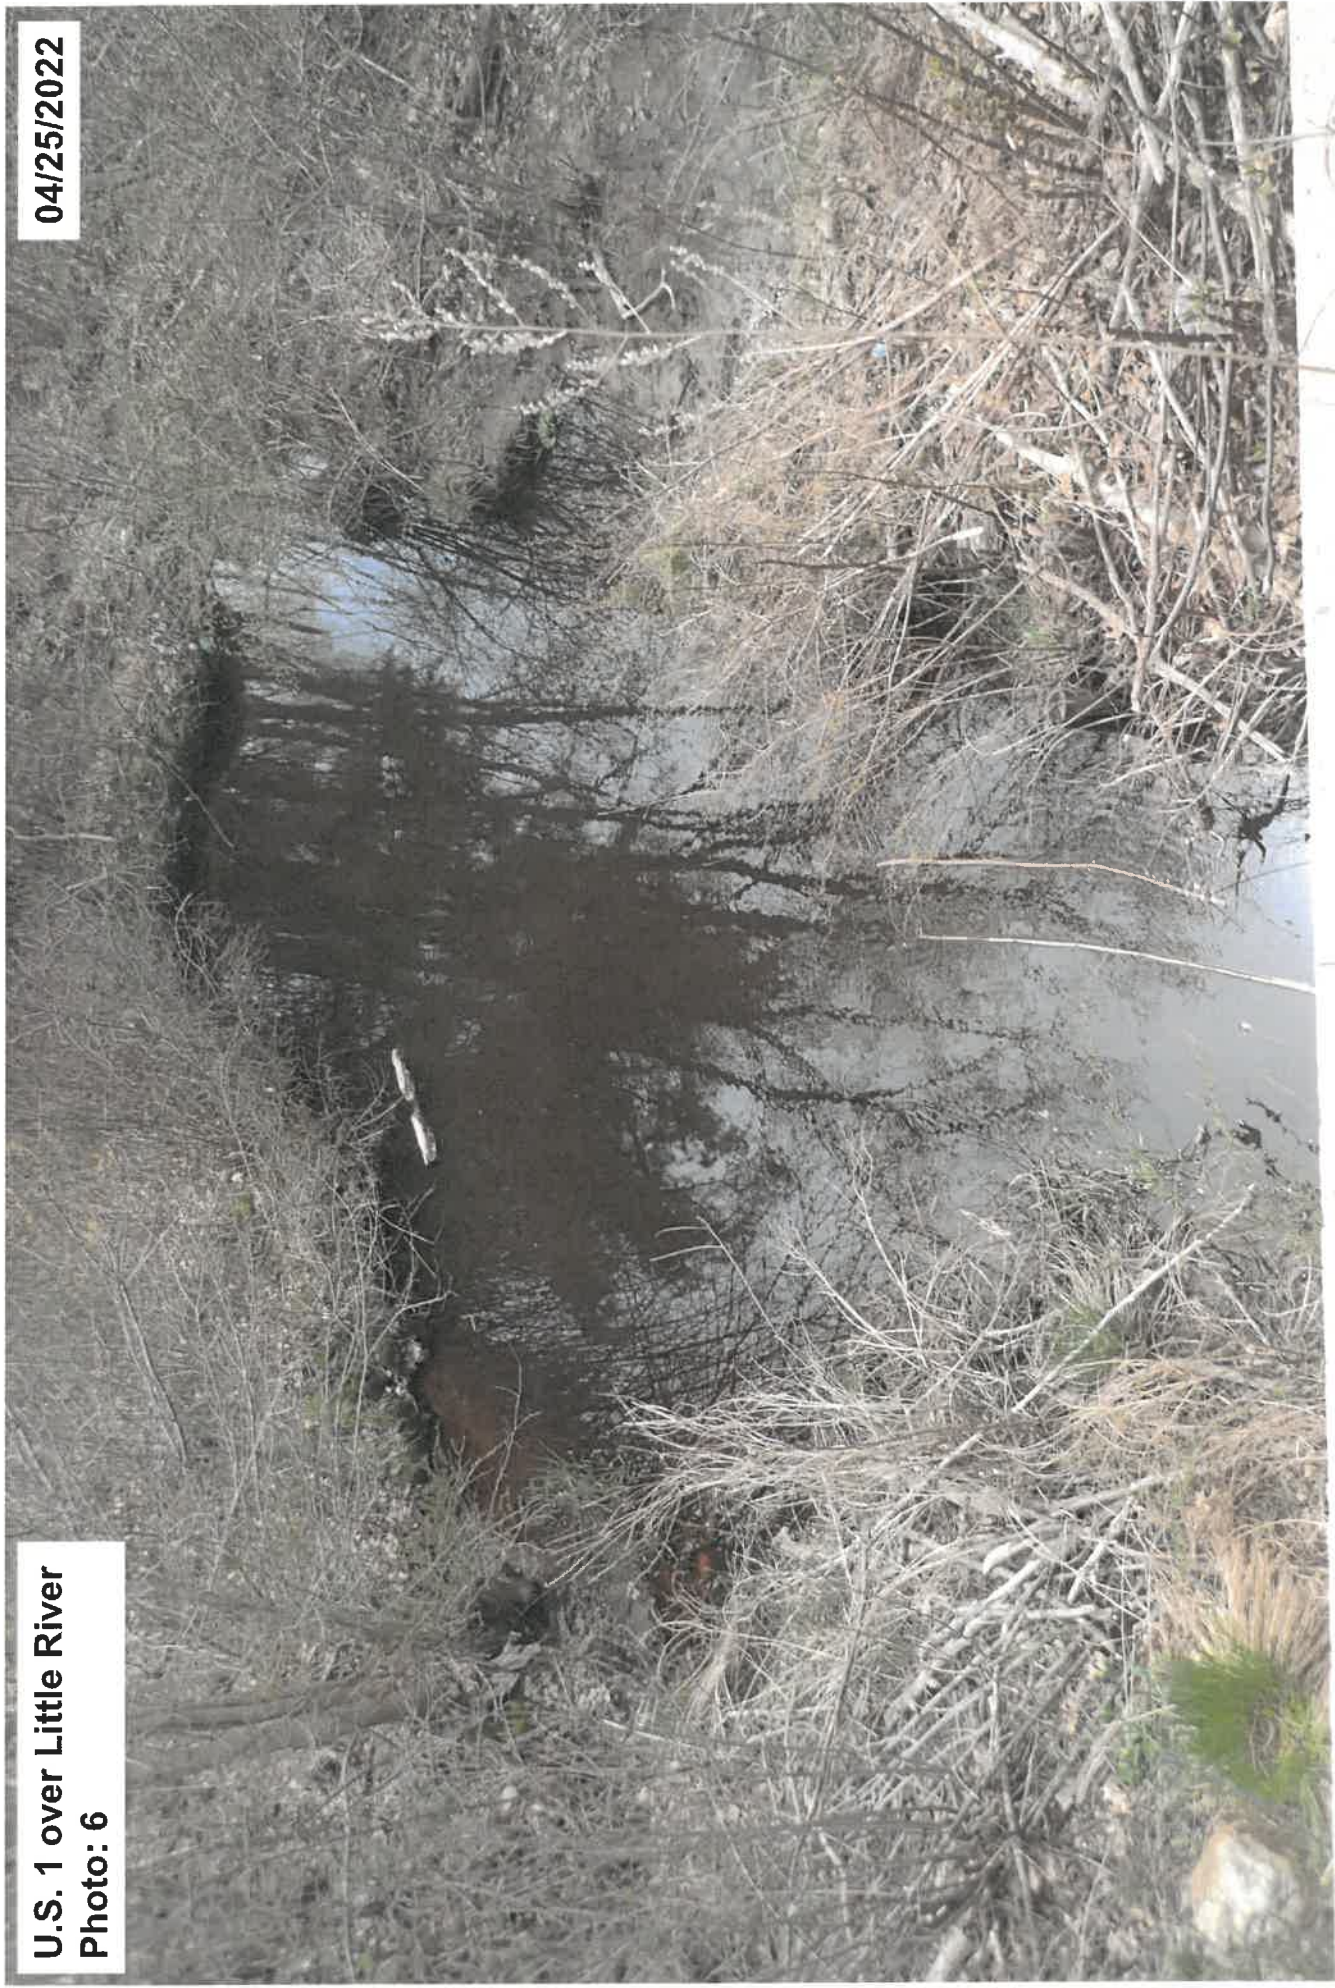
U.S. 1 over Little River
Photo: 7

Both the east and west headwalls exhibit a few scattered hairline cracks, most of which along the east headwall have light efflorescence and there are areas of light scaling present throughout (**Photos 7 and 8**). The east headwall appears to be plumb, the west headwall is leaning outward 3.5° and the fill depth is estimated to be approximately 7.0'. The masonry abutments within the main stone portion of the culvert have scattered areas of cracked and missing mortar, scattered missing chink stones and a few areas with evidence of slight settlement (**Photos 9, 10, 12, 13, 15, 16, 18 and 19**). The north and south concrete walls of the concrete extensions exhibit isolated hairline cracks (**Photos 21 and 22**).

(Hairline vertical
cracks, some with
efflorescence)

East elevation, looking west.

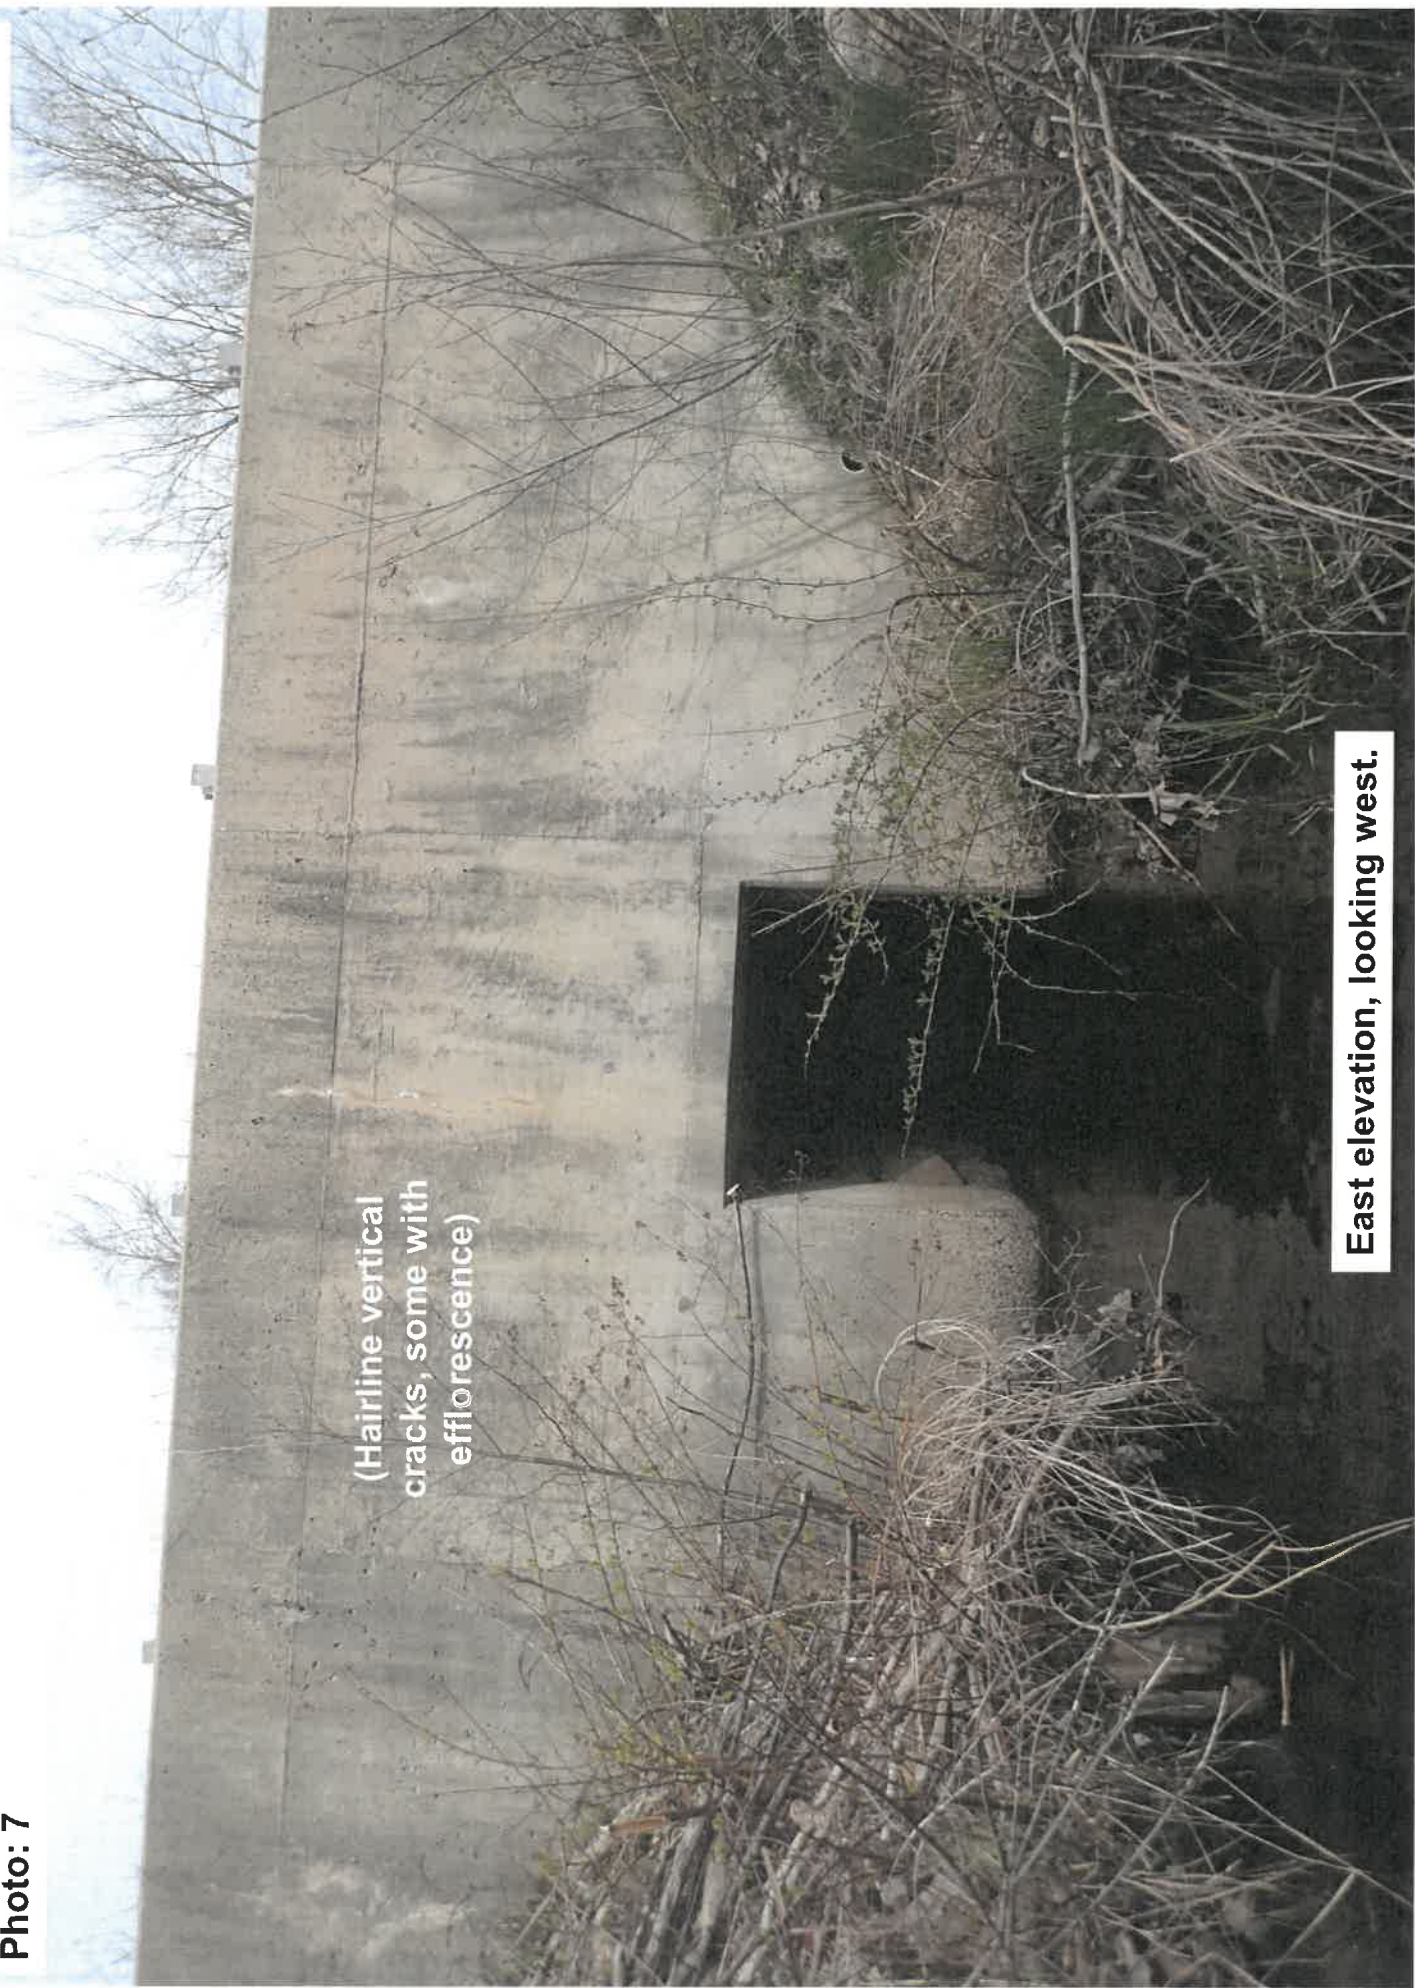
U.S. 1 over Little River
Photo: 8

(Hairline vertical cracks, some with efflorescence)

(Note stationing marks which correspond to undermining sketch)

West elevation, looking east.

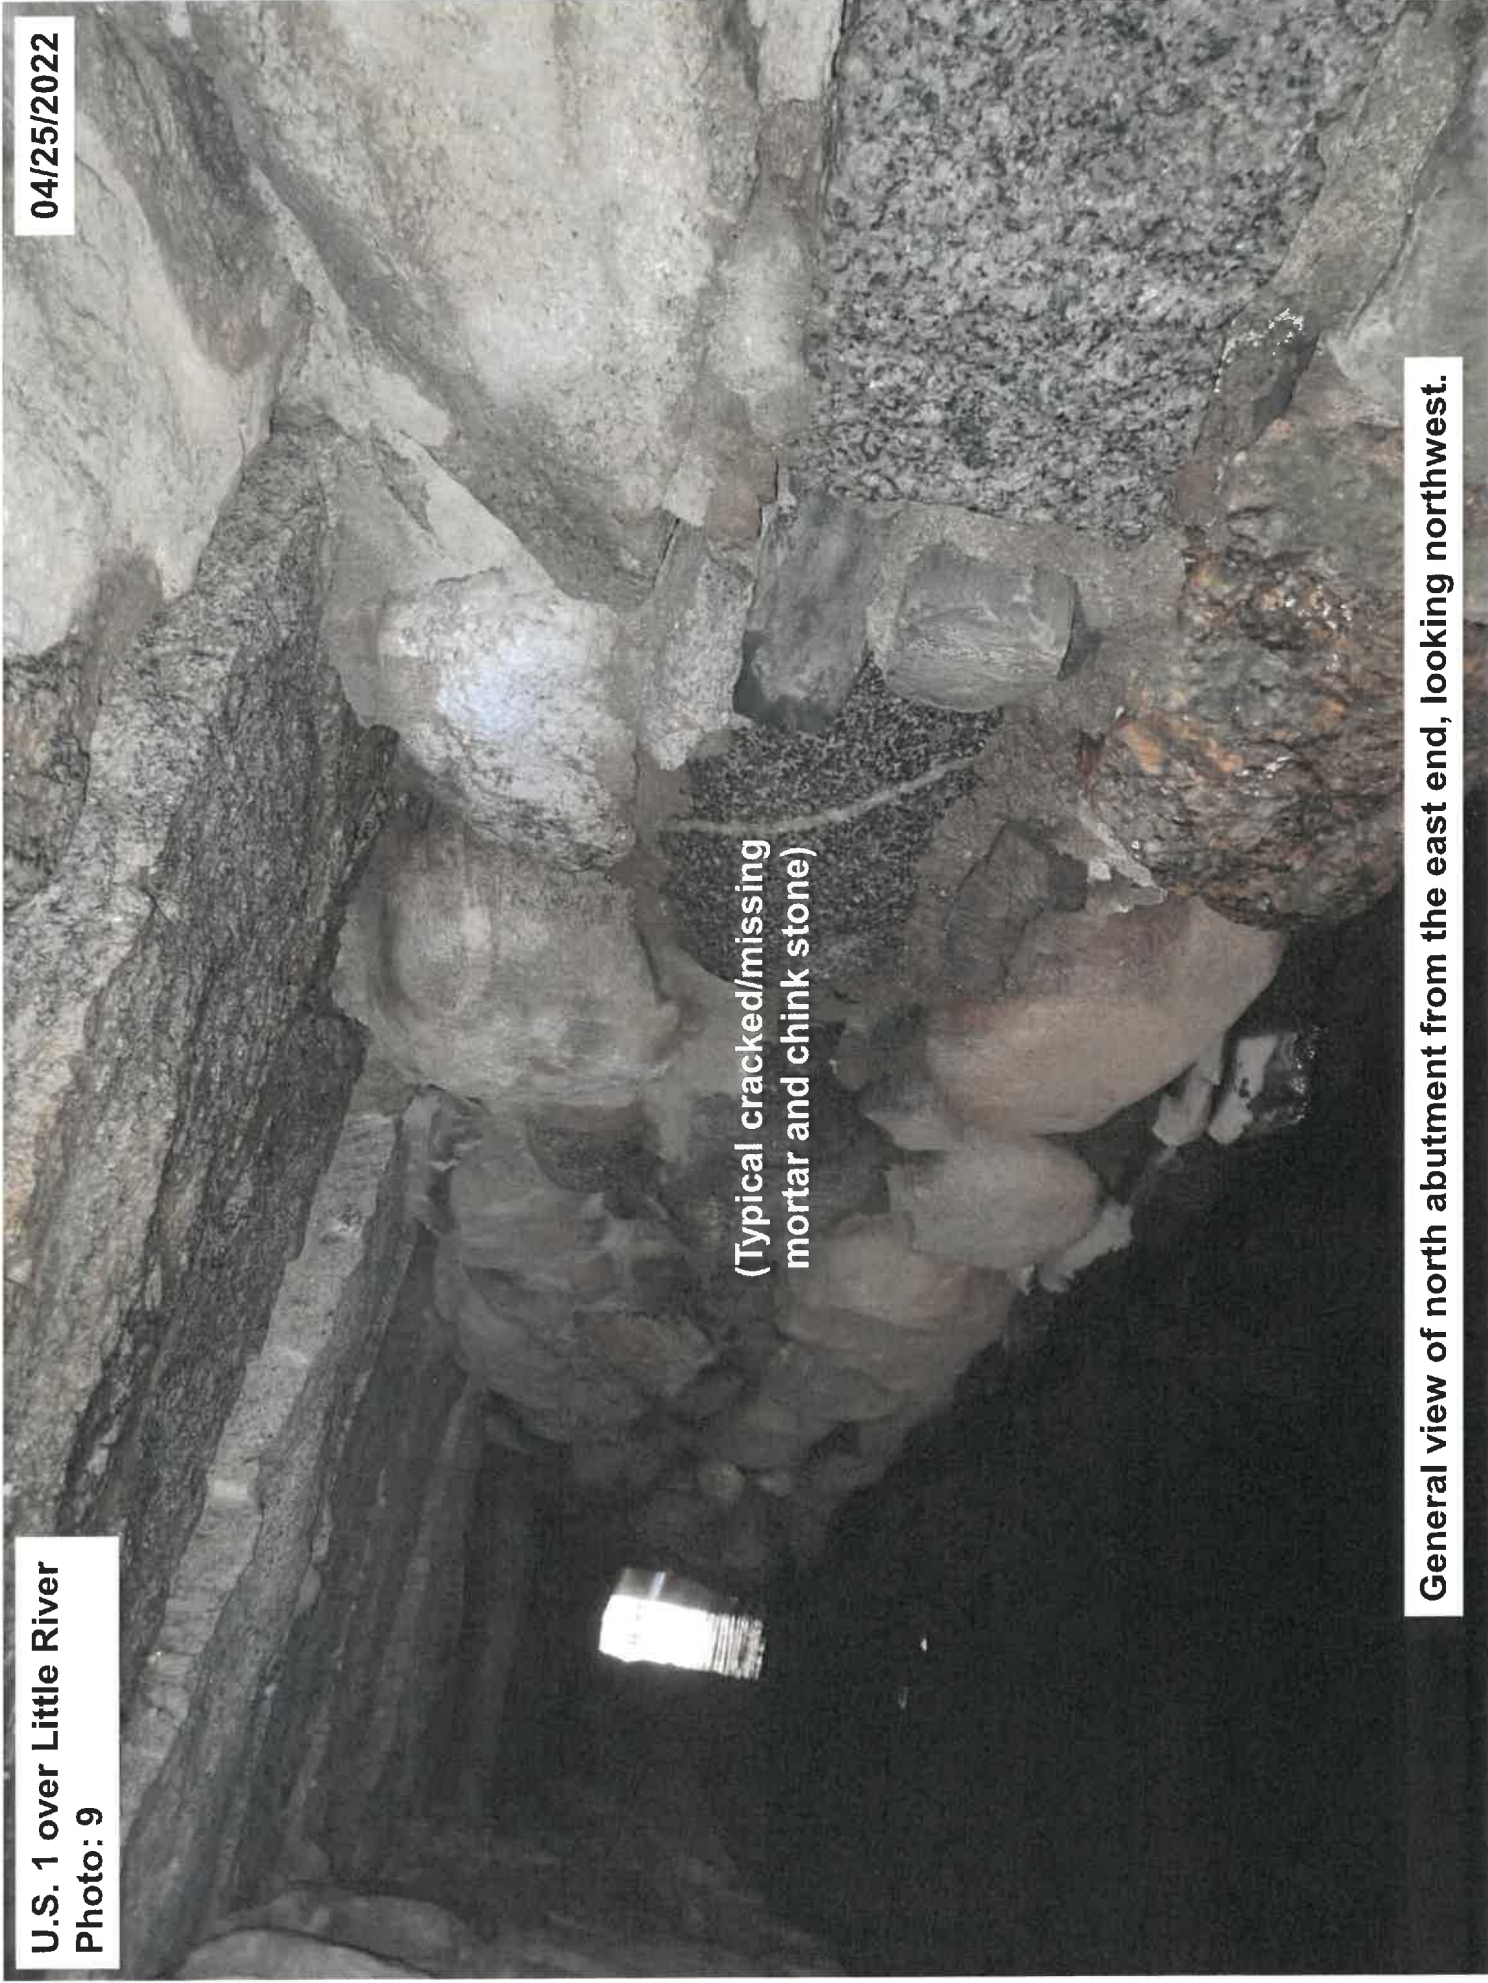
U.S. 1 over Little River
Photo: 10

The granite roof slabs are missing the majority of their mortar and several of the chink stones. At the locations of missing mortar/chink stones, minor penetrations into the roof of the culvert were observed. Isolated evidence of minor leakage was observed from the roof slabs within the culvert (**Photos 11, 14, 17 and 20**). Heavier evidence of leakage and water penetration was noted near the west end of the masonry portion of the culvert. Approximately 21.0' from the east end of the culvert, a granite roof slab has rotated and the lowest corner is approximately 8" lower than the adjacent stone, penetrations of up

(Typical cracked/missing
mortar and chink stone)

General view of south abutment from the east third point, looking west.

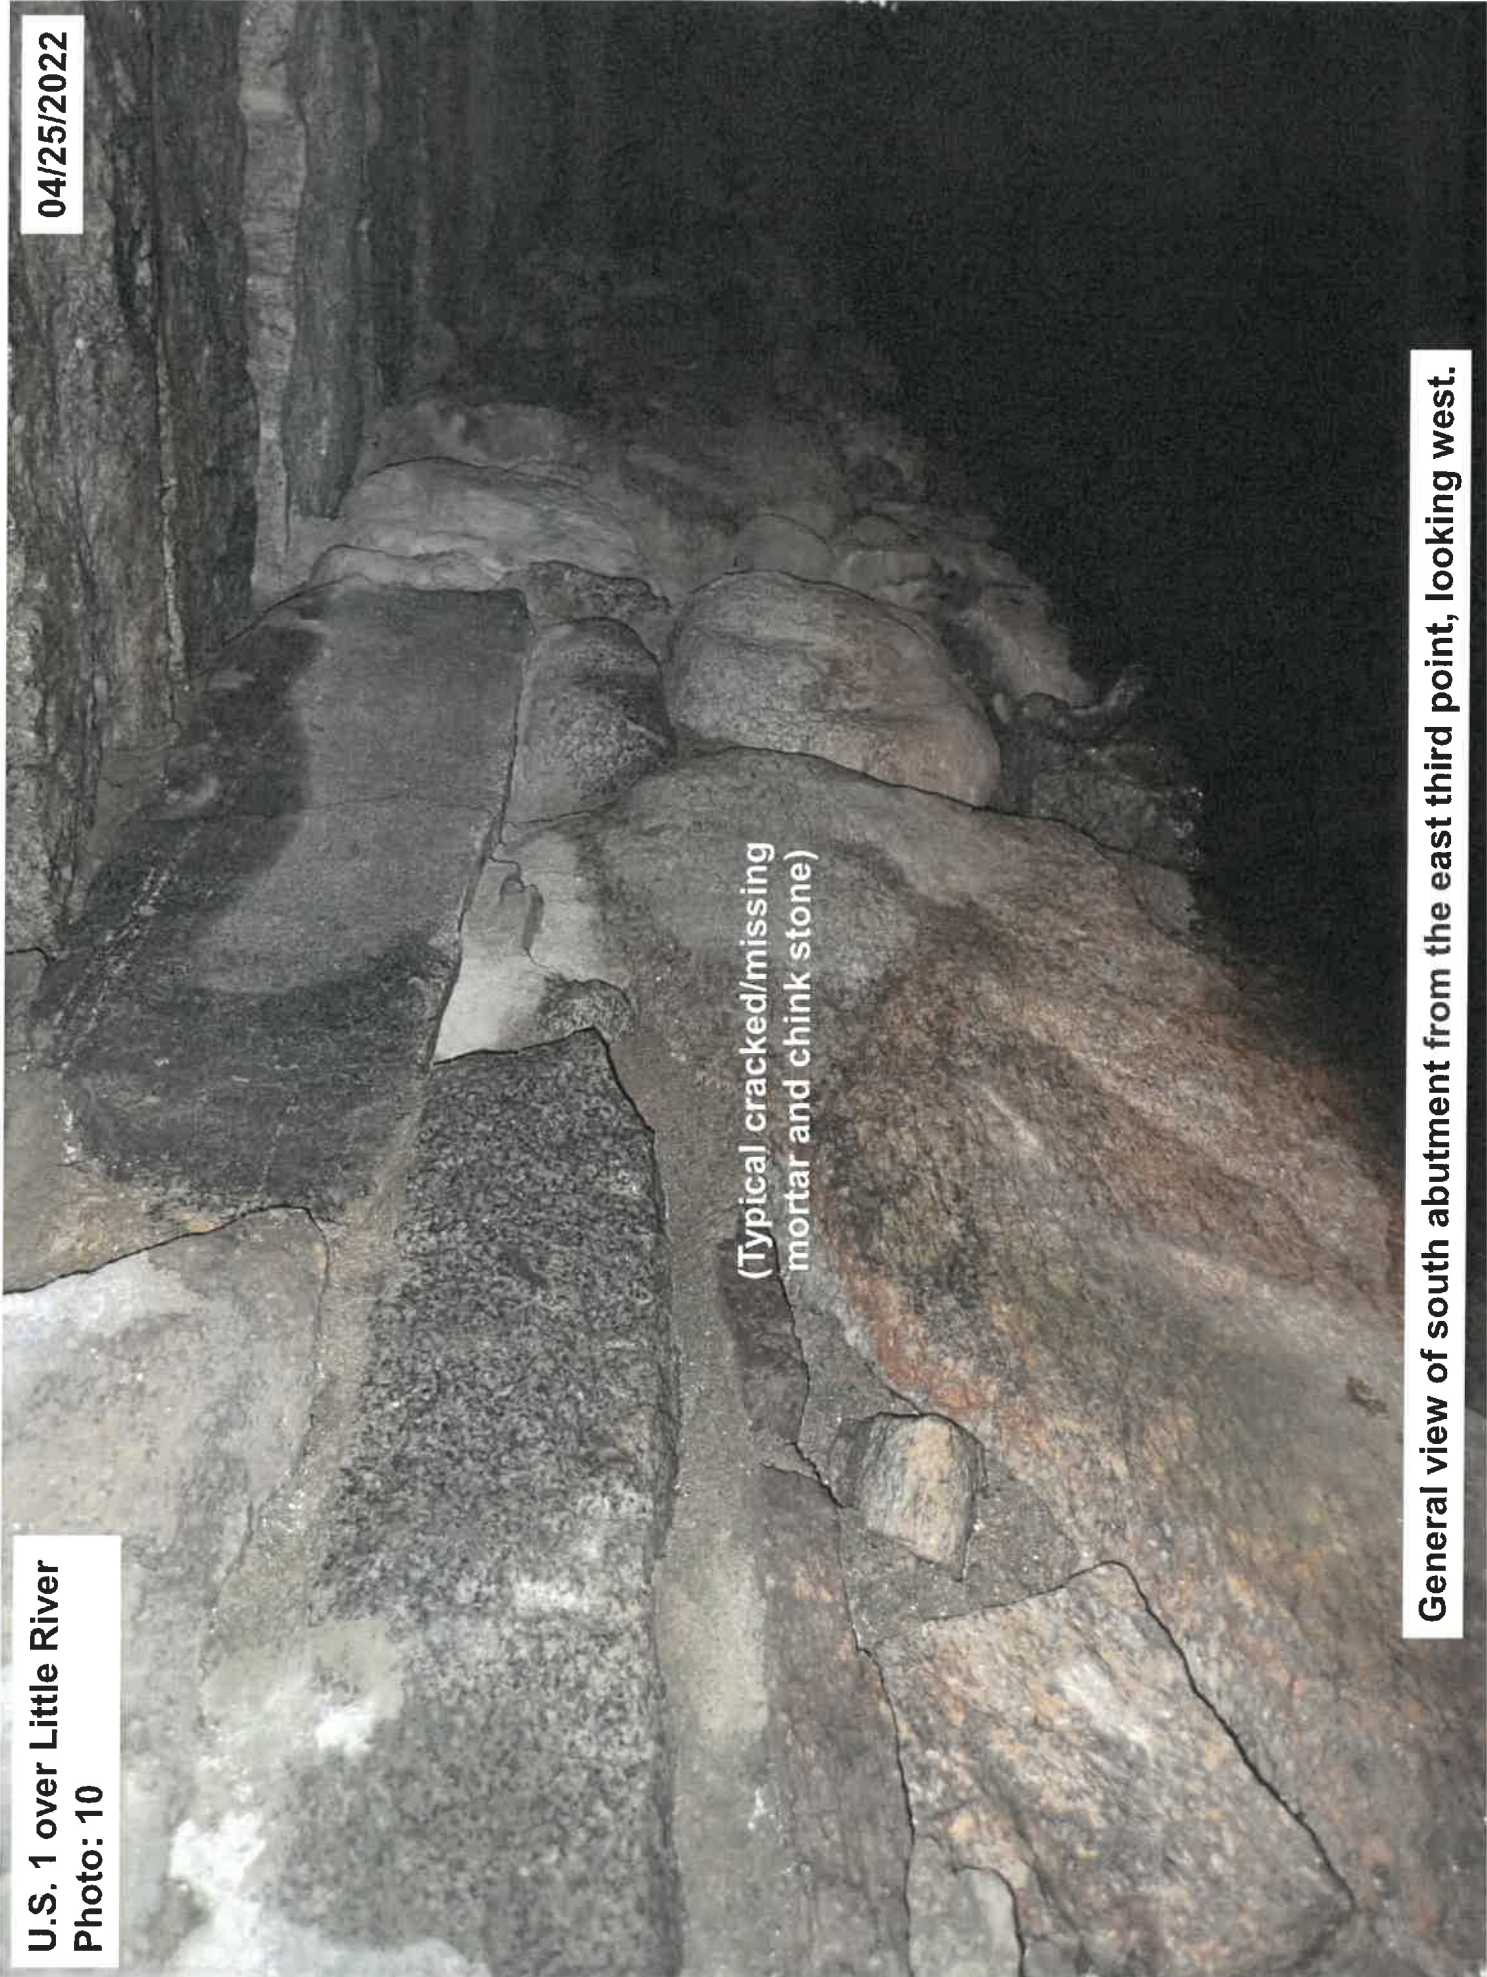
U.S. 1 over Little River
Photo: 11

(Typical cracked/missing
mortar and chink stone)

General view of masonry culvert from the east end, looking west.

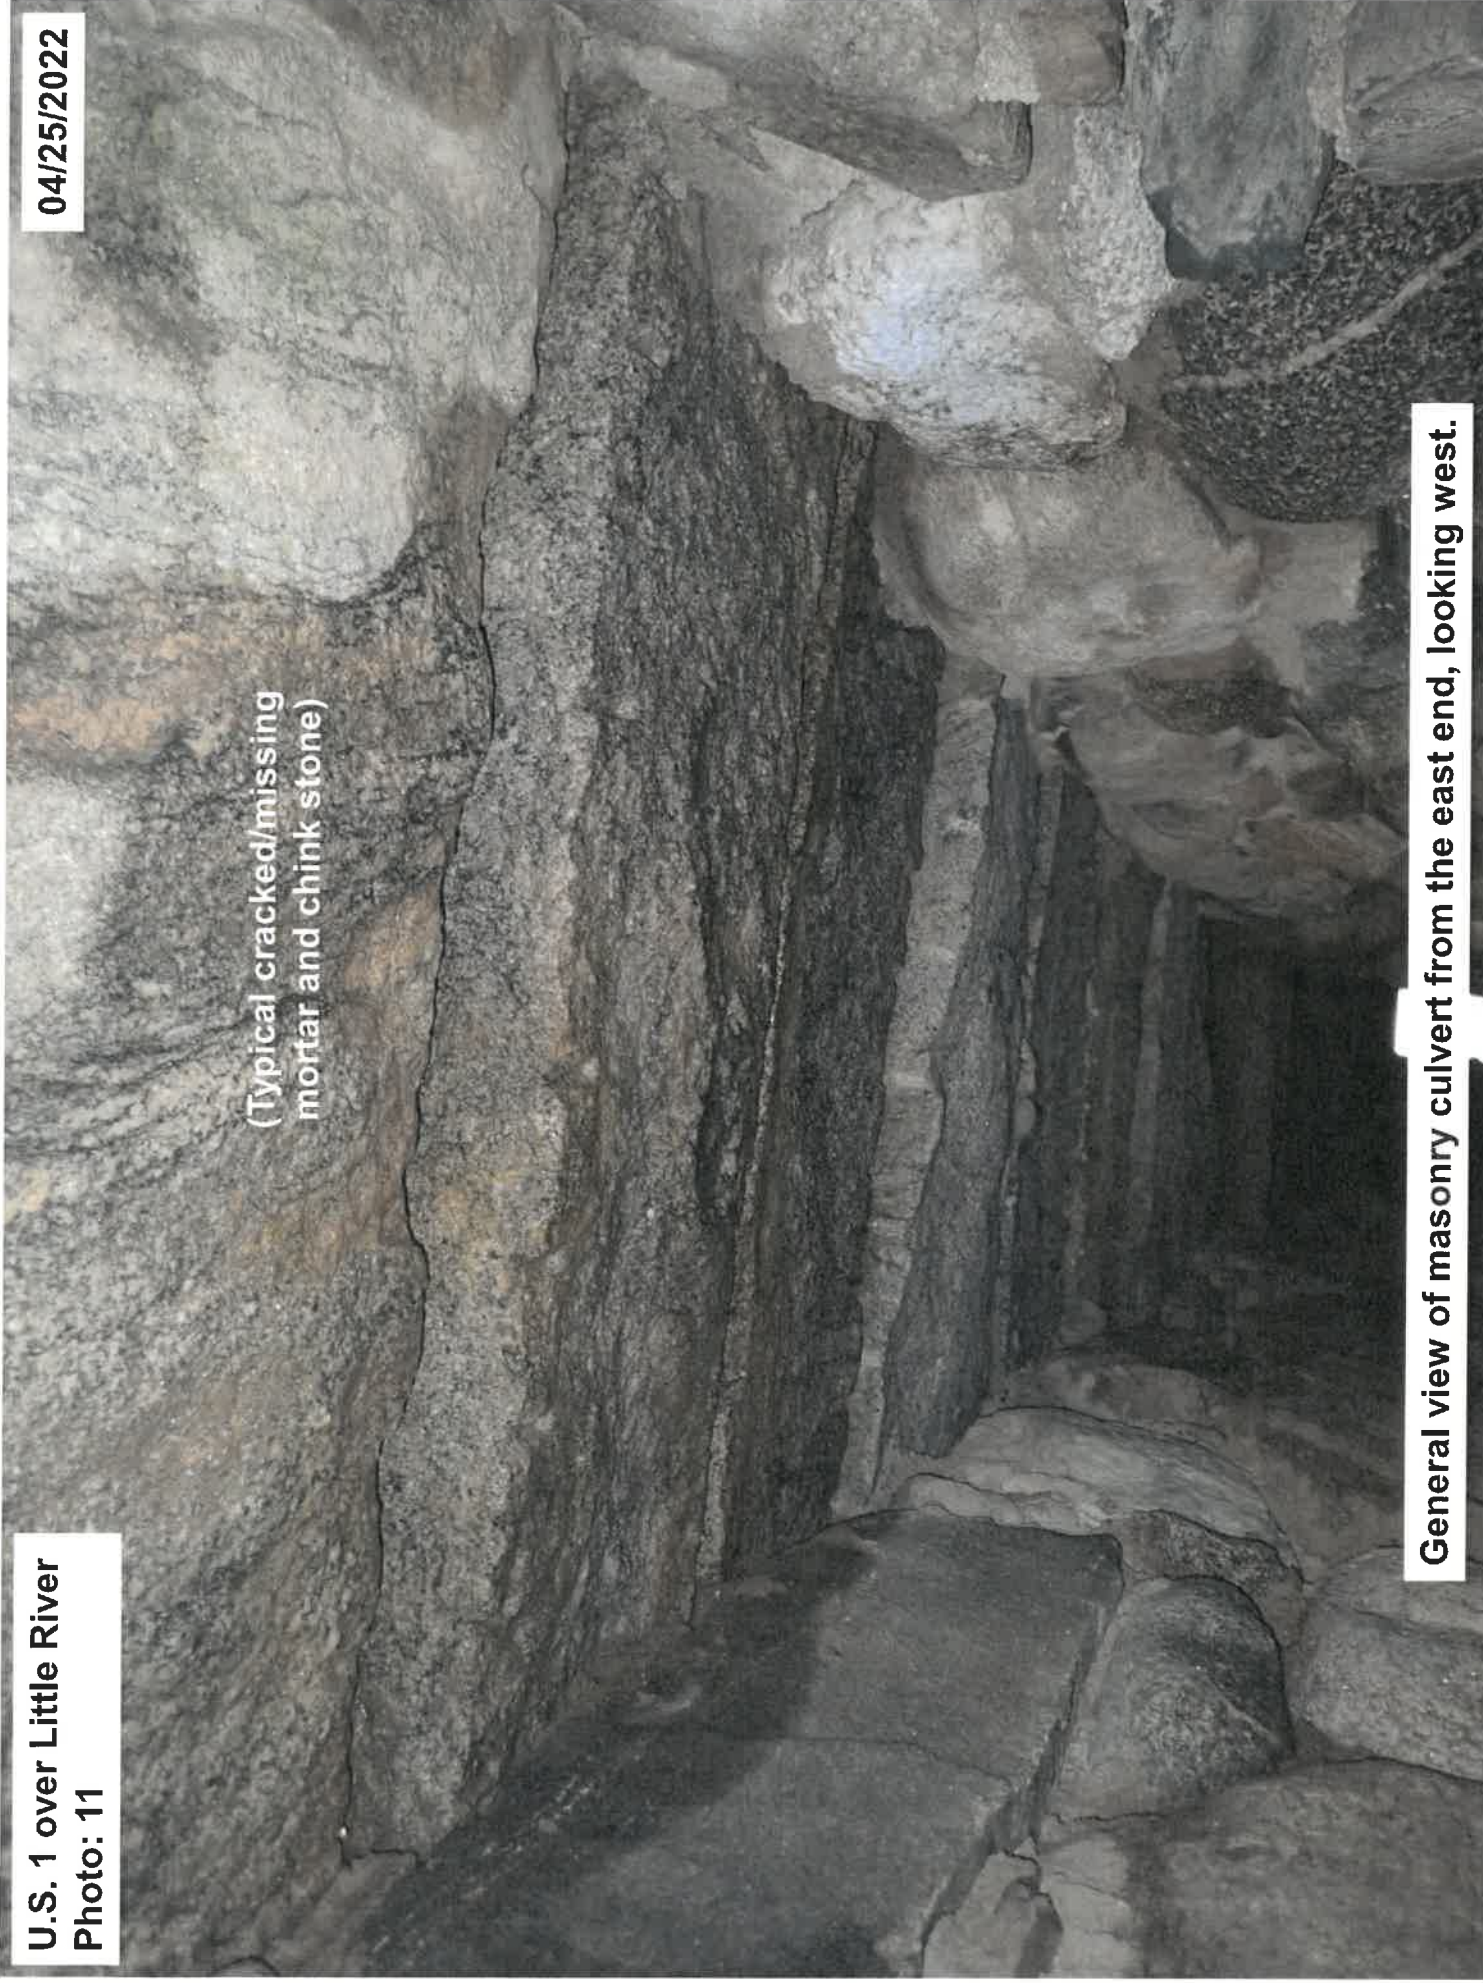
U.S. 1 over Little River
Photo: 12

(Typical cracked/missing
mortar and chink stone)

General view of north abutment 22' from the east end, looking northwest.

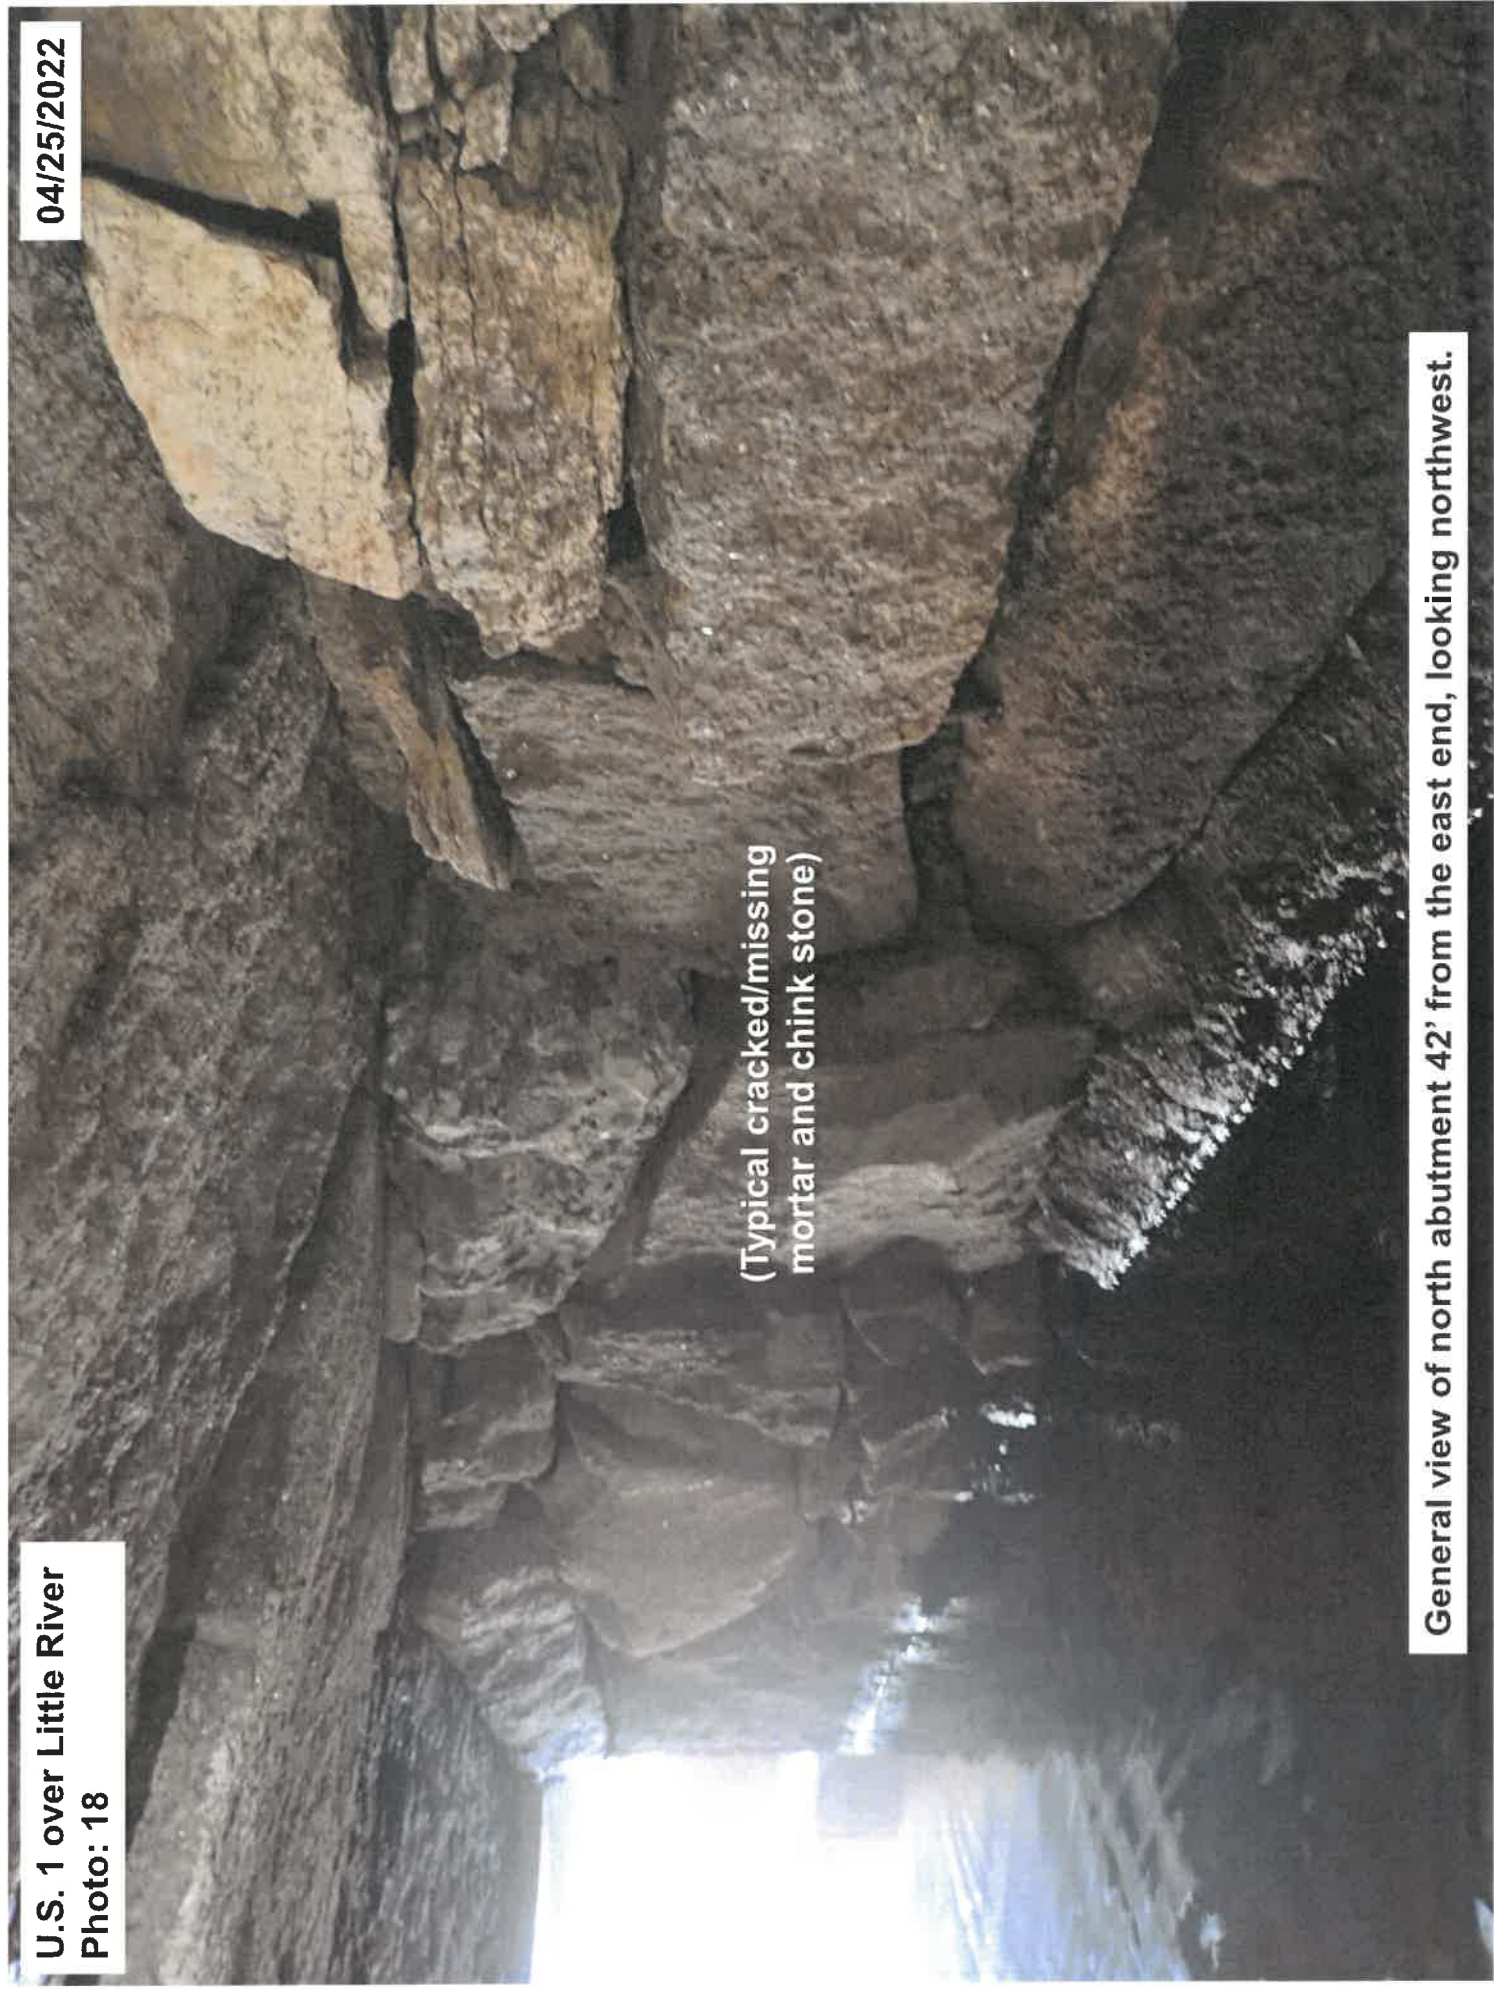
U.S. 1 over Little River
Photo: 19

(Typical cracked/missing
mortar and chink stone)

General view of south abutment 42' from the east end, looking west.
