CULVERT INSPECTION REPORT

**NHDOT 43937
NORTH HAMPTON**

**US ROUTE 1
OVER LITTLE RIVER**

Location: U.S. Route 1 (Lafayette Road) over Little River
Locale: North Hampton, NH
Purpose: Culvert Investigation

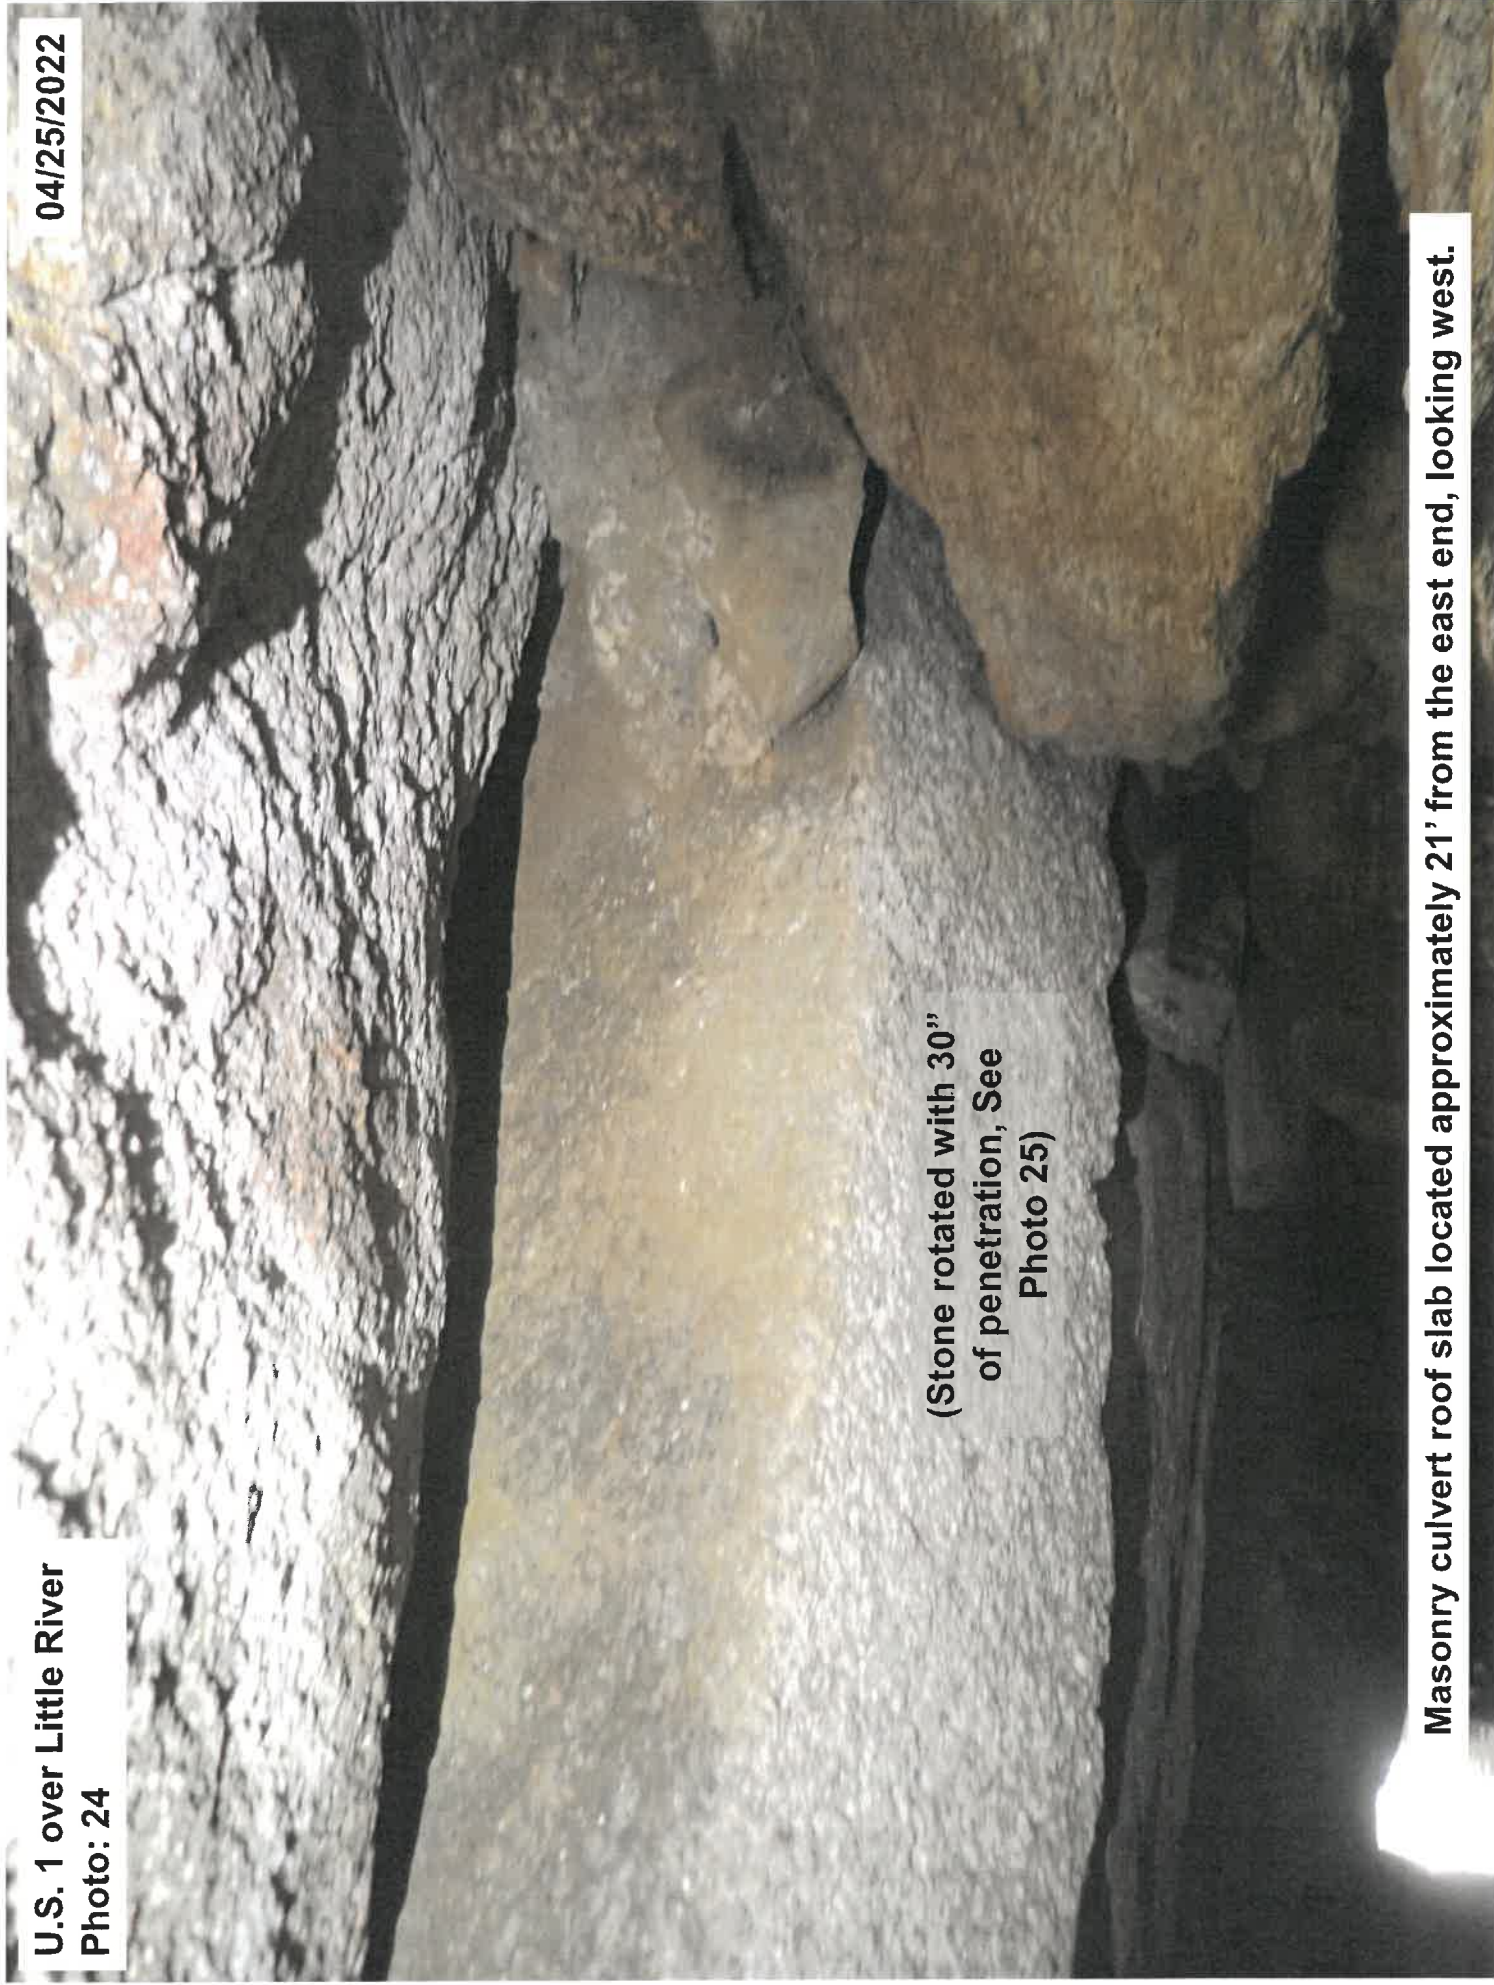
U.S. 1 over Little River
Photo: 25

to 30" into the roof of the culvert were measured at this location **(Photo 24)**. The roof within the concrete extensions was generally in good condition **(Photo 23)**. None of the noted settlement or rotated stones appear to have been recent.

(Stone rotated with 30"
of penetration)

Masonry culvert roof slab located approximately 21' from the east end, looking north.

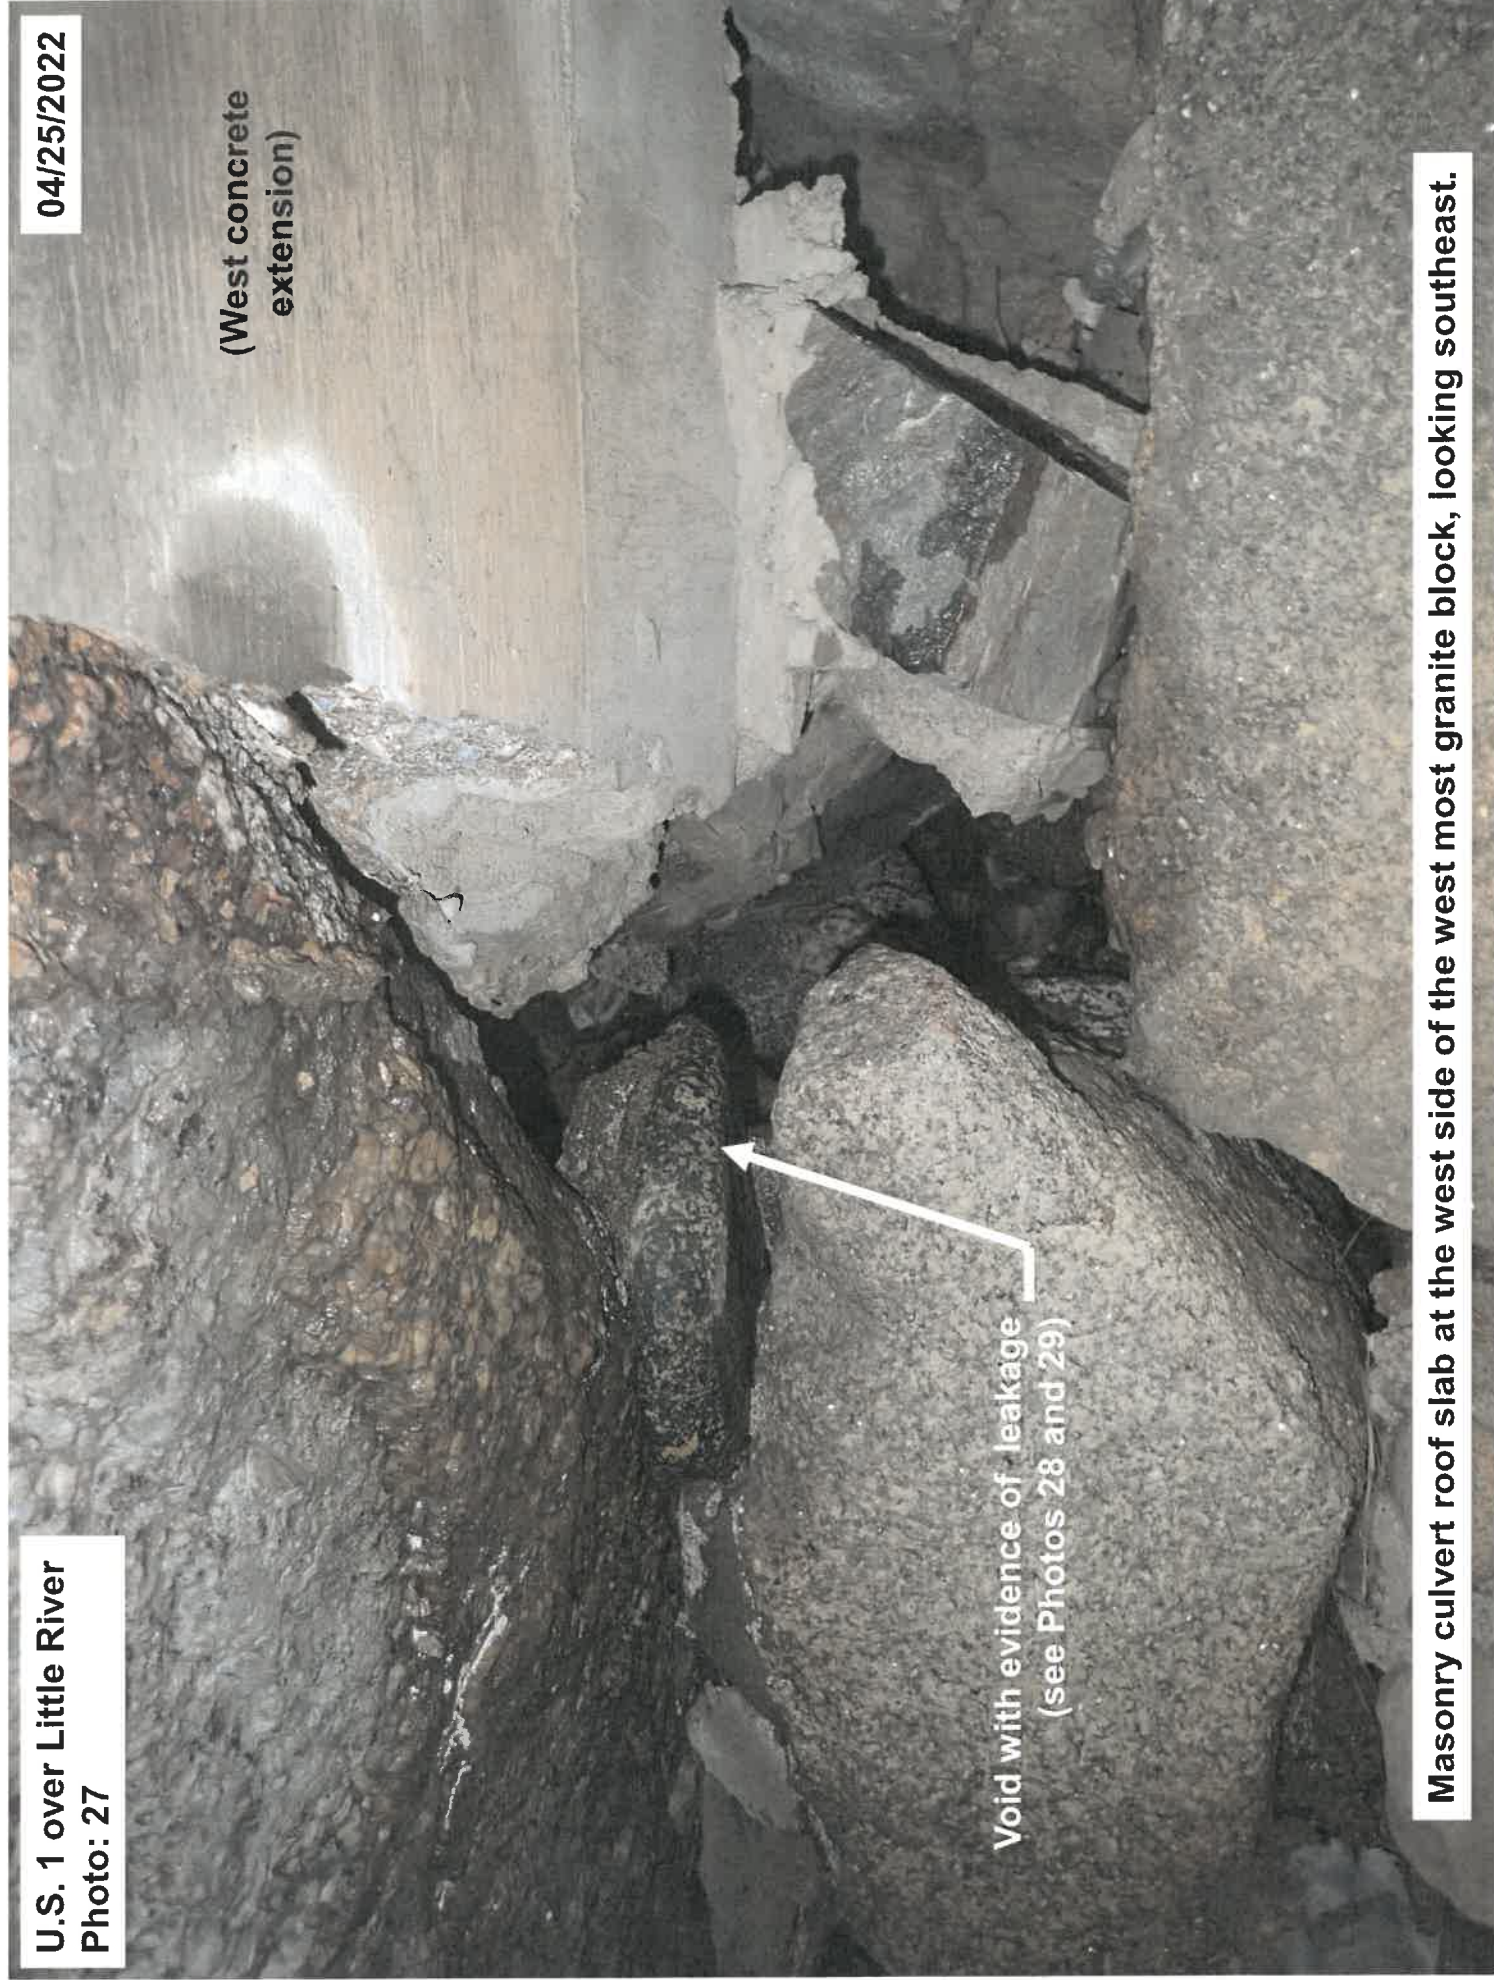
U.S. 1 over Little River
Photo: 28

(West concrete
extension)

Void extends 45" deep in
the south direction

Masonry culvert roof slab at the west side of the west most granite block, looking south.

- Remedy areas of undermining at the west concrete extension with considerations for smoothing the transition from the west concrete extension to the masonry culvert.
- Remedy the area of undermining at the west edge of asphalt.
- Monitor the tilt of the west concrete extension and condition of rip rap placed at the west embankment.

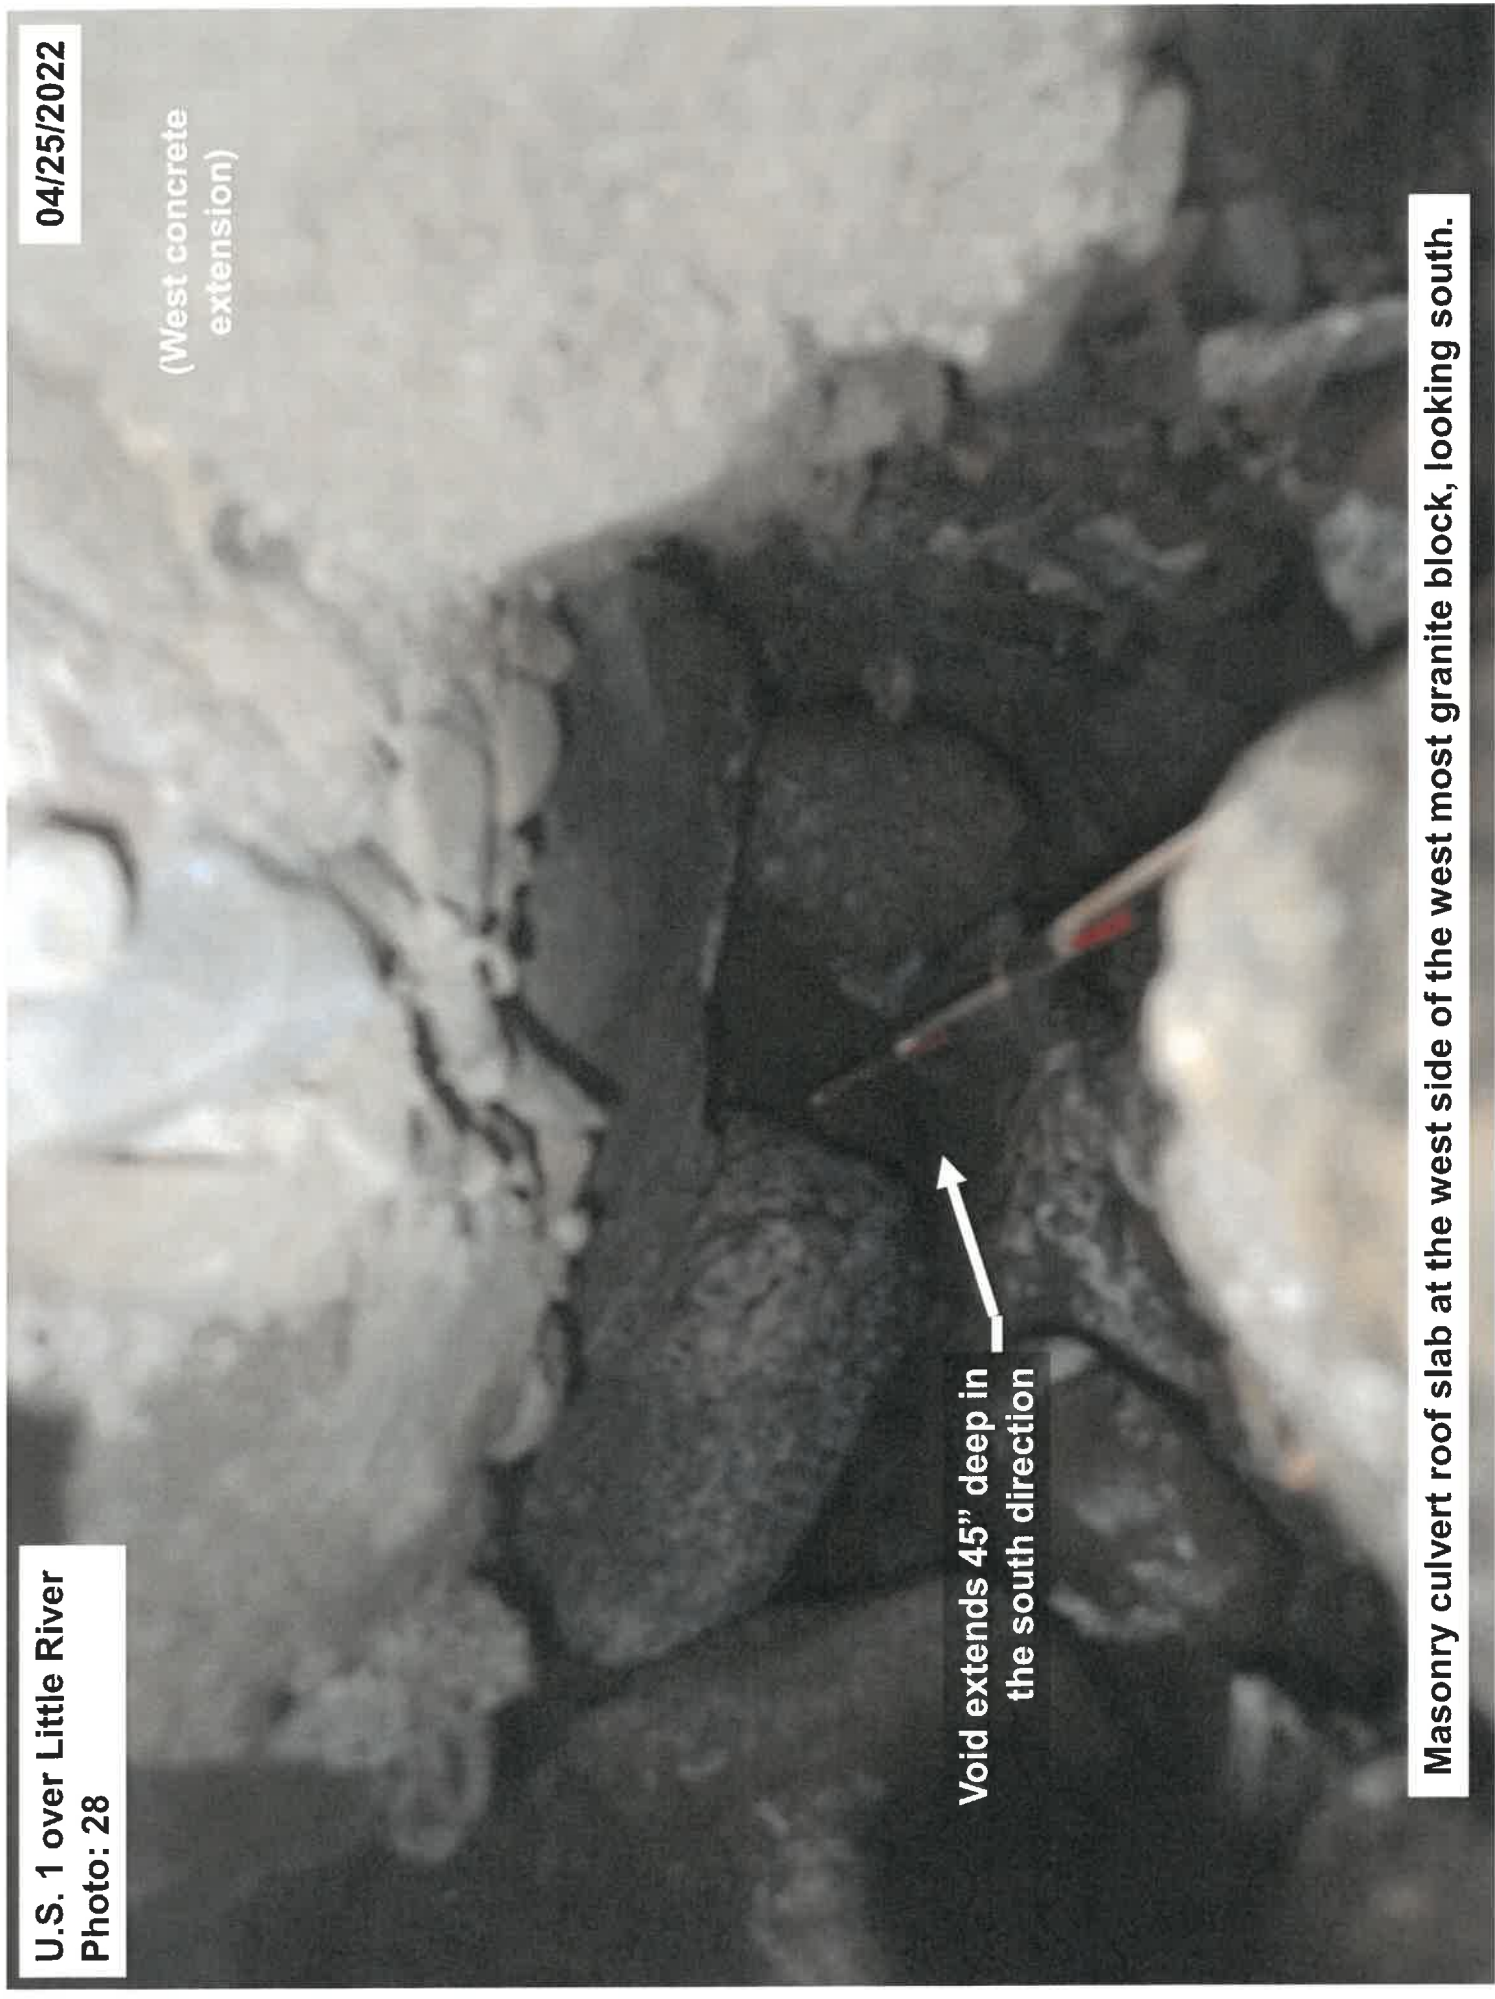
U.S. 1 over Little River
Photo: 29

Void extends up to 40"
deep in the vertical
direction

Masonry culvert roof slab at the west side of the west most granite block, looking south and up.

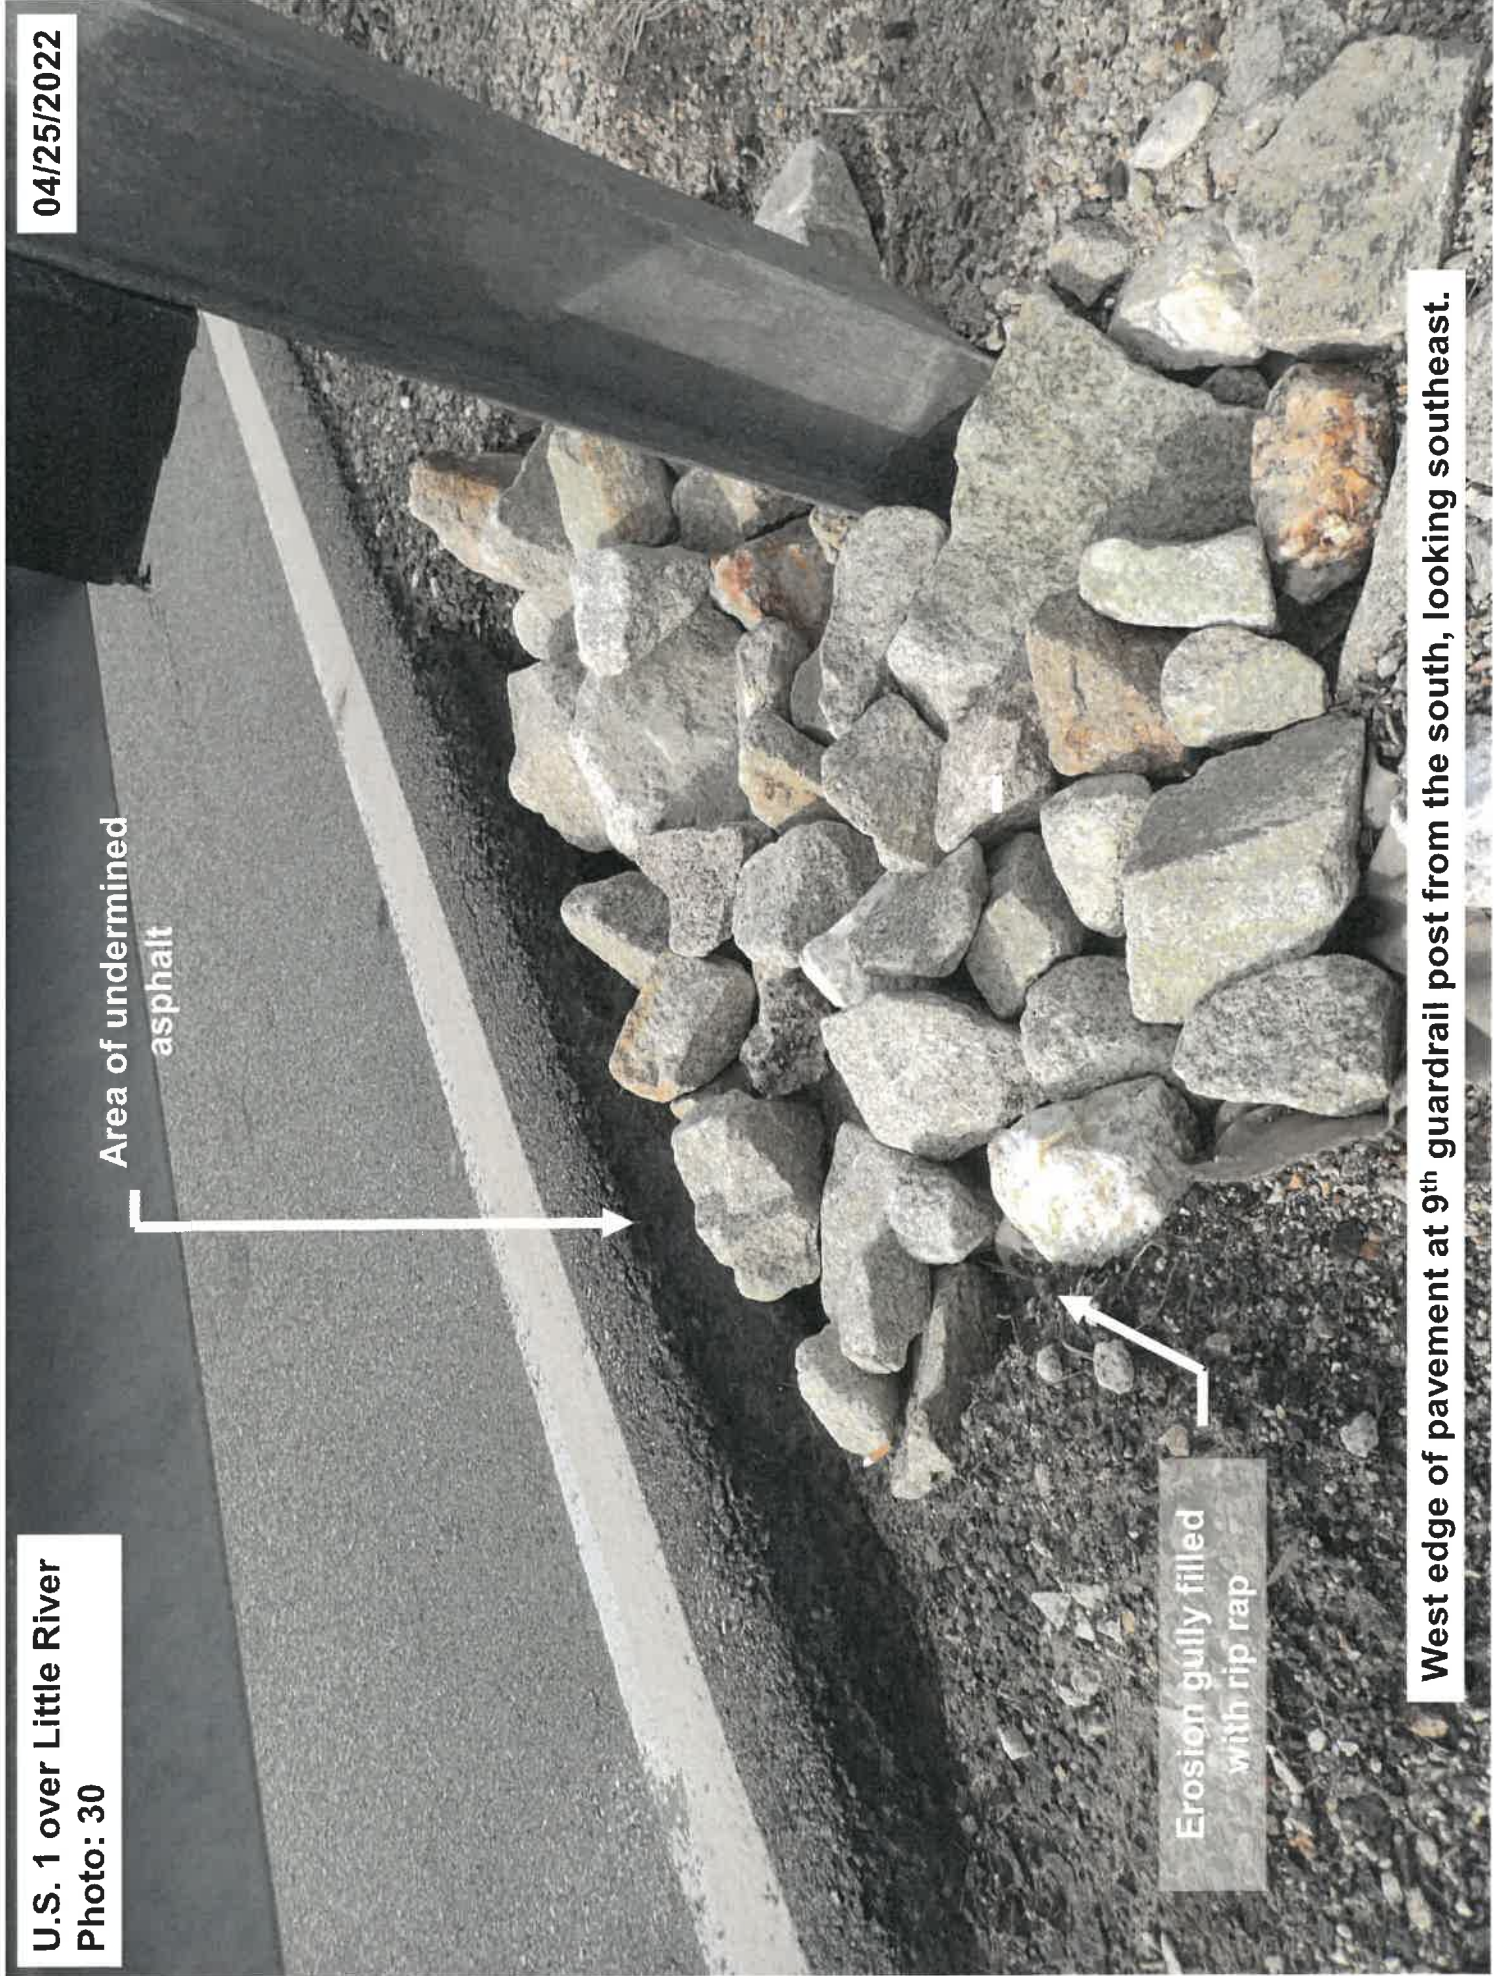
U.S. 1 over Little River
Photo: 31

There is no apparent additional settlement at the areas of the west embankment headwall areas where rip rap has been placed **(Photo 4)**. At the west guardrail, 9th post from the south end of the rail there is an area of erosion, which has been filled with rip rap, measuring 41" long x 39" wide x up to 8" deep that undermines the edge of the asphalt for a 41" length x up to 4-1/2" deep **(Photos 30 and 31)**.

Area of undermined
asphalt

Erosion gully filled
with rip rap

West edge of pavement at 9th guardrail post from the south, looking southeast.

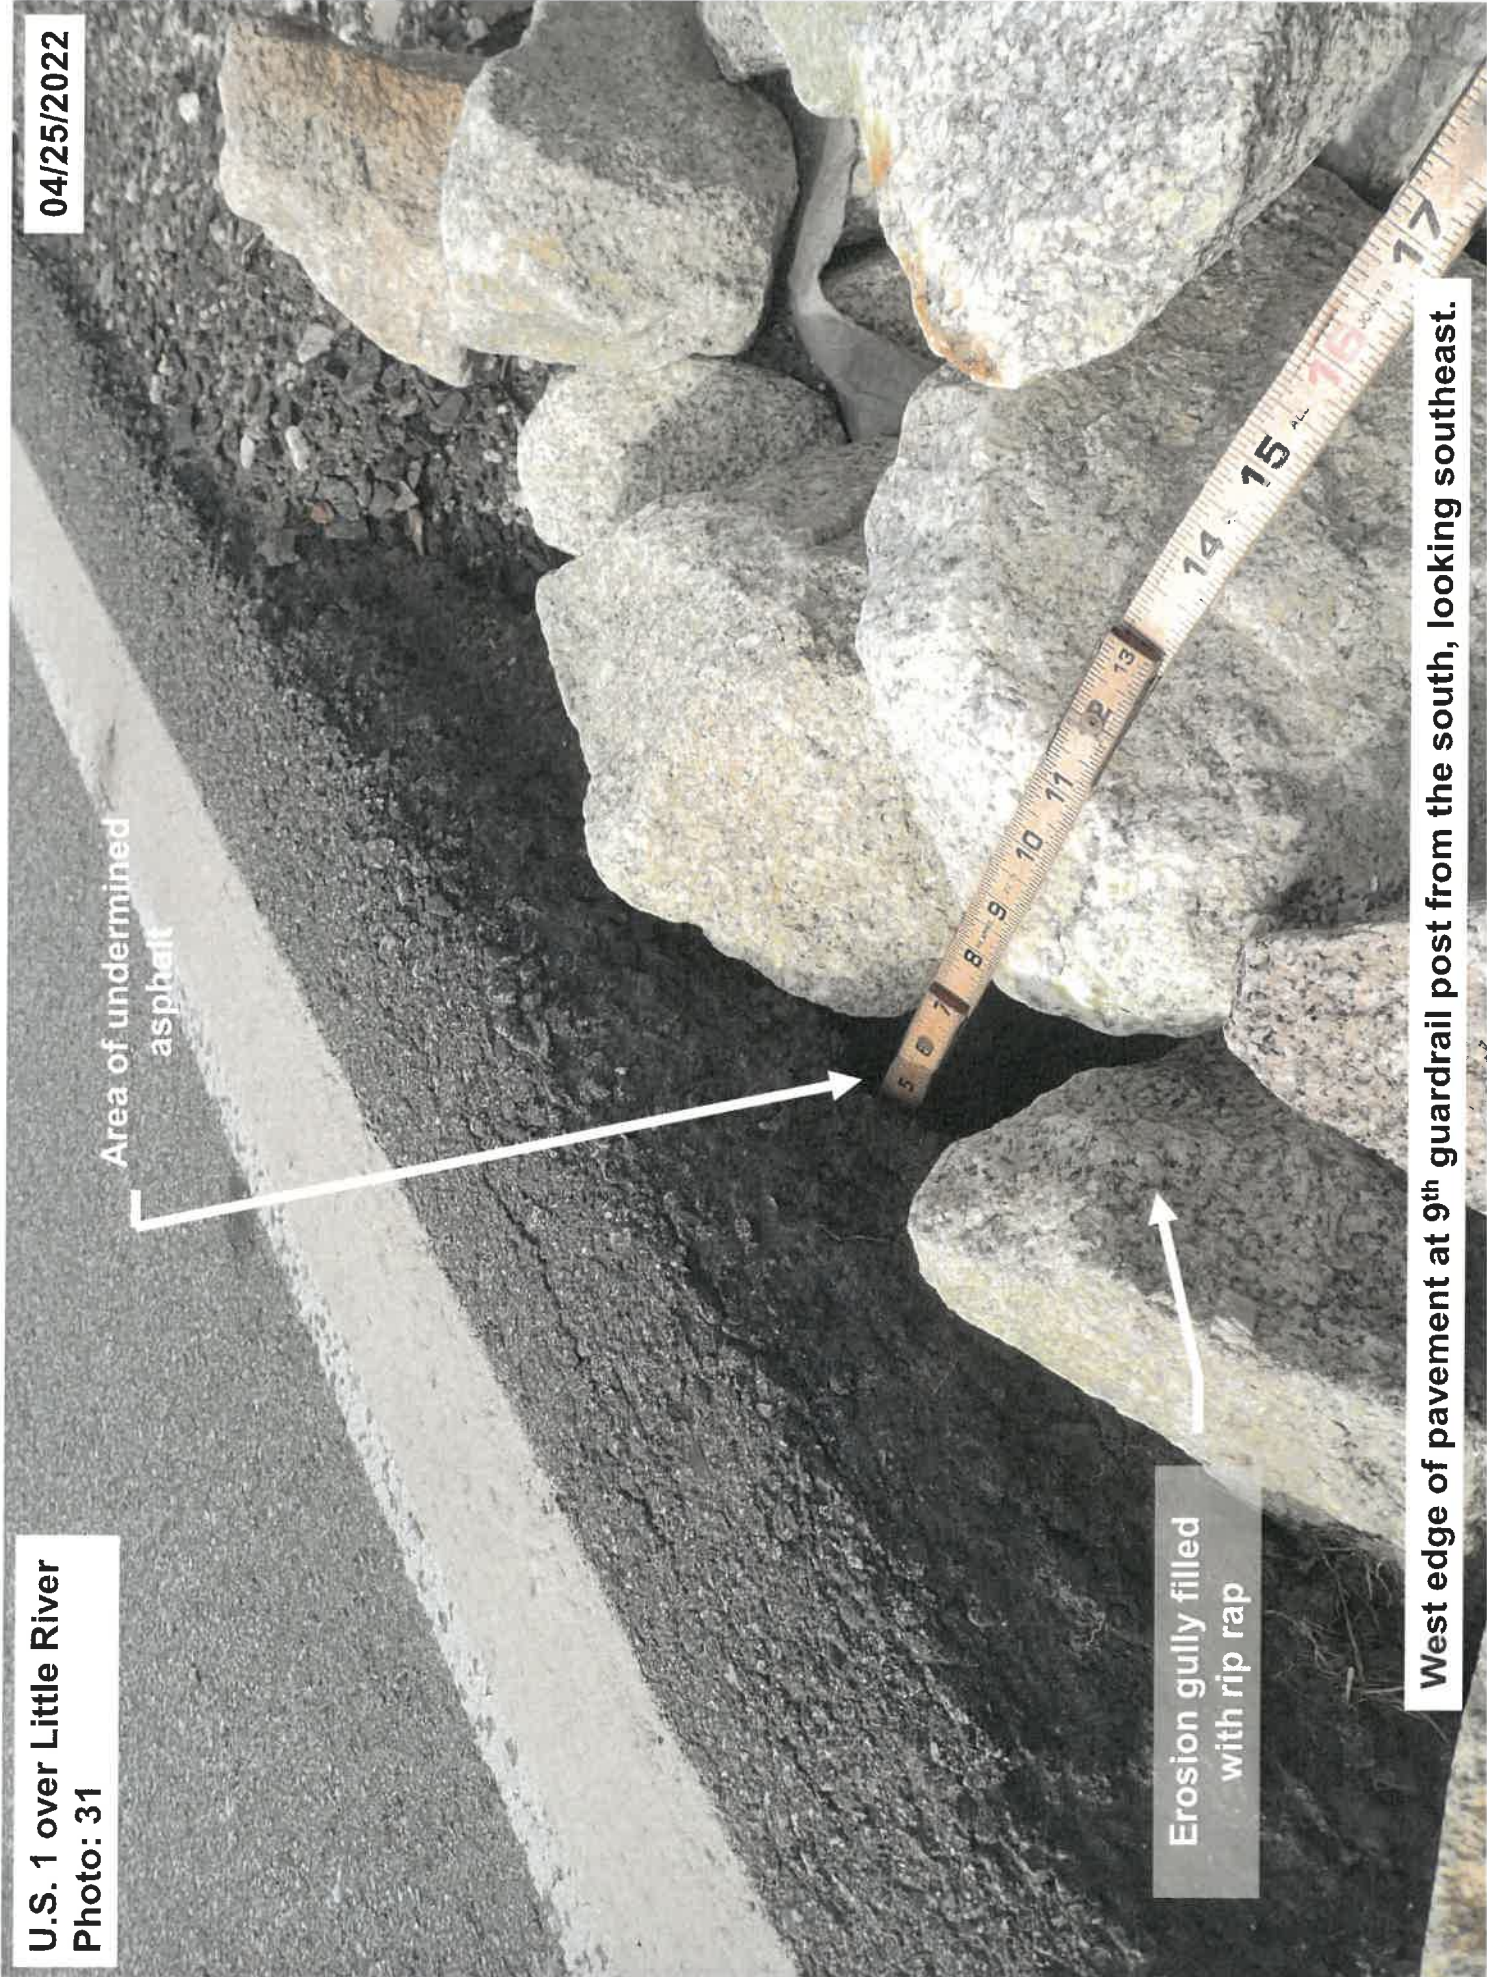
U.S. 1 over Little River
Photo: 32

At the south end of the southwest wingwall (west headwall) there is a void measuring 10" deep (east direction) x 22" high x 11" long (south direction) with evidence of minor fill spilling through **(Photo 32)**. The west headwall is 3.5° out-of-plumb, leaning away from the roadway. North of the west headwall, there is an erosion gully measuring full height of the sloped portion of the embankment x 12" wide x 16" deep **(Photo 33)**

Void, 10" deep x 22"
high x 11" long

South end of west headwall, looking southeast.

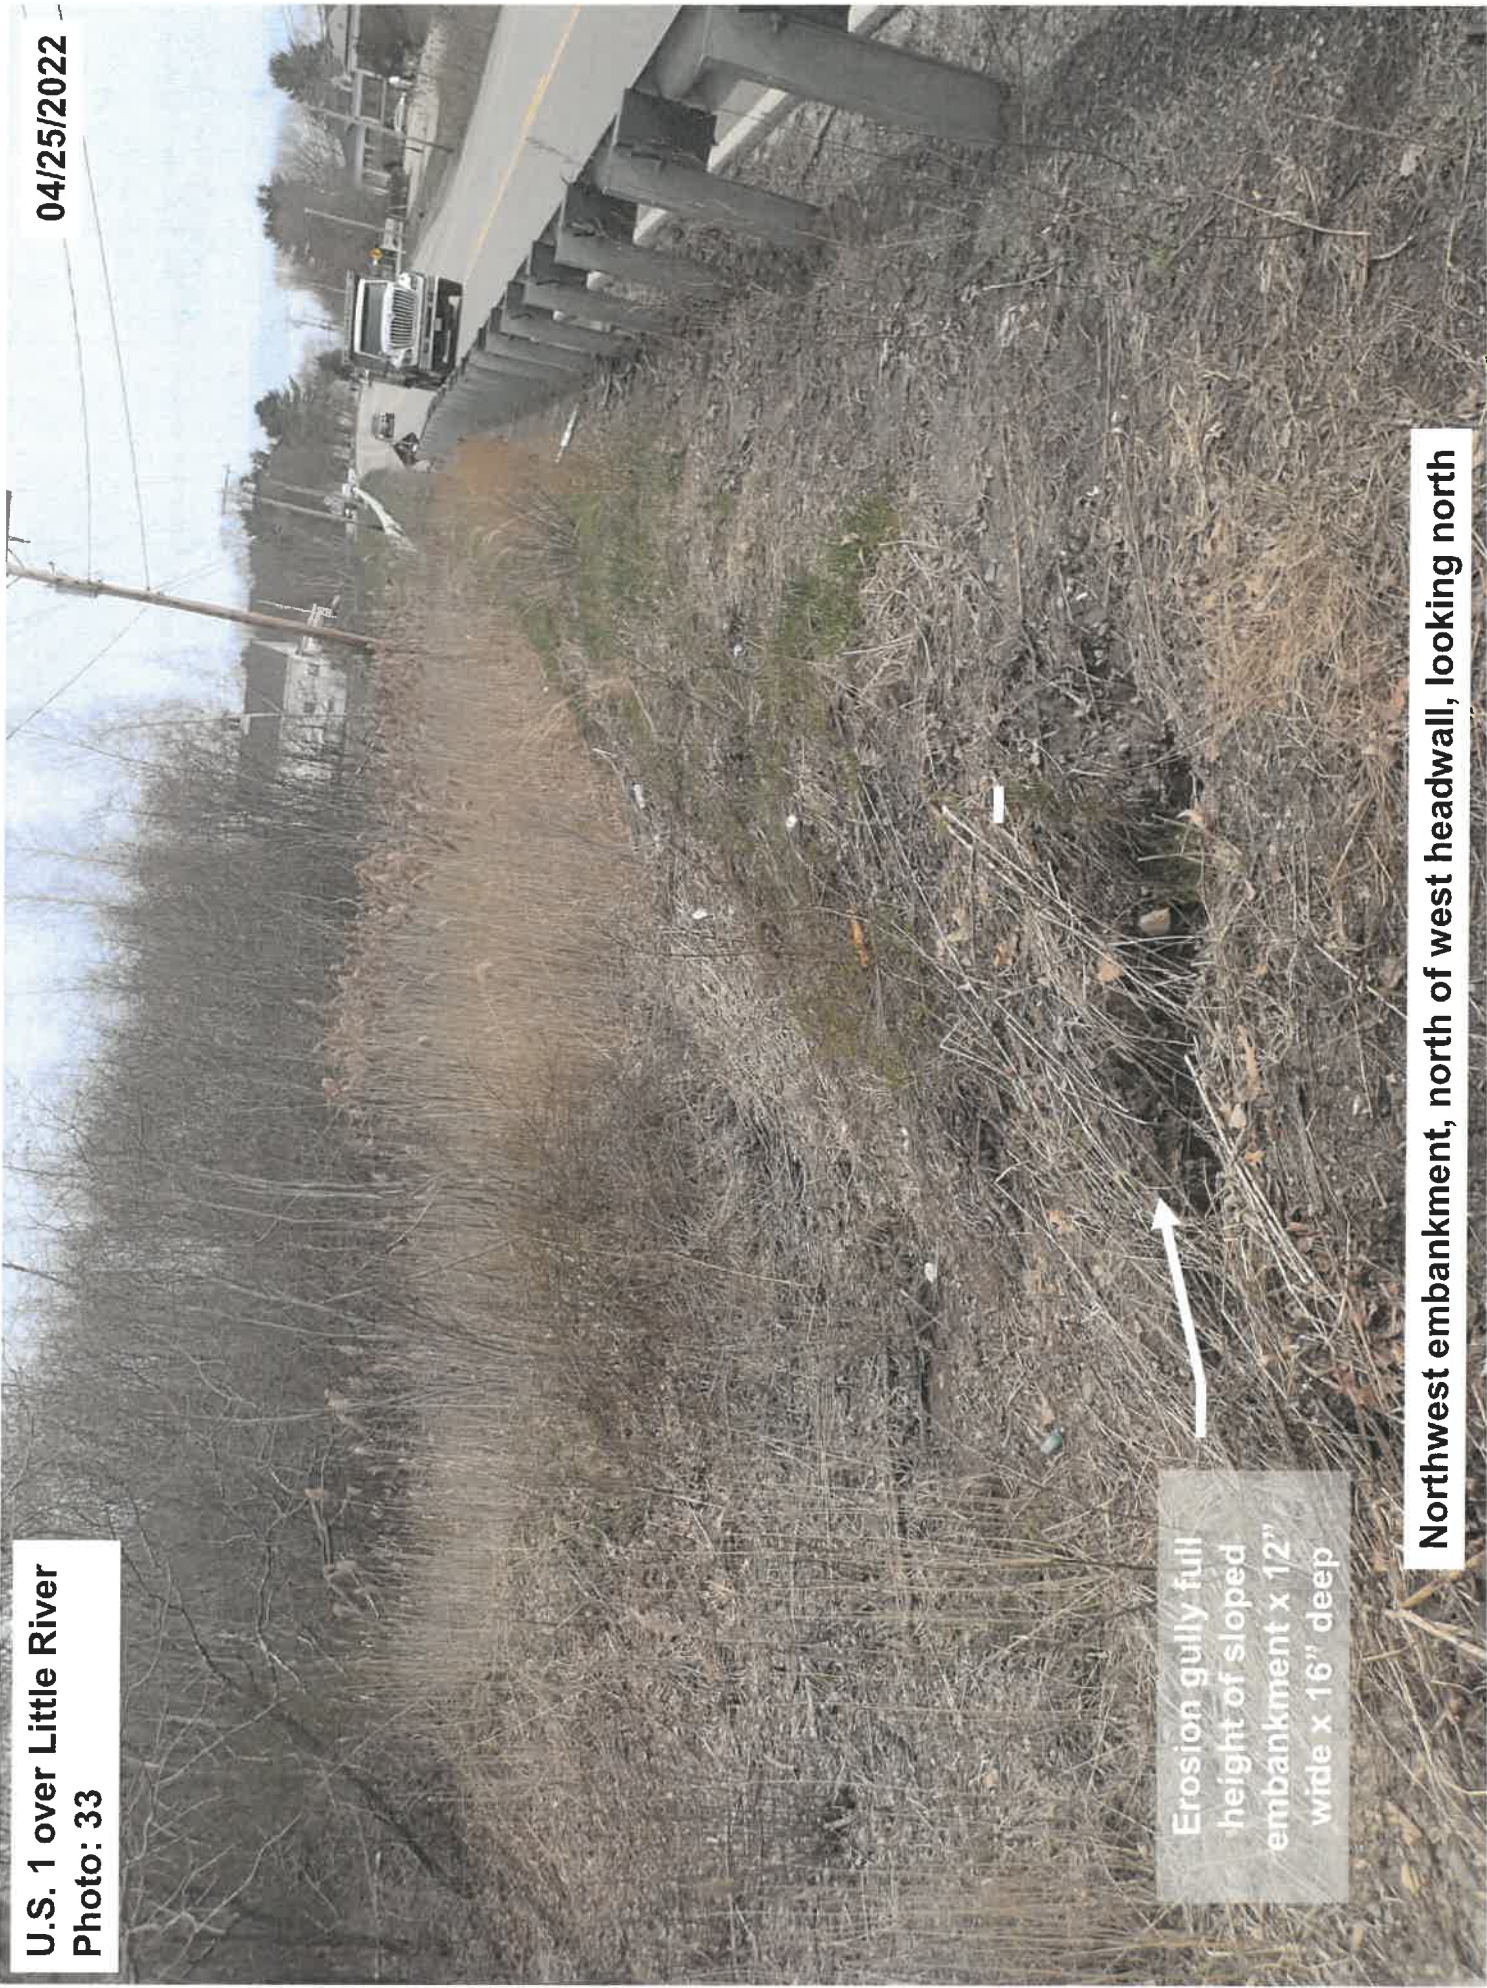
U.S. 1 over Little River
Photo: 33

Erosion gully full
height of sloped
embankment x 12"
wide x 16" deep

Northwest embankment, north of west headwall, looking north
