# CULVERT INSPECTION REPORT

**NHDOT 43937  
NORTH HAMPTON**

**US ROUTE 1  
OVER LITTLE RIVER**

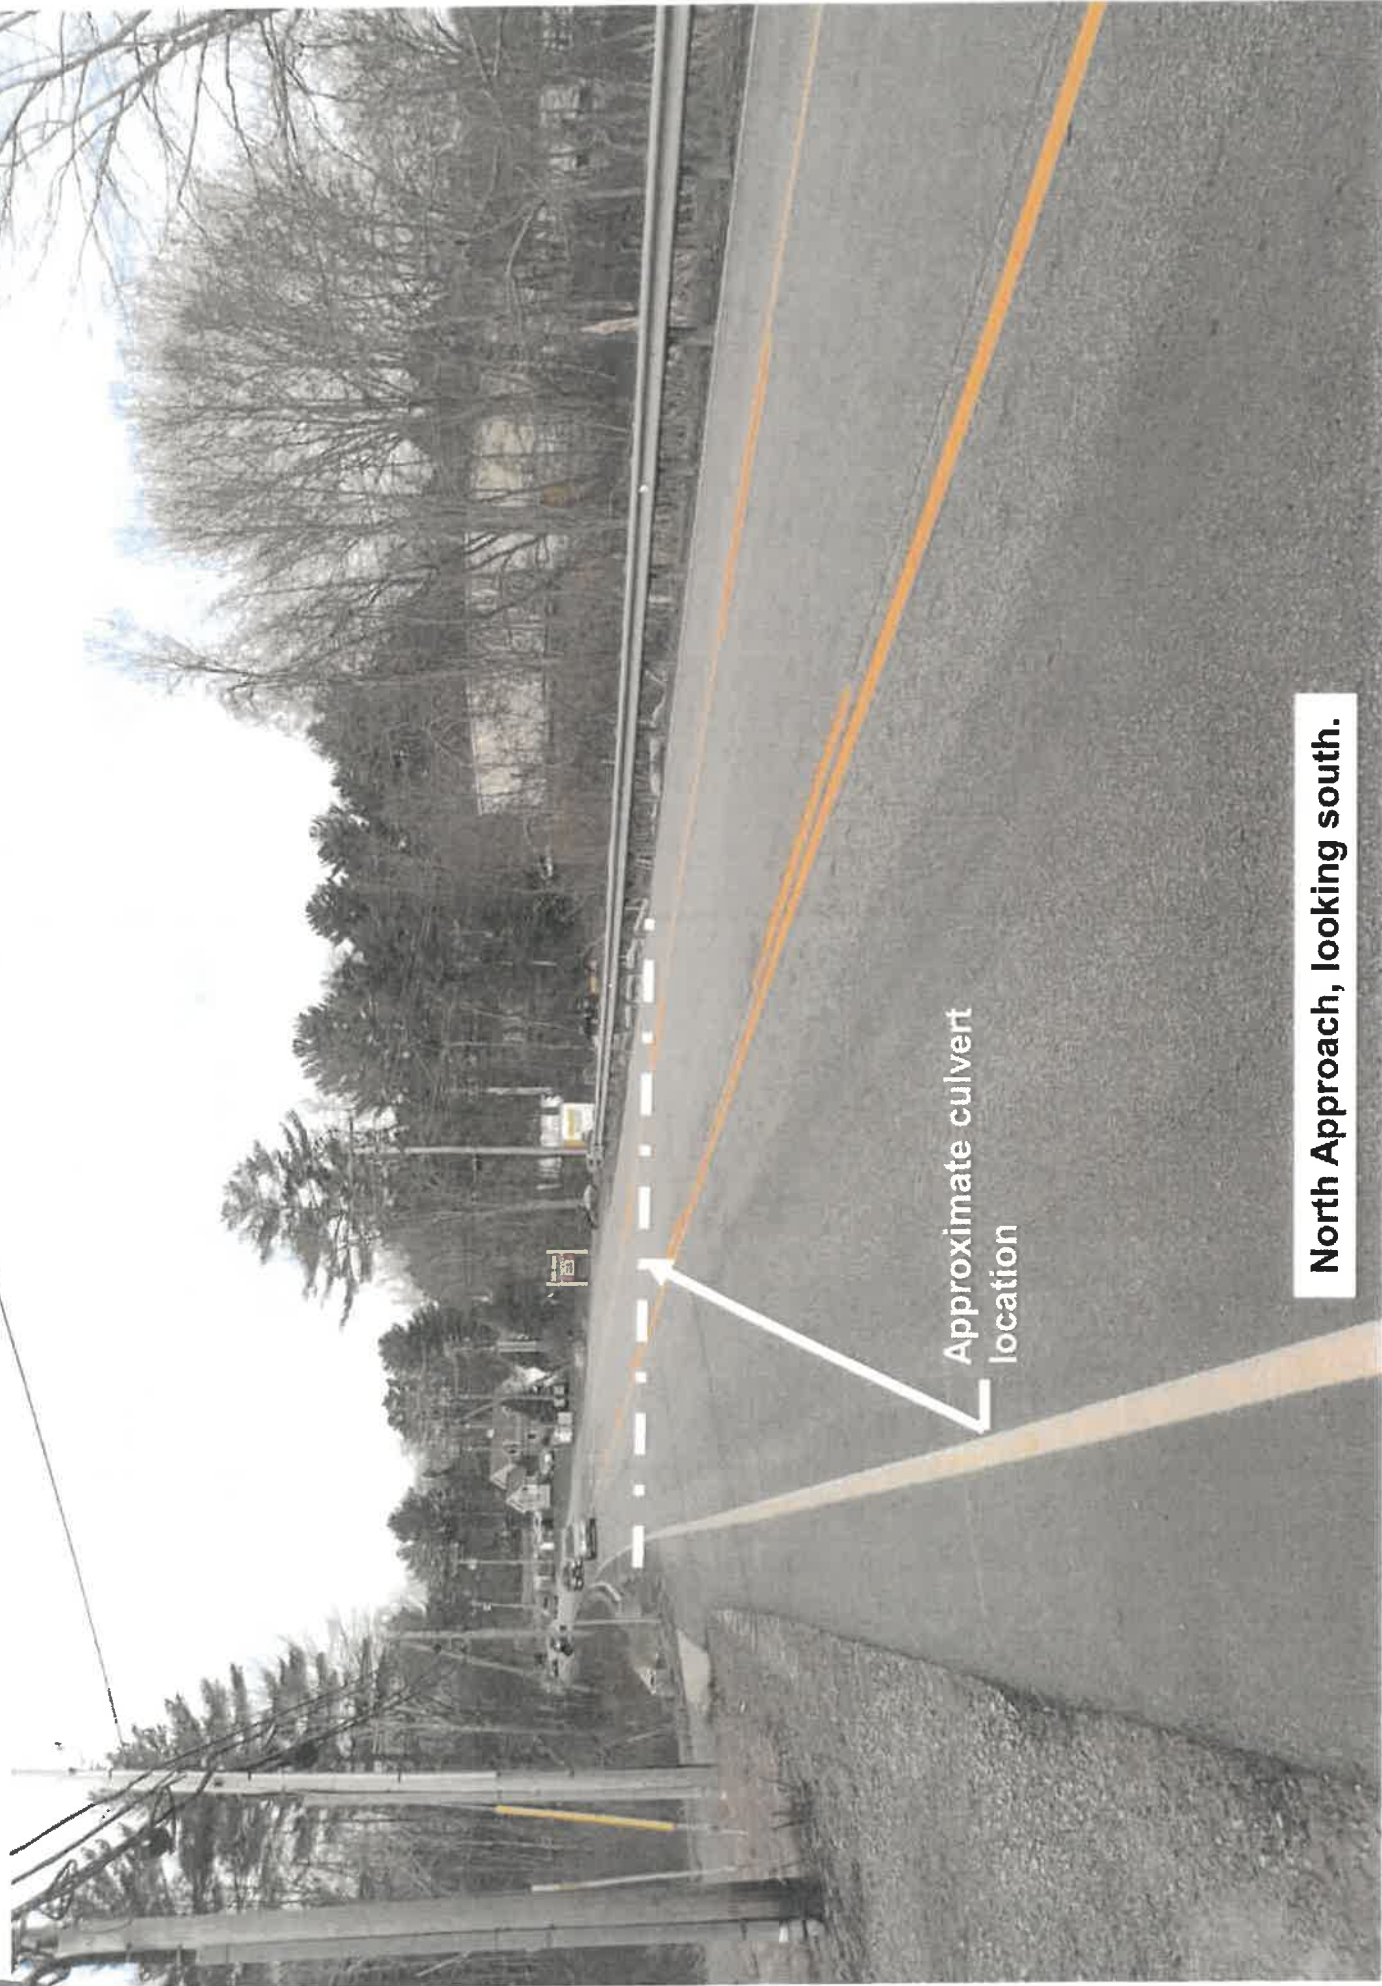
U.S. 1 over Little River  
Photo: 3

North Approach, looking south.

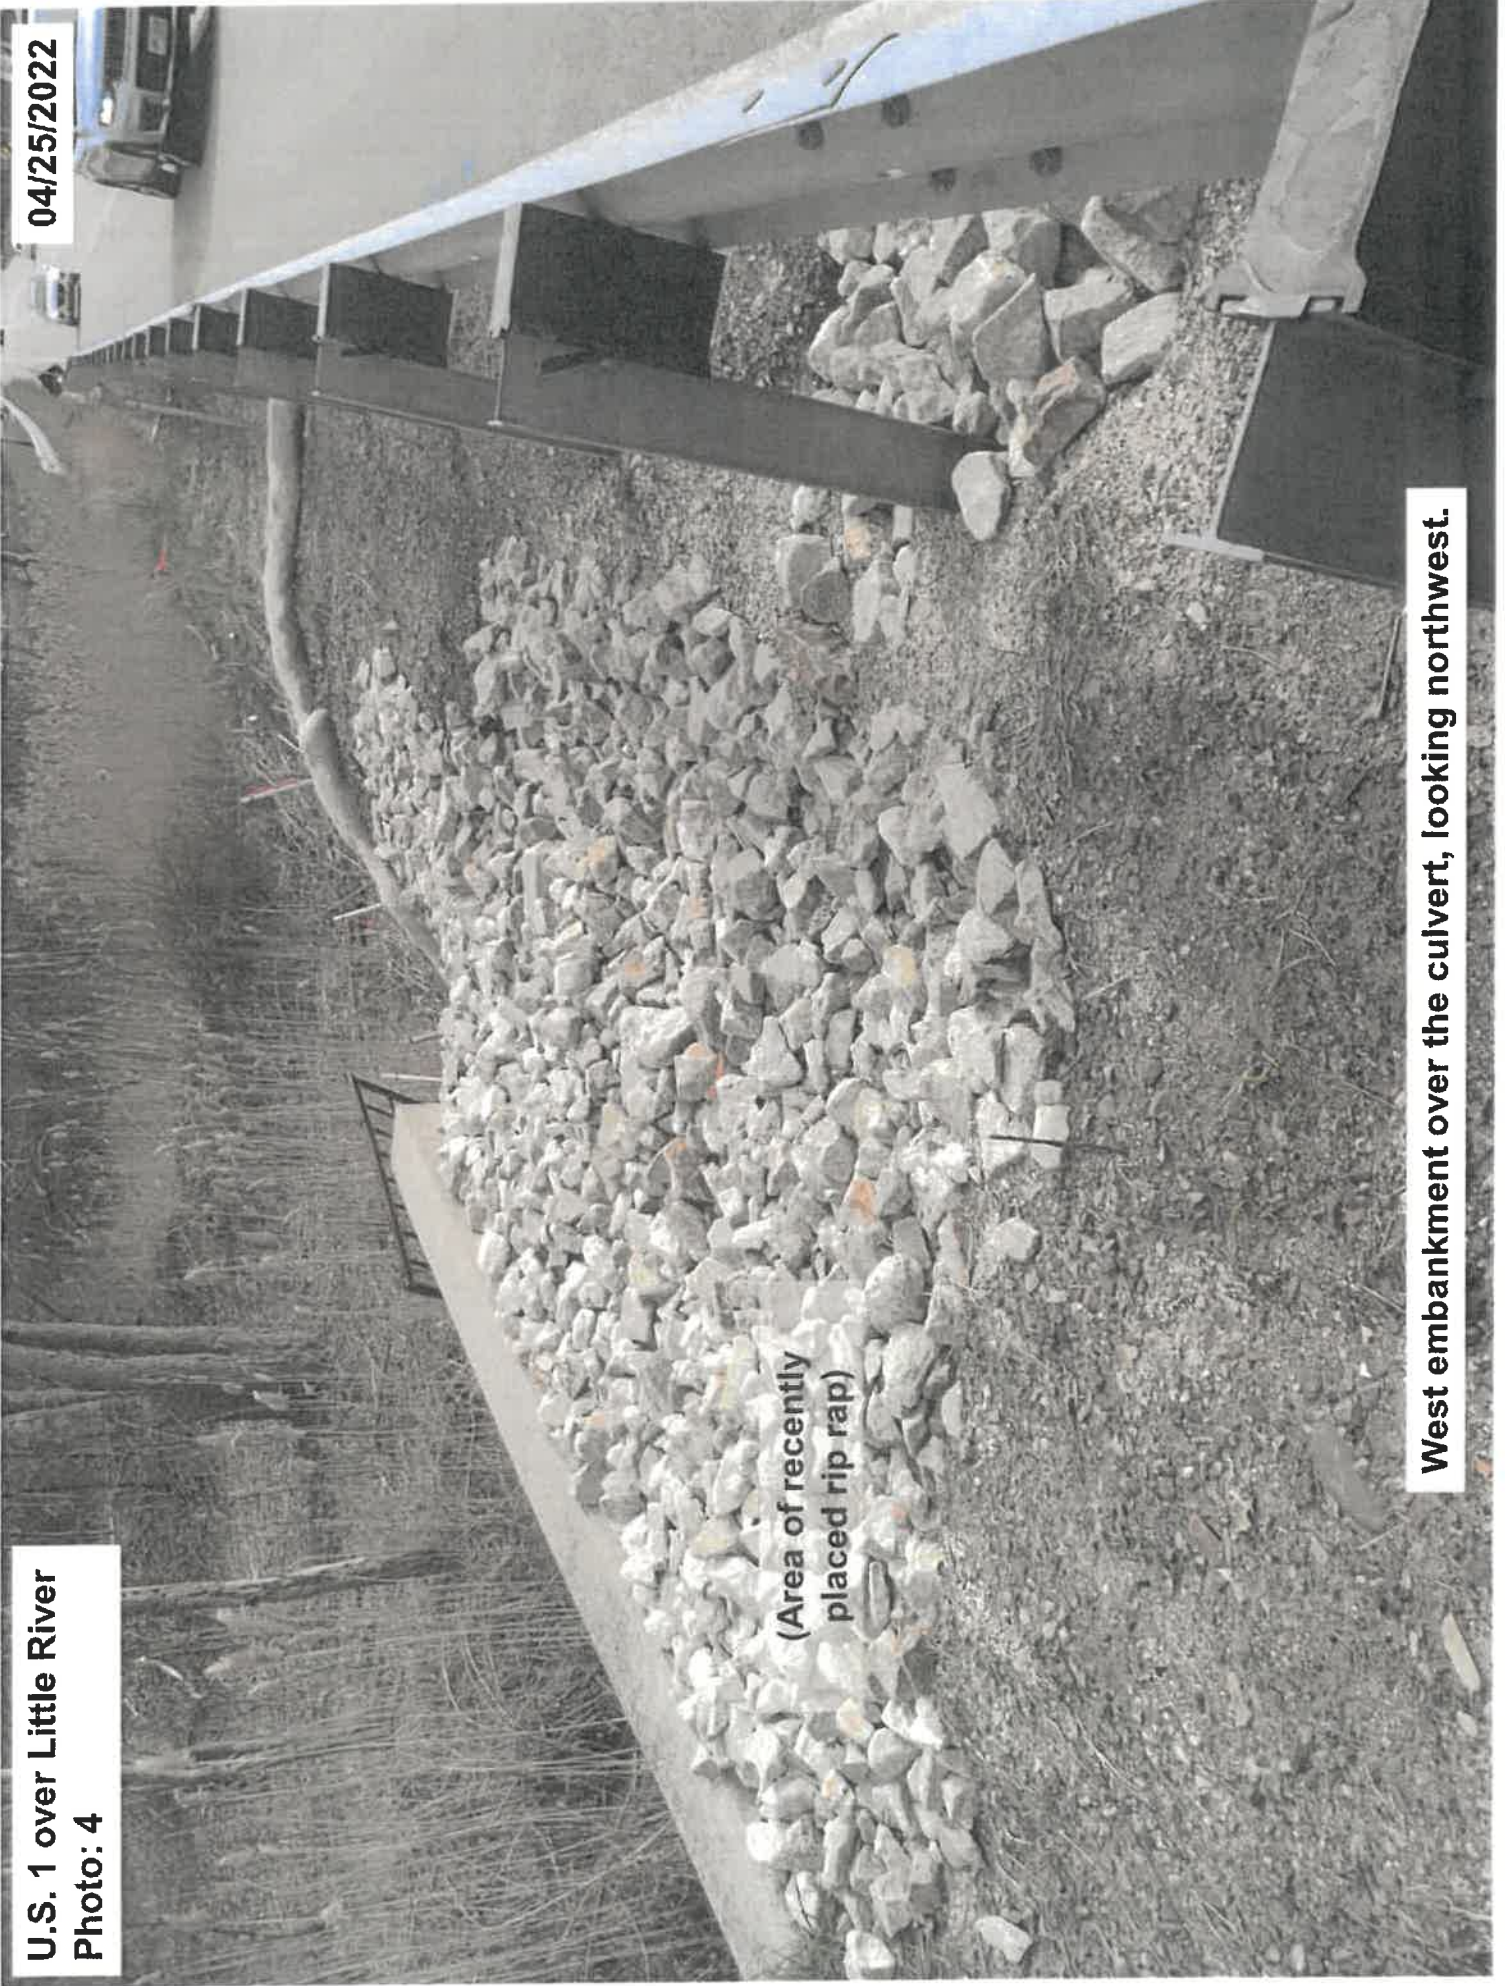
U.S. 1 over Little River  
Photo: 4

There is no apparent additional settlement at the areas of the west embankment headwall areas where rip rap has been placed (**Photo 4**). At the west guardrail, 9<sup>th</sup> post from the south end of the rail there is an area of erosion, which has been filled with rip rap, measuring 41" long x 39" wide x up to 8" deep that undermines the edge of the asphalt for a 41" length x up to 4-1/2" deep (**Photos 30 and 31**).

(Area of recently  
placed rip rap)

West embankment over the culvert, looking northwest.

- Remedy areas of undermining at the west concrete extension with considerations for smoothing the transition from the west concrete extension to the masonry culvert.
- Remedy the area of undermining at the west edge of asphalt.
- Monitor the tilt of the west concrete extension and condition of rip rap placed at the west embankment.

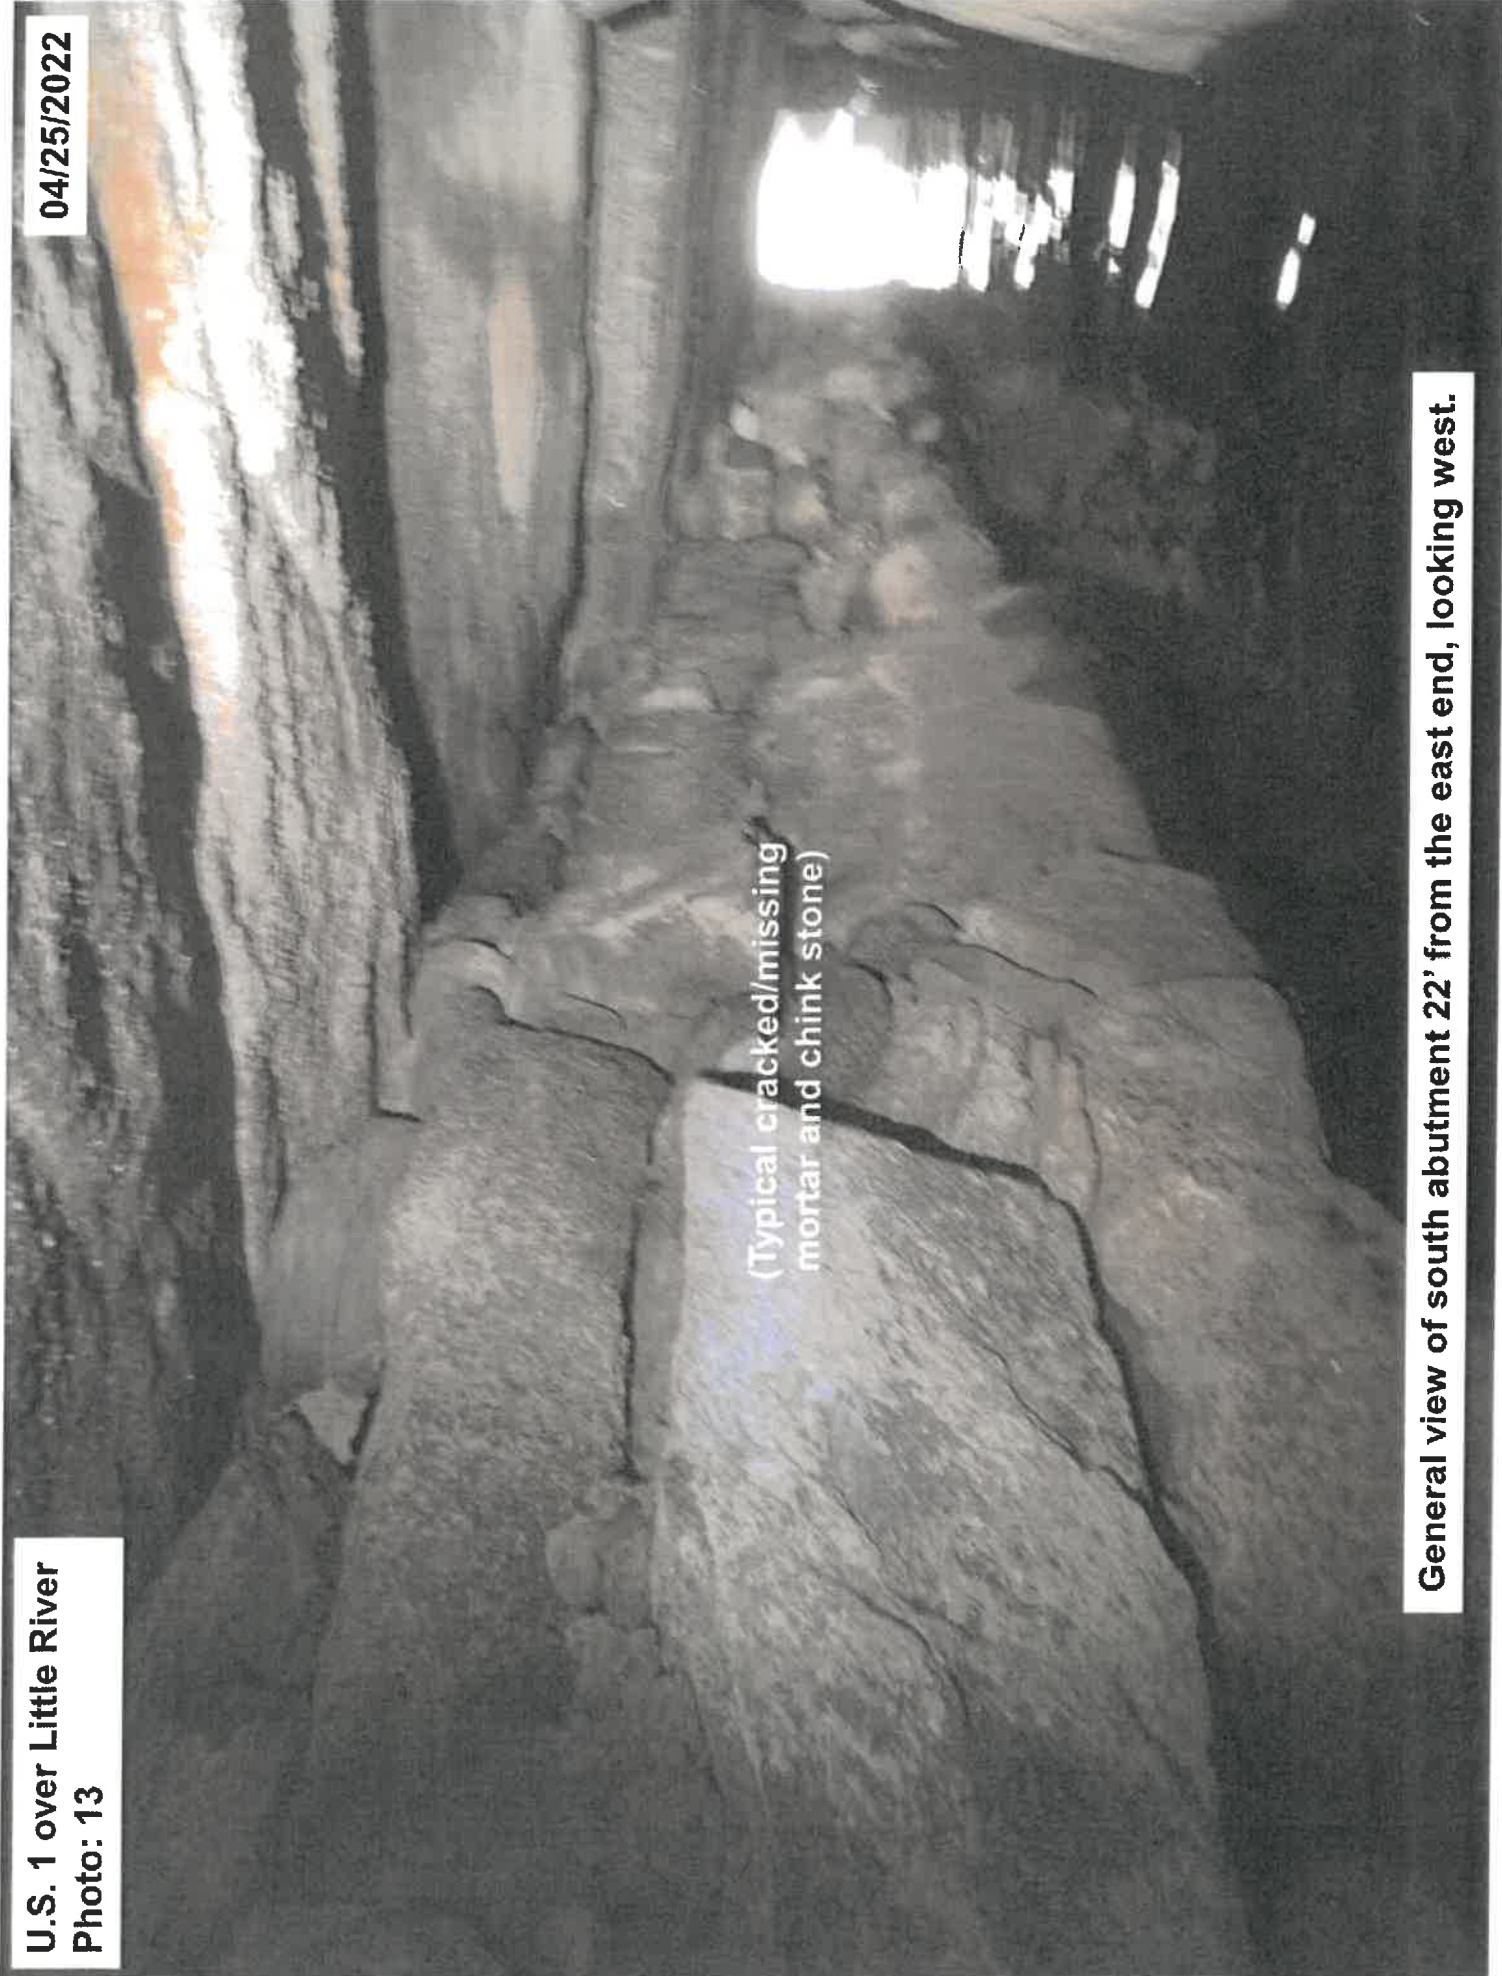
**U.S. 1 over Little River  
Photo: 14**

(Typical cracked/missing  
mortar and chink stone)

**General view of masonry culvert 22' from the east end, looking west.**

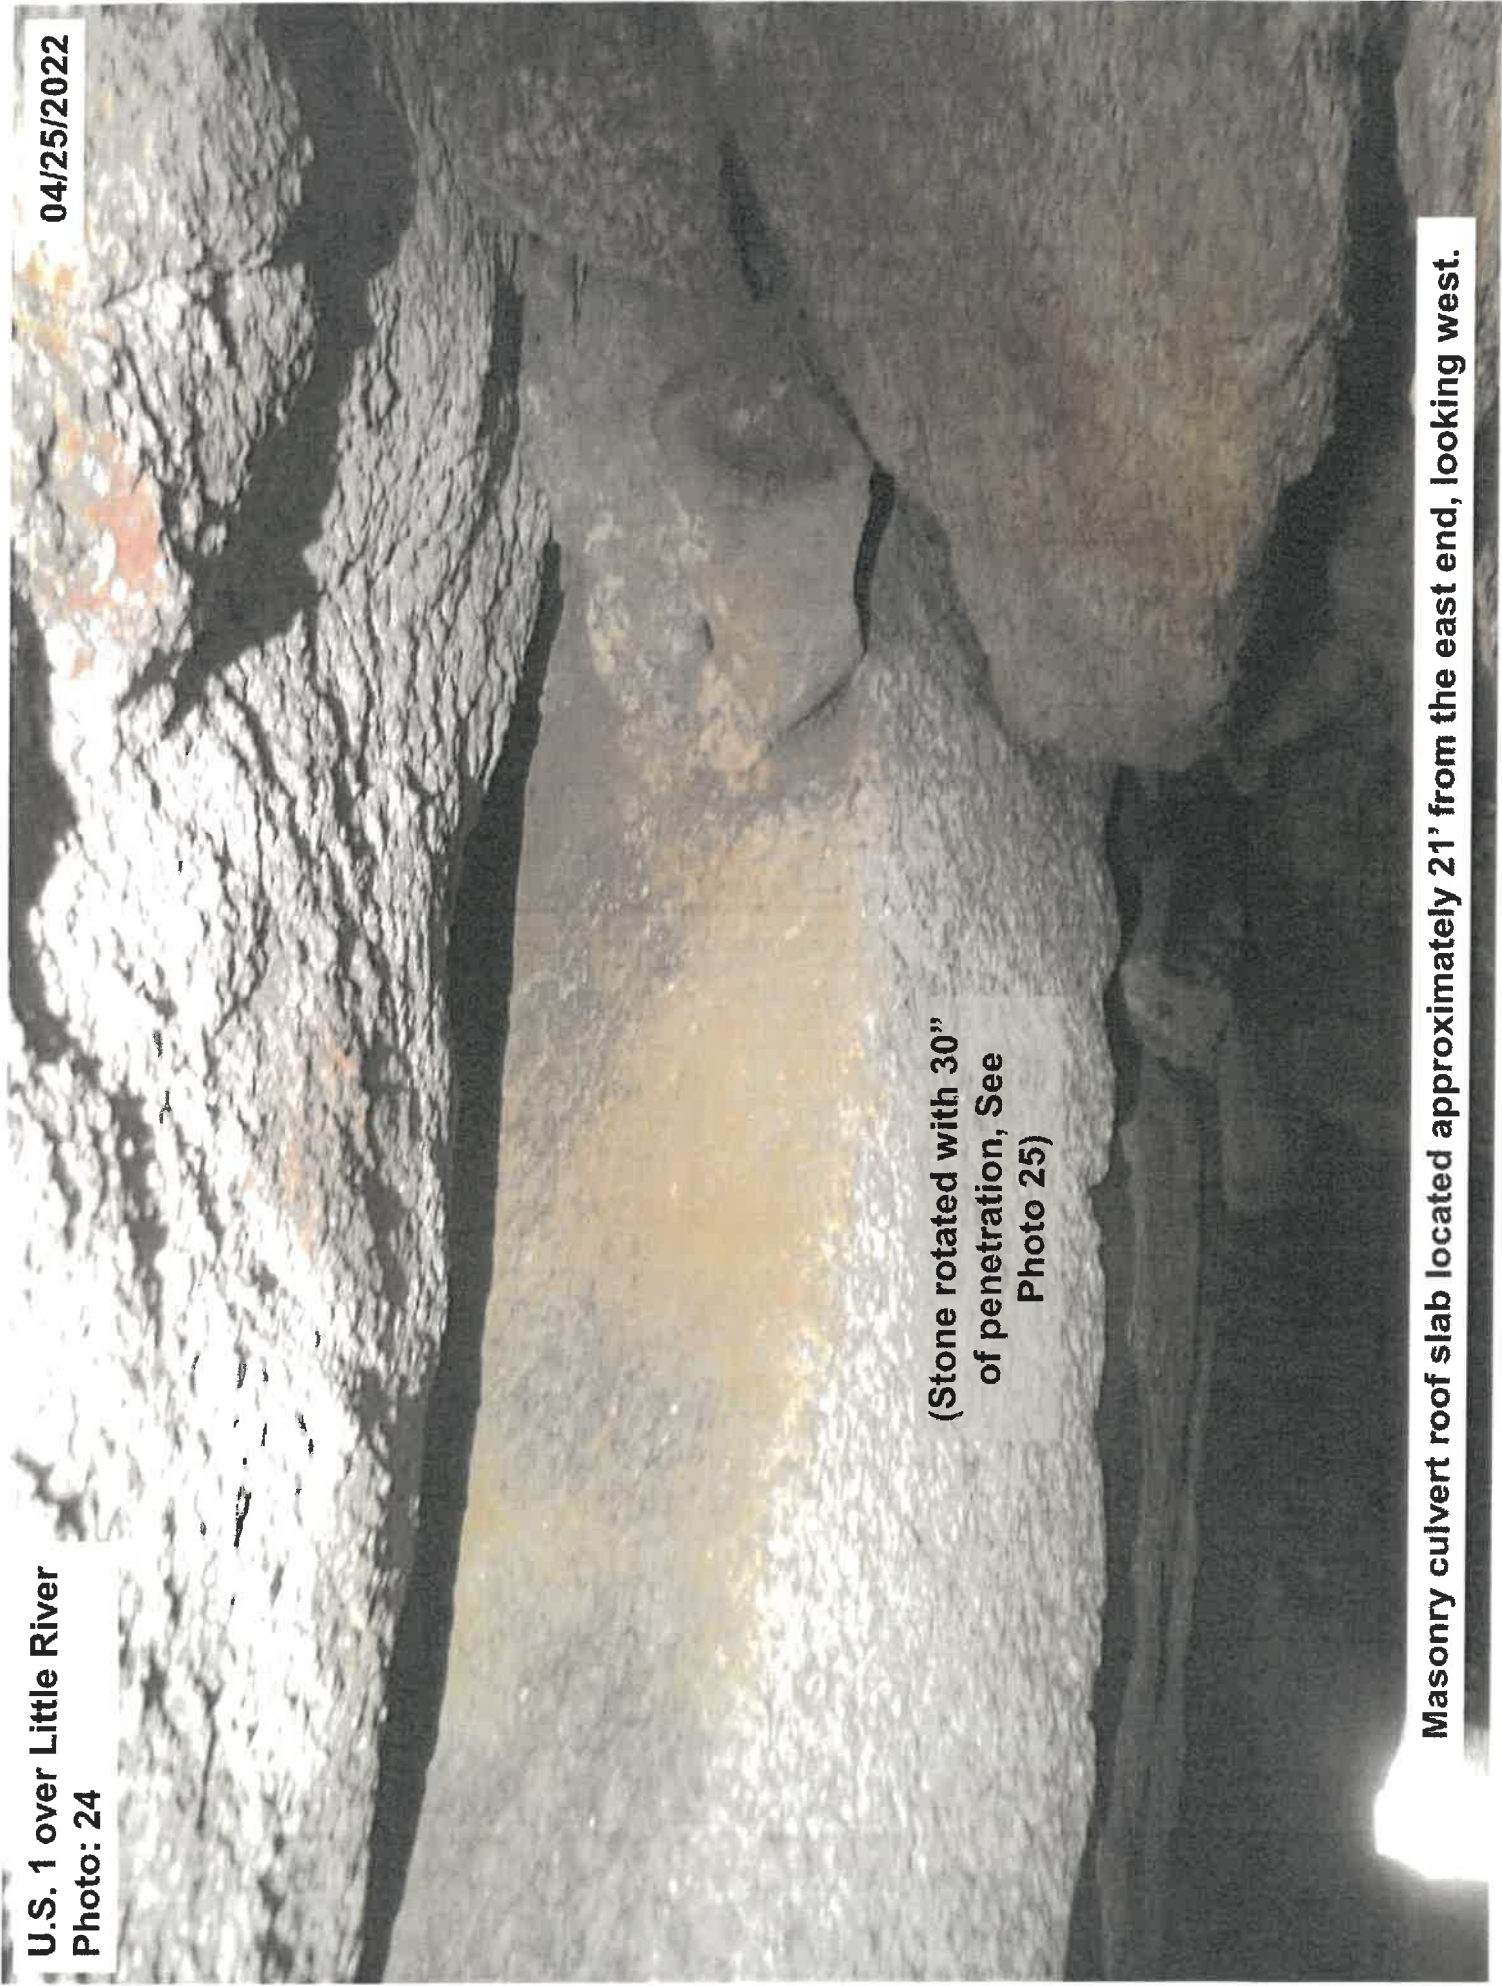
U.S. 1 over Little River  
Photo: 25

(Stone rotated with 30"  
of penetration)

Masonry culvert roof slab located approximately 21' from the east end, looking north.

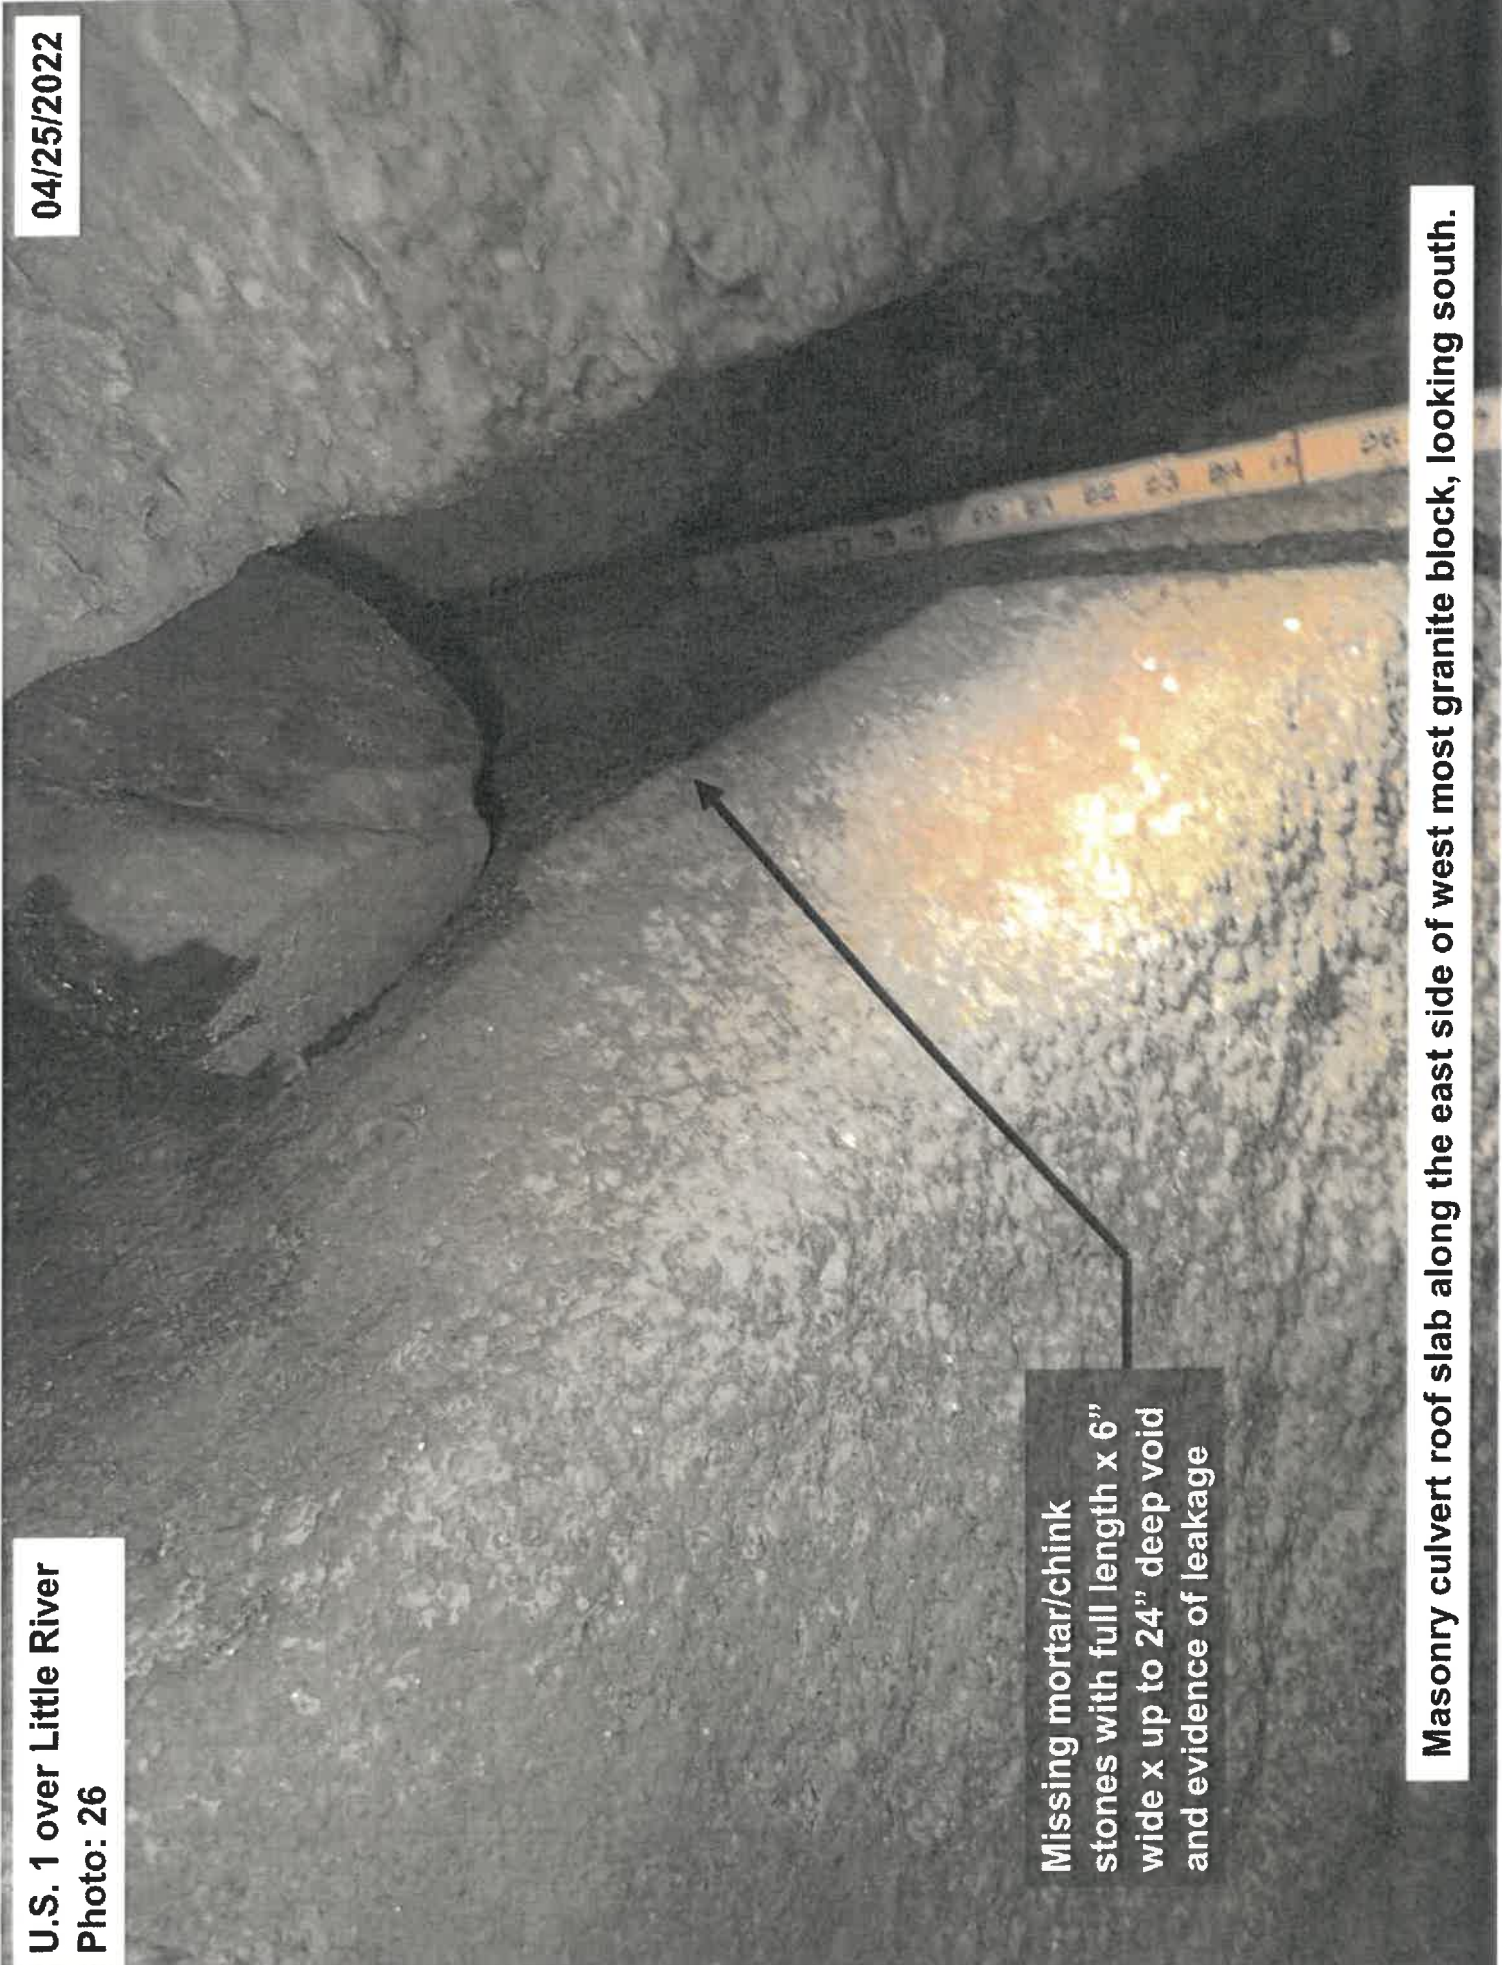
**U.S. 1 over Little River  
Photo: 27**

**(West concrete  
extension)**

**Void with evidence of leakage  
(see Photos 28 and 29)**

**Masonry culvert roof slab at the west side of the west most granite block, looking southeast.**

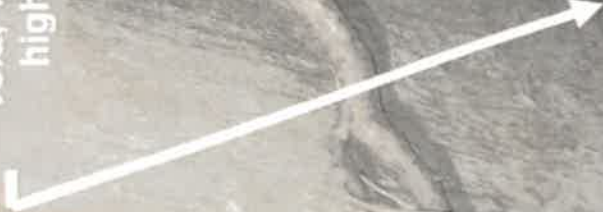
**U.S. 1 over Little River  
Photo: 32**

At the south end of the southwest wingwall (west headwall) there is a void measuring 10" deep (east direction) x 22" high x 11" long (south direction) with evidence of minor fill spilling through (**Photo 32**). The west headwall is 3.5° out-of-plumb, leaning away from the roadway. North of the west headwall, there is an erosion gully measuring full height of the sloped portion of the embankment x 12" wide x 16" deep (**Photo 33**)

Void, 10" deep x 22"  
high x 11" long

**South end of west headwall, looking southeast.**
