LARGE GROUNDWATER WITHDRAWAL PERMIT APPLICATION NOTIFICATION FORM

AQUARION is seeking a Large Groundwater Withdrawal Permit for a new bedrock public water supply well in Hampton, NH. A preliminary estimates of the potential yield of Well 22 is up to 940 gallons per minute (gpm) or approximately 1,350,000 gallons per day (gpd). Well 22 is located approximately 120 feet from AQUARION's Well 7, a sand and gravel packed public water supply well which yields over 500 gpm. Aquarion Water Company provides drinking water to Hampton, North Hampton, and parts of Rye NH.

**Preliminary Report and Large Groundwater
Withdrawal Permit Application
(Env-Wq 403, Env-Ws 302)**

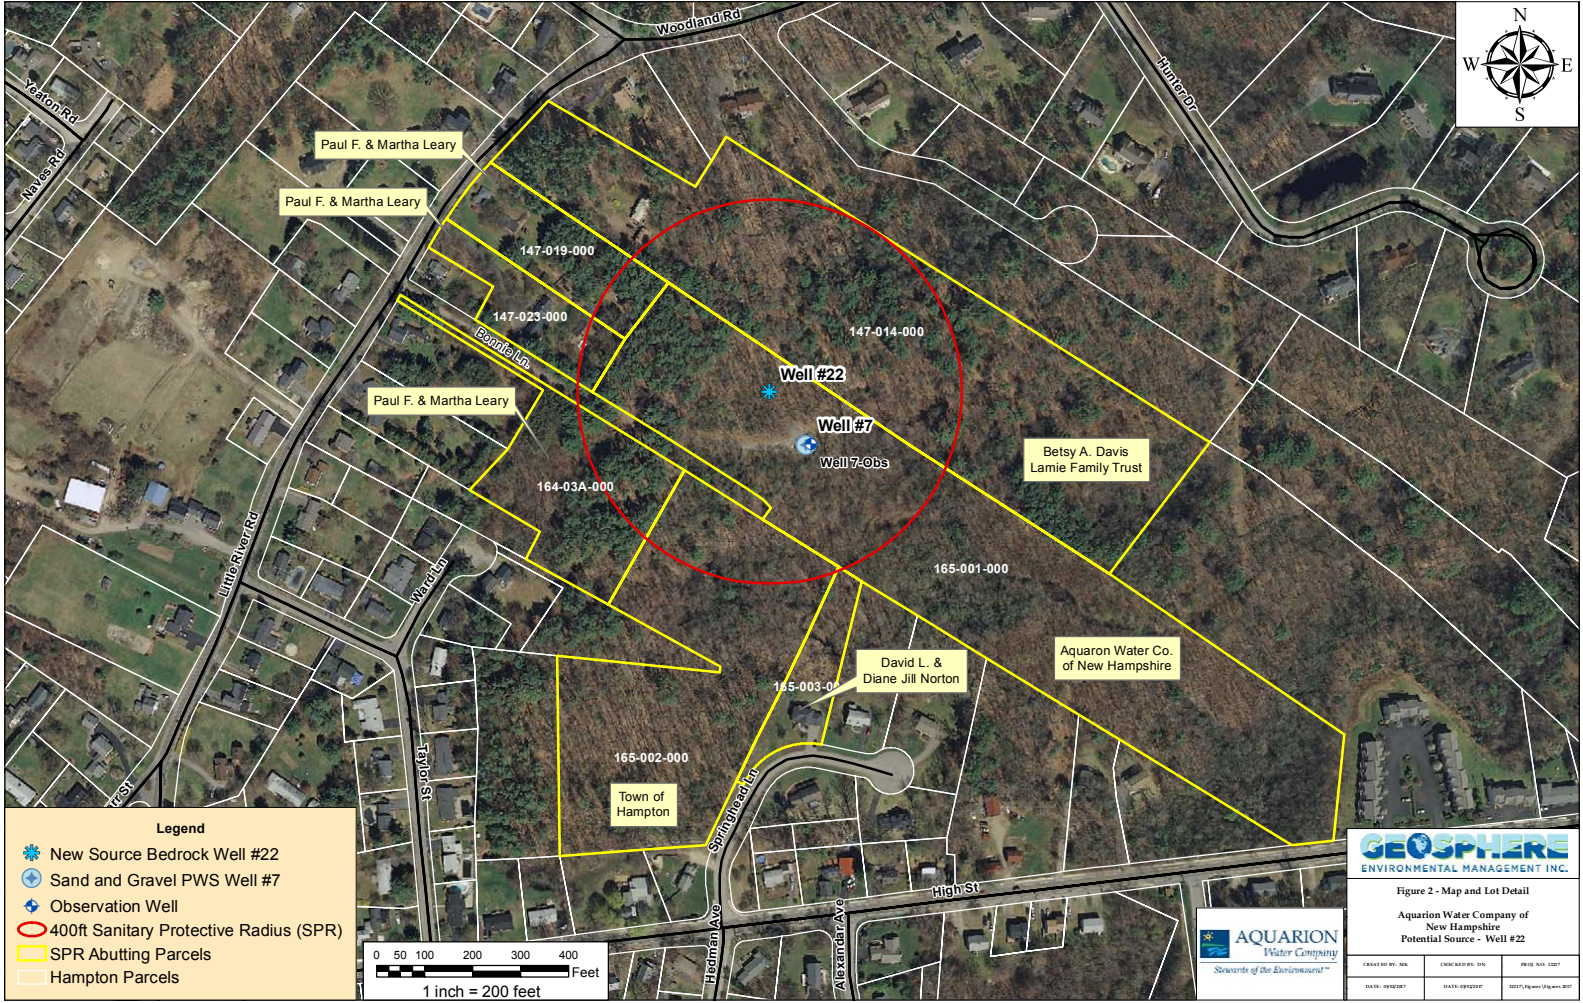
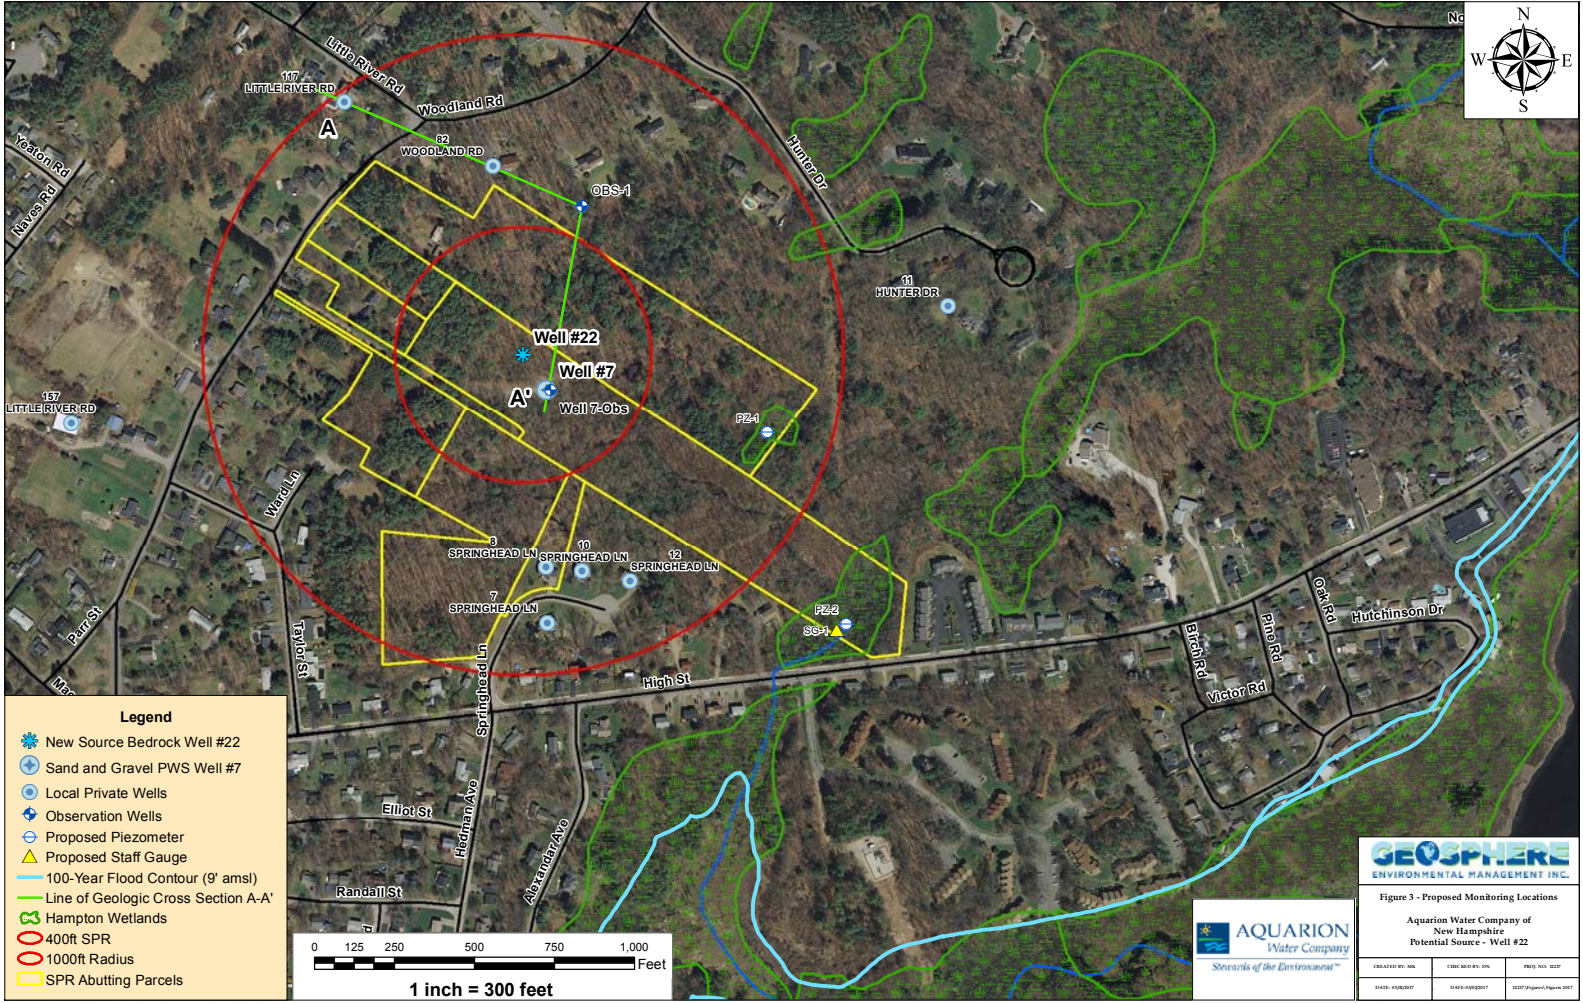
Figure 3 - Proposed Monitoring Locations
Aquarion Water Company of
New Hampshire
Potential Source - Well #22

- New Source Bedrock Well #22
- Sand and Gravel PWS Well #7
- Local Private Wells
- Observation Wells
- Proposed Piezometer
- Proposed Staff Gauge
- 100-Year Flood Contour (9' amsl)
- Line of Geologic Cross Section A-A'
- Hampton Wetlands
- 400ft SPR
- 1000ft Radius
- SPR Abutting Parcels

The 100-Year Flood Plain and its proximity relative to Well 22 can be found in **Figure 3**. The 100-Year Flood Plain Elevation is 9 ft. above sea level, which is well below the elevation of the western edge of the site at 45 ft. The flood plain boundary is located 1,500 ft. from Well 22 and does not encroach the well site property. The Flood Insurance Rate Map can be found in **Appendix G**.

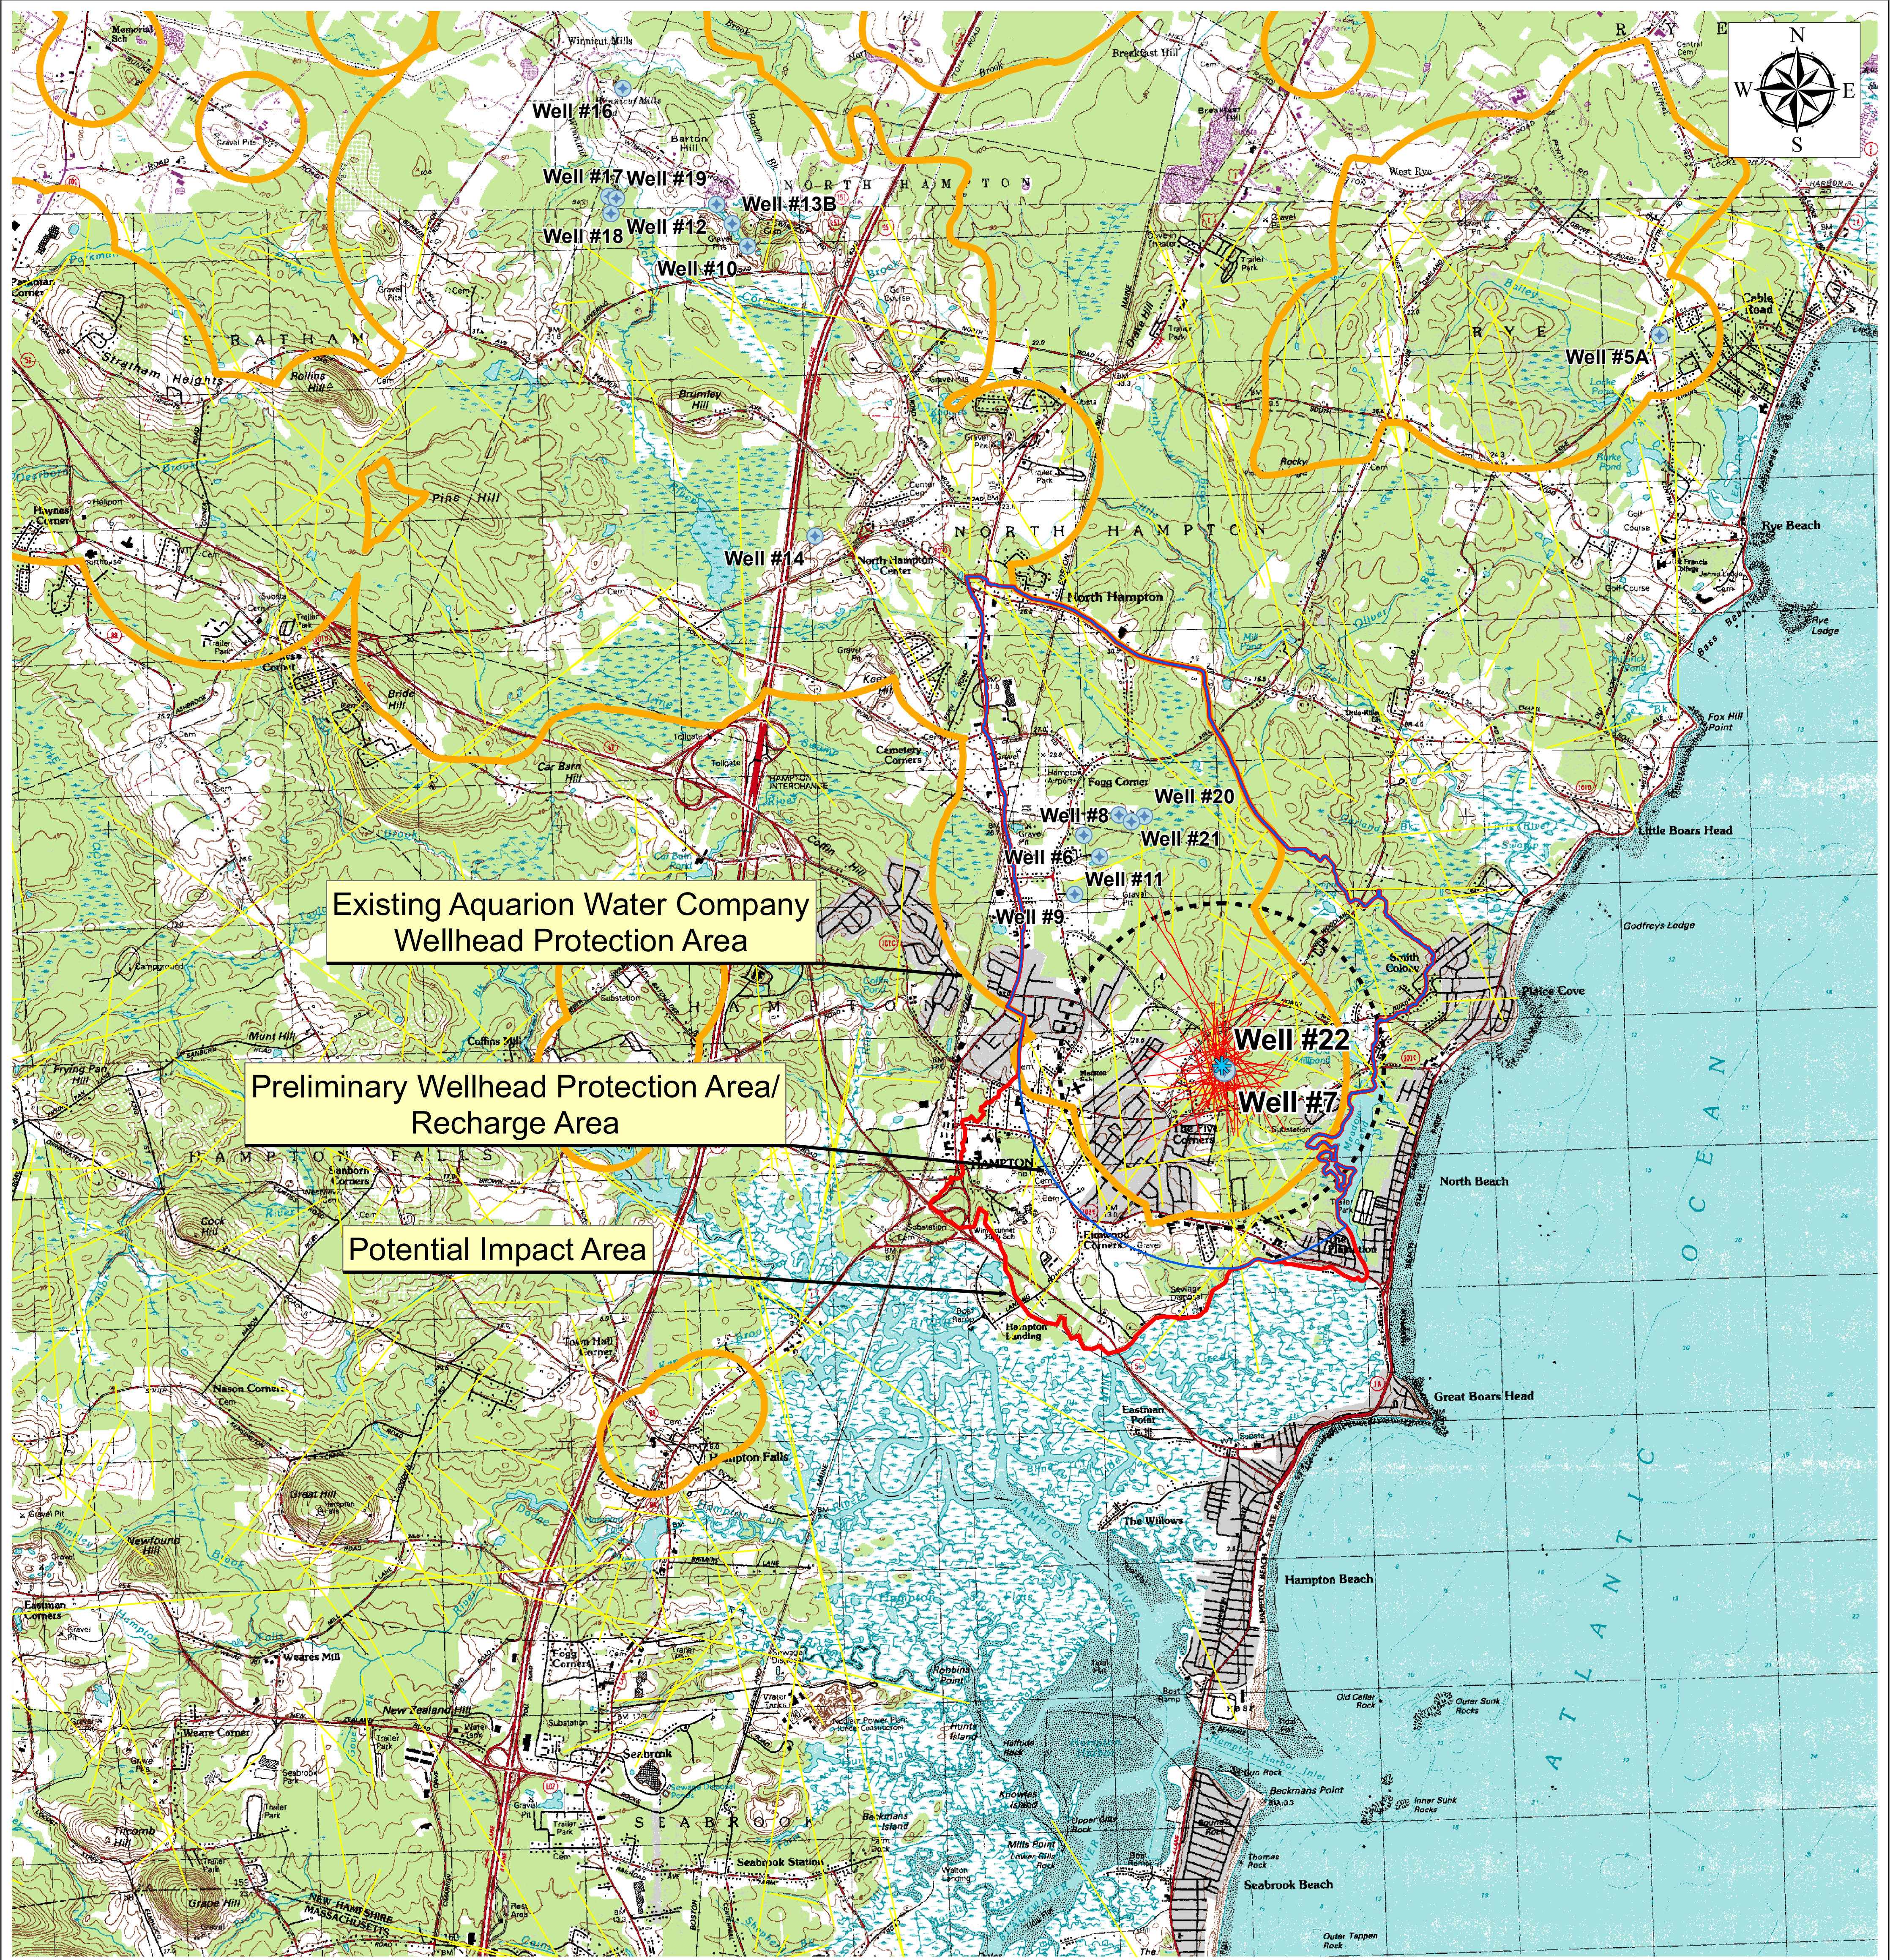
Figure 6

Potential Impact Area and Preliminary Wellhead Protection Area/ Recharge Area

A default 4,000-foot radius was chosen as the basis of a preliminary cone of depression (COD) for Well 22, given that insufficient data is currently available to calculate the COD (see **Figure 6** for COD). However, the presence of mapped lineaments extending from the area surrounding Well 22 to areas outside the preliminary COD indicates that the maximum COD under continuous pumping conditions with no recharge will likely extend beyond the preliminary COD.

The recharge area for the withdrawal was estimated based on several factors including the characteristics of the topography of the area, the surficial and bedrock geology of the site vicinity, and the locations and alignments of mapped lineaments indicative of bedrock fractures. The recharge area was extended in the upgradient direction to the adjacent watershed boundary to the northeast in order to incorporate recharge areas to the mapped lineaments (both GEOSPHERE and USGS) that were observed to extend beyond the watershed boundary and that emanate from the Well 22 withdrawal location (see **Figure 6** for the Preliminary WHPA/recharge area). The total area of the recharge area is approximately 4.10 sq. mi. This recharge area also coincides with the Preliminary Wellhead Protection Area (WHPA).

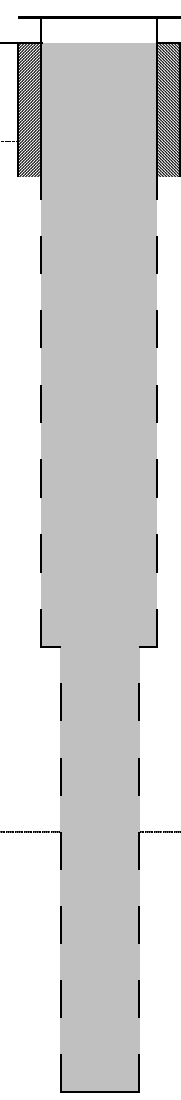
20.0	(0'-50') Coarse Sand and Gravel, with Cobbles, trace Clays present from 48'-50'.

40.0								
60.0	(50' - 420') Dark Grey/Green foliated schist. (Rye Formation)					50'	CONCRETE SANITARY SEAL AROUND CASING 0 - 67 FT BGS BEDROCK INTERFACE

80.0		Fn	90'			67'	10-INCH STEEL CASING TO 67 FT BGS OPEN 10-INCH BORE HOLE 67 - 320 FT BGS	
100.0								
120.0								
140.0		Fn	135'					
160.0		Fn	150'

Drilling of Well 22 confirmed the presence of sand and gravel deposits to depths of up to approximately 50 feet deep, followed by the Rye Formation. Another rock type, a granite, was encountered in Well 22 at a depth of 420 – 560 ft. below ground surface (bgs). This rock is believed to represent the Breakfast Hill Granite, an intrusive quartz feldspar granite rock found adjacent to and intruded into the Rye formation (see **Appendix B** for Well 22 borehole log).

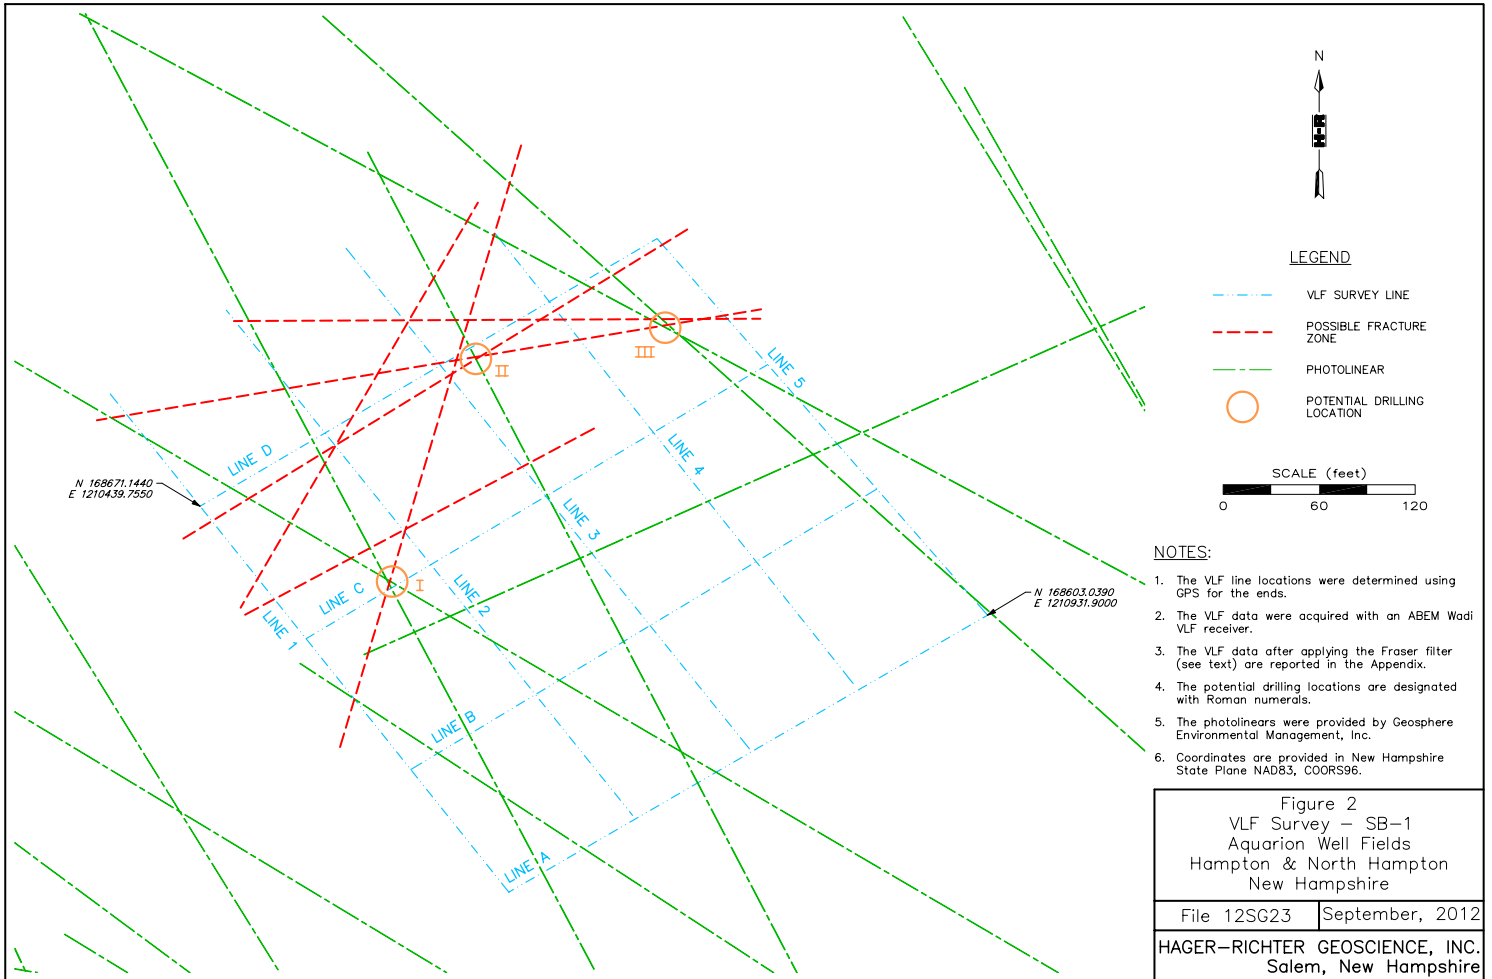
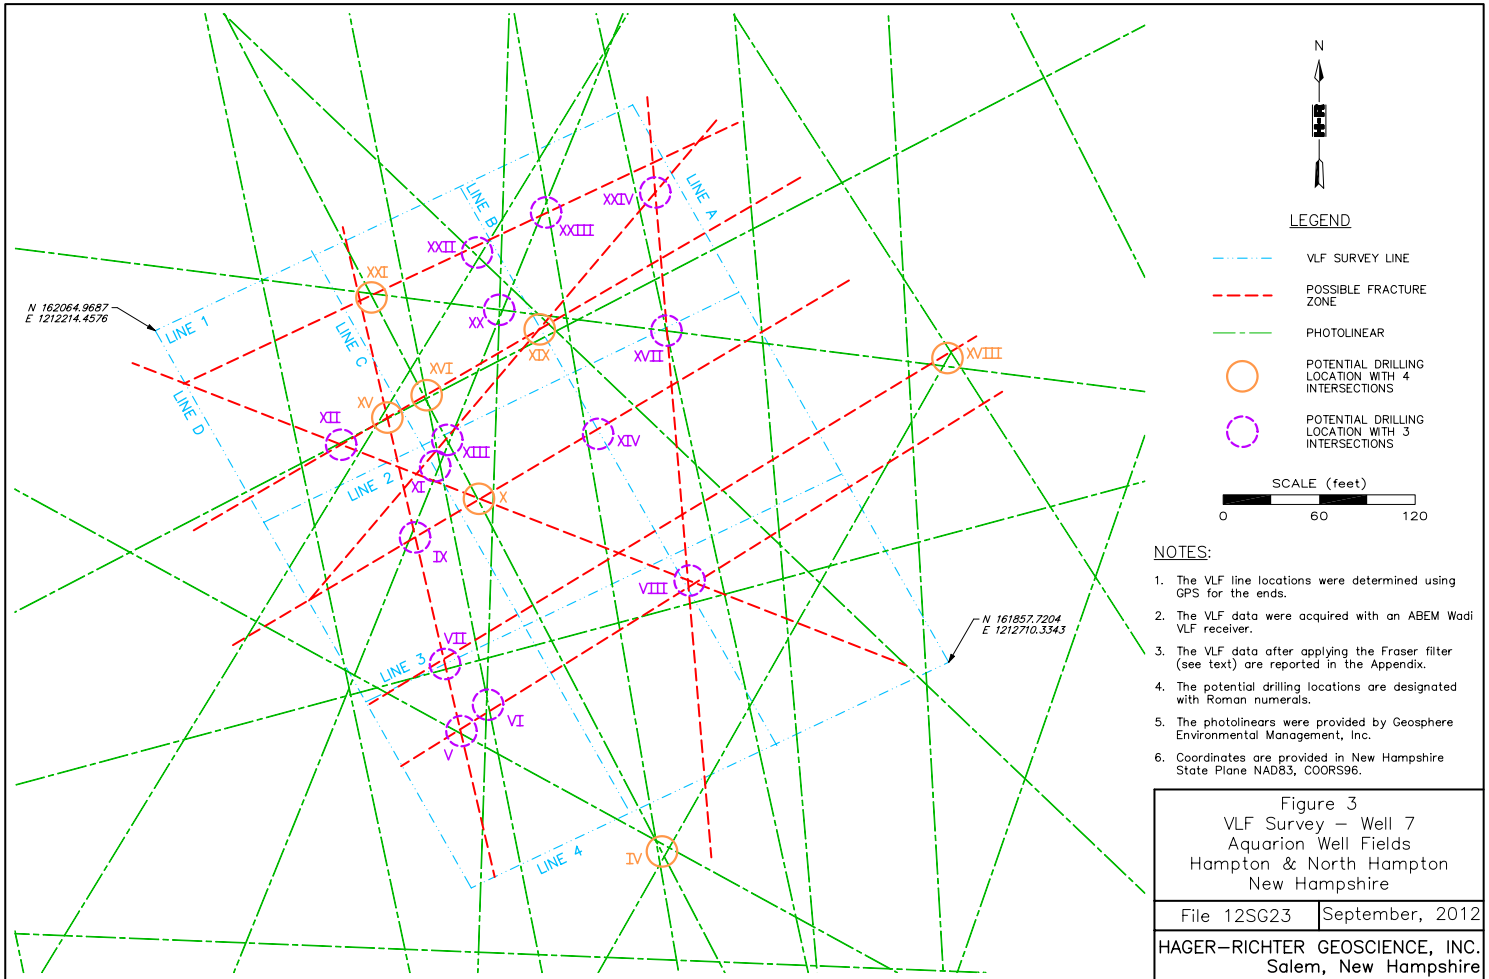
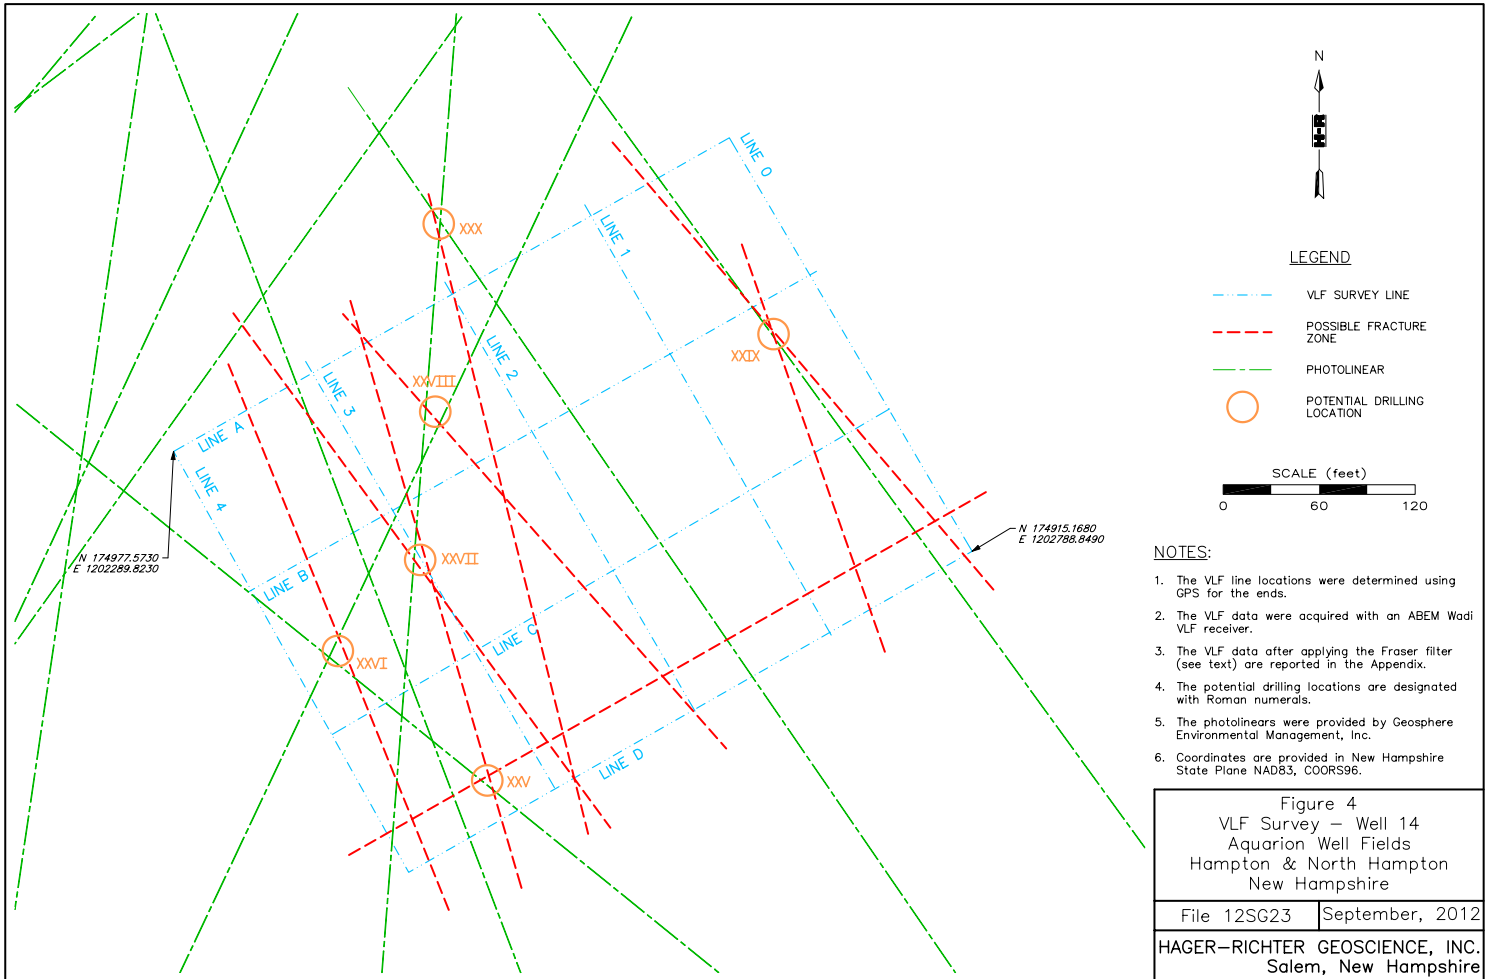
- VLF SURVEY LINE
- POSSIBLE FRACTURE ZONE
- PHOTOLINEAR
- POTENTIAL DRILLING LOCATION

In August of 2012 Hager-Richter Geoscience, Inc. (Hager-Richter) conducted a very low frequency (VLF) geophysical survey of the well site in Hampton. The objective of the VLF survey was to provide data that could be integrated with the FTA data to identify locations for exploration drilling. The results of the VLF survey identified possible fractures coincident with photolinears identified by GEOSPHERE. Survey lines were prepared by GEOSPHERE in GIS format and a GPS unit was used to stake the intersections and endpoints of identified possible fractures (see **Figure 5**). **Appendix C** contains Hager-Richter's VLF survey report prepared for the well site (The Hager-Richter report also contains results from two other AQUARION well sites).

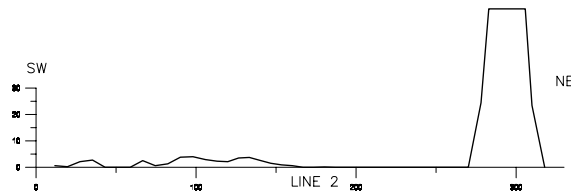
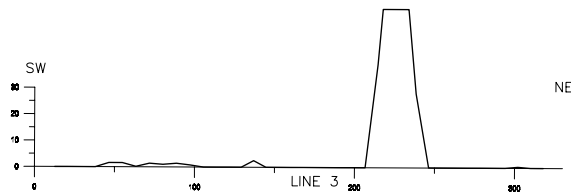
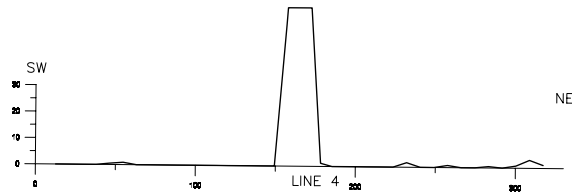
Appendix 3 VLF Data Northwest to Southeast - Well 7 Aquarion Well Fields Hampton & North Hampton New Hampshire	
File 12SG23	September, 2012
HAGER-RICHTER GEOSCIENCE, INC. Salem, New Hampshire

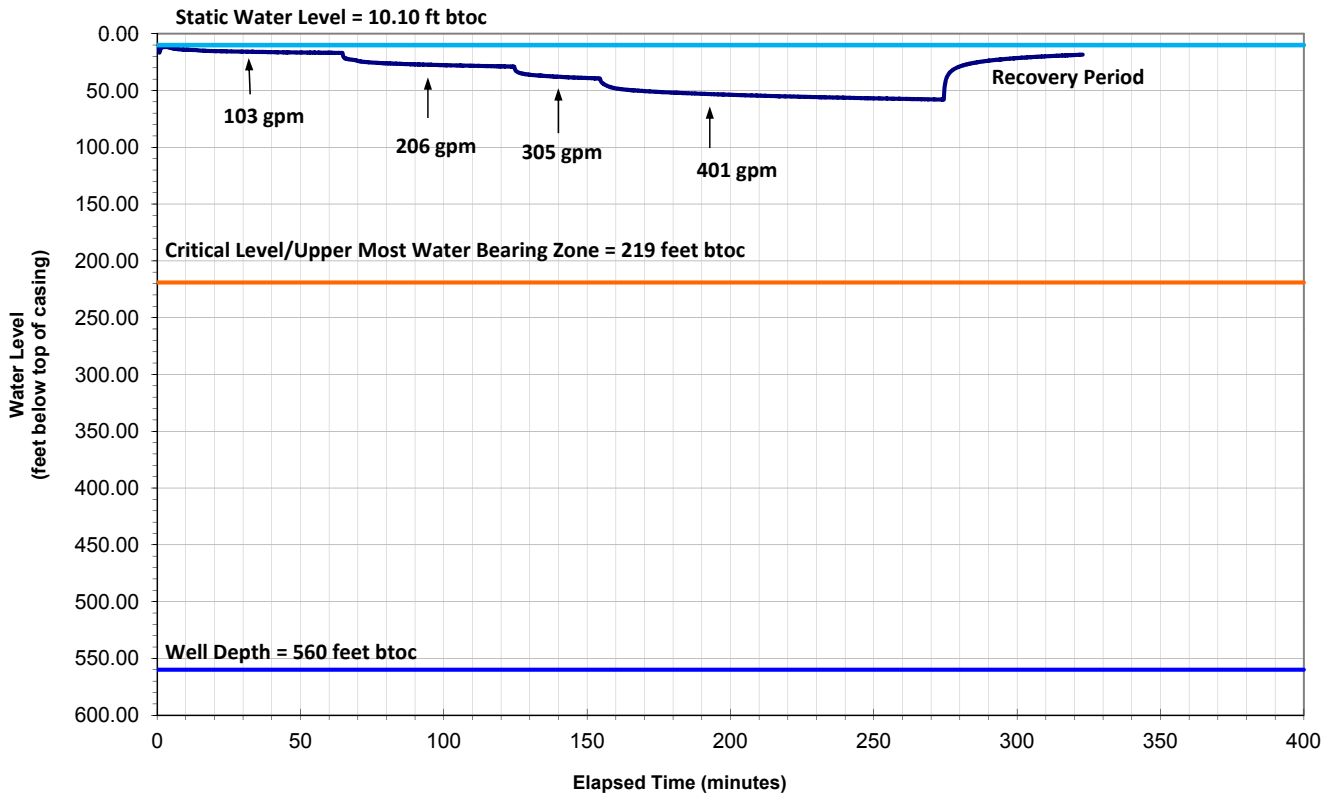
Aquarion Water Company
Well 22 Step-Drawdown Withdrawal Test - 2012
Water Levels vs Elapsed Time

btoc = below top of casing, top of casing is 2 feet above ground surface

Water levels observed in Well 22 during the 2012 step-drawdown test are presented in **Figure D-1** in **Appendix D**. This graph also shows the static groundwater level (10.1 feet below top of casing [btoc]), the total depth of the well (560 feet bgs), and the upper most water-bearing zone (219 feet bgs). The upper most water-bearing zone represents the critical pumping level as defined by the NH DES LGWP regulations. The NH DES LGWP regulations require that for any groundwater withdrawal wells, the pump must be set above the upper most water-bearing fracture to reduce the risk of de-watering fracture zones currently utilized by other users (private wells). As shown, the groundwater levels in Well 22 during each pumping rate remained well above the uppermost water-bearing zone. In fact, the groundwater level under the highest rate of 401 gpm did not drop below 58.08 feet, which is above the bottom of the well casing (67 feet bgs).

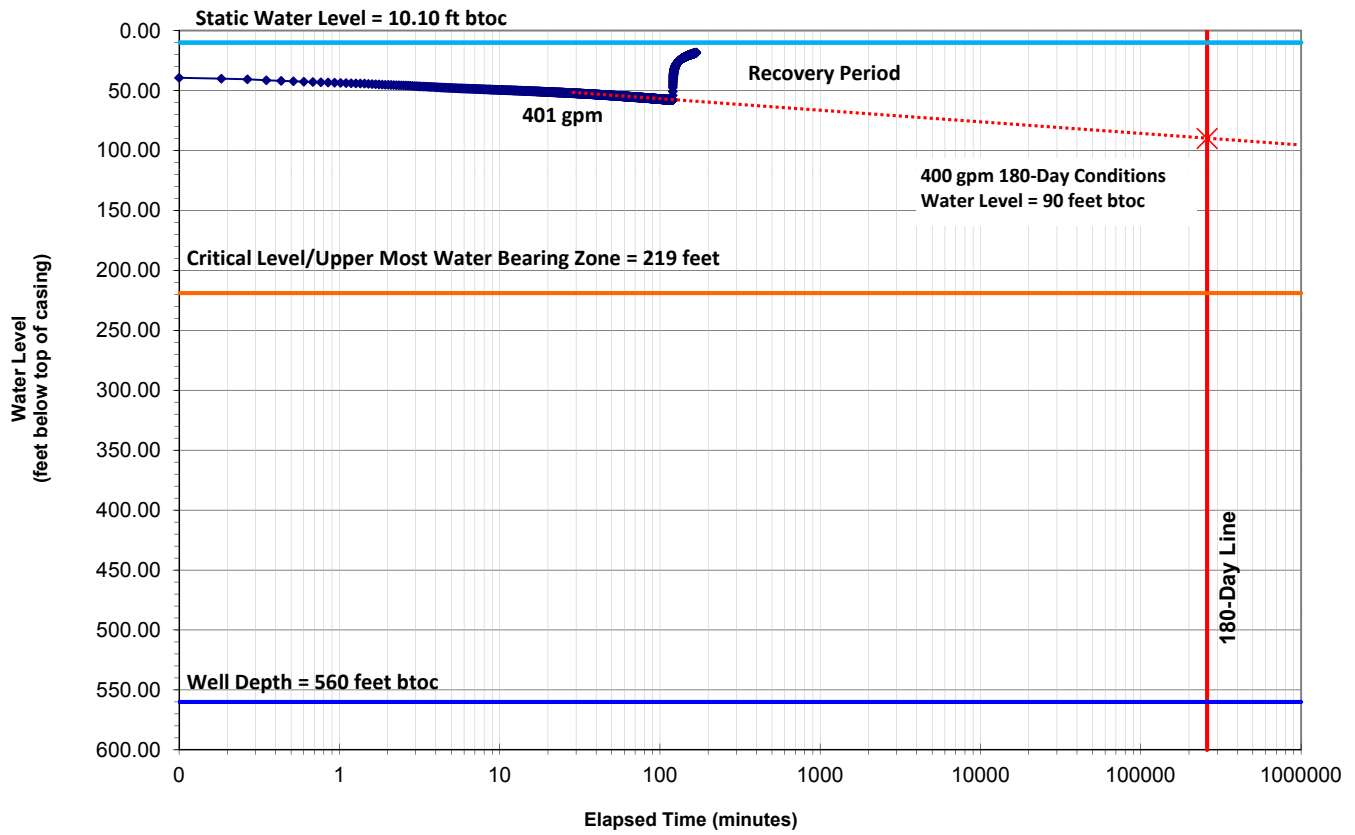
FIGURE D-2
Aquarion Water Company
Well 22 Step-Drawdown Withdrawal Test - 2012
Water Levels vs Elapsed Time (Logarithmic)

Notes:
 btoc = below top of casing, top of casing is 2 feet above ground surface
 Step-Drawdown Testing was performed on October 16, 2012 at 4 different withdrawal rates (103 gpm, 206 gpm, 305 gpm, and 401 gpm)

Figure D-2 in **Appendix D** presents the groundwater level data recorded during the highest pumping rate of 401 gpm. The groundwater levels are presented against elapsed time on the log scale in order to extrapolate a pumping level under the NH DES defined 180-day continuous pumping with no recharge groundwater withdrawal conditions. As shown, the extrapolated groundwater level under the 180-day conditions is approximately 90 feet btoc. Based upon extrapolation of the groundwater level data recorded during the step-drawdown test, Well 22 can produce well over 400 gpm over an extended period of time (180-days) without dropping the water level below the critical level of 219 feet bgs.

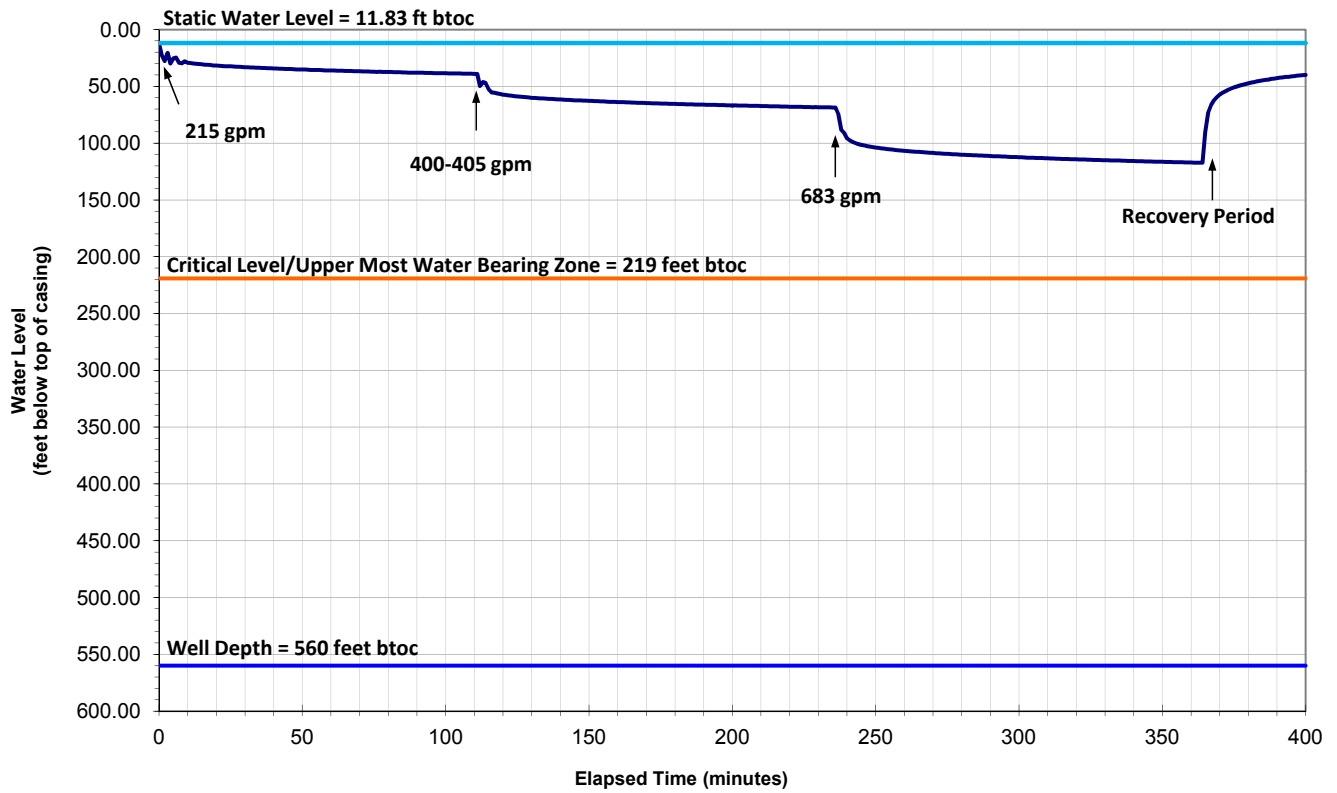
FIGURE D-3

Aquarion Water Company
Well 22 Step-Drawdown Withdrawal Test - 2016
Water Levels vs Elapsed Time

btoc = below top of casing, top of casing is 2 feet above ground surface

Water levels observed in Well 22 during the 2016 step-drawdown test are presented in **Figure D-3** in **Appendix D**. As shown, the groundwater levels during each pumping rate remained well above the uppermost water-bearing zone. In fact, the pumping level under the highest rate of 683 gpm did not drop below 116.43 feet.

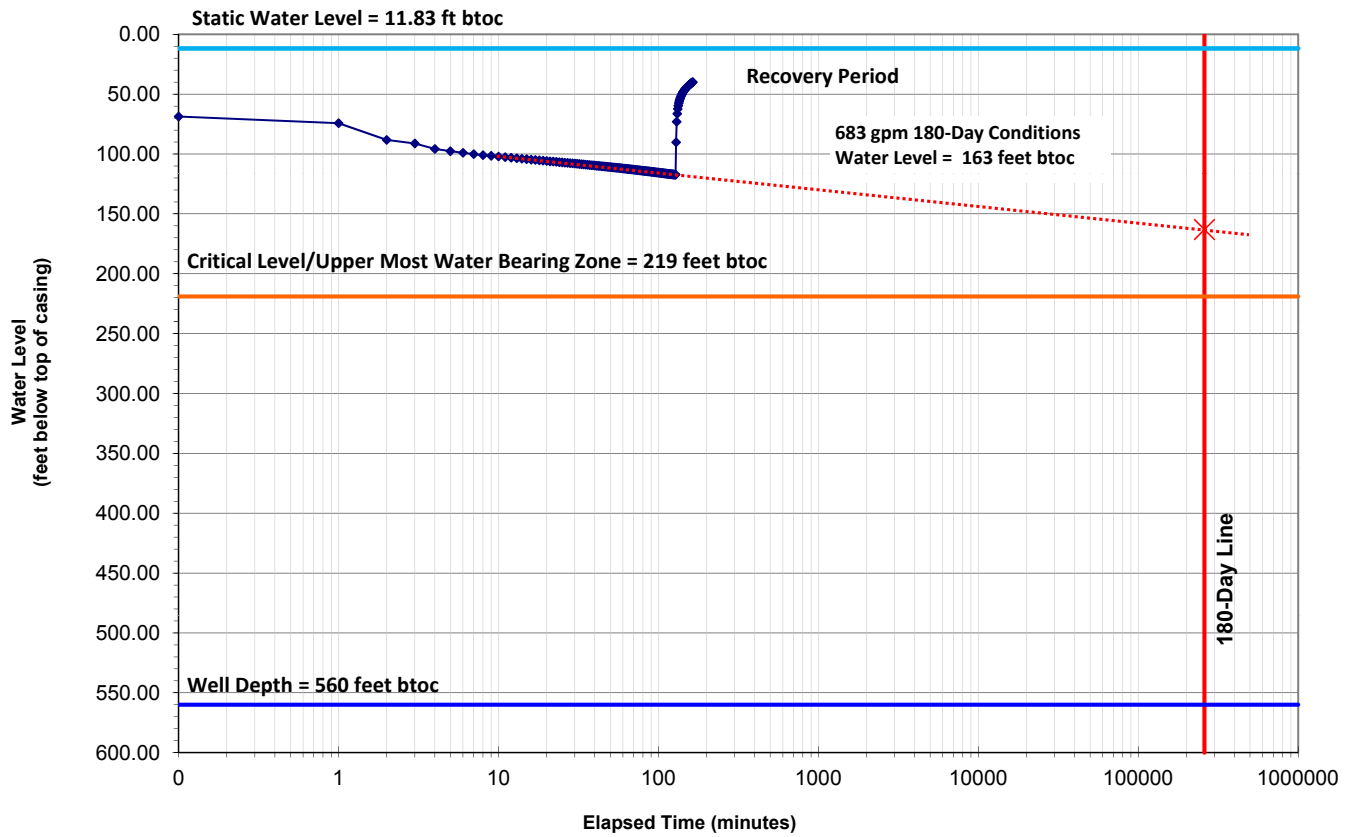
FIGURE D-4
Aquarion Water Company
Well 22 Step-Drawdown Withdrawal Test - 2016
Water Levels vs Elapsed Time (Logarithmic)

Notes:
 btoc = below top of casing, top of casing is 2 feet above ground surface
 Step-Drawdown Testing was performed on December 14, 2016 at 3 different withdrawal rates (215 gpm, 400-405 gpm, and 683 gpm)

Figure D-4 in **Appendix D** presents the groundwater level data recorded during the highest pumping rate of 683 gpm. The groundwater levels are presented against elapsed time on the log scale in order to extrapolate a pumping level under the NH DES defined 180-day continuous pumping with no recharge groundwater withdrawal conditions. As shown, the extrapolated groundwater level under the 180-day conditions is approximately 163 feet btoc. Based upon extrapolation of the groundwater level data recorded during the step-drawdown testing, Well 22 can produce over 683 gpm over an extended period of time (180-days) without dropping the water level below the critical level of 219 feet bgs. Based upon a specific capacity calculation of 4.5 gpm/ft for the 180-day extrapolation point (683 gpm/150 ft of drawdown), Well 22 theoretically could produce up to 940 gpm (4.5 gpm/ft. x 209 ft.) before drawdown in the well would fall below the upper most water-bearing fracture located at 219 ft. bgs (209 ft. below static water level).
