Energy Audit Report

Town of North Hampton Facilities

North Hampton Energy Committee

North Hampton Town Facilities Energy Audit

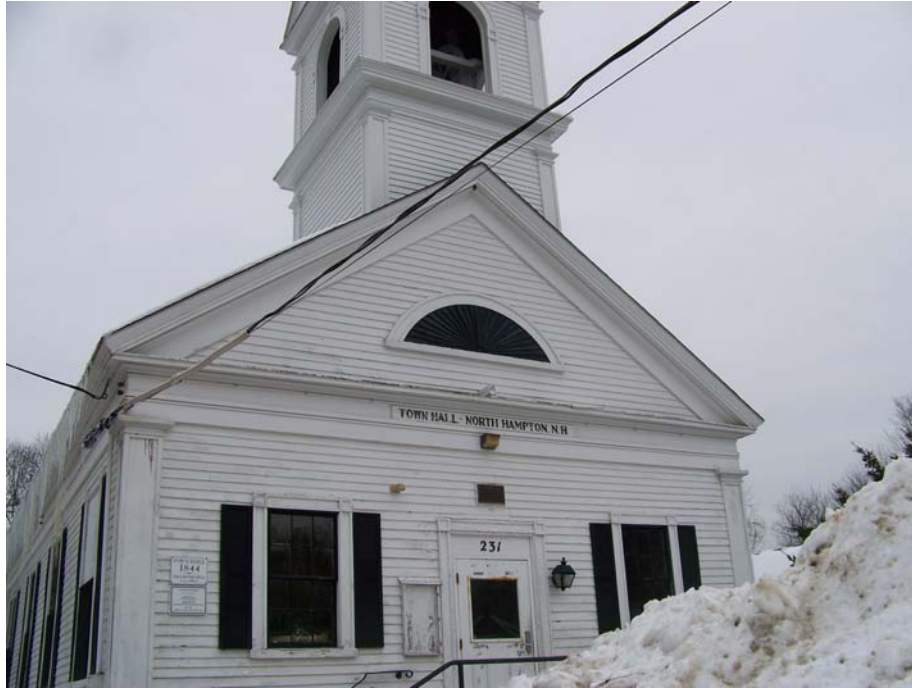
OLD TOWN HALL

The Old Town Hall is a model of inefficiency. Simply said this building should not be open during the winter months. Although the thermostat was set at a reasonable 61°F the large single pane windows, poorly insulated walls, and uninsulated floors all add up to wasted energy and giant fuel costs. The oil furnace looked to be in fairly good condition however it is old and should be replaced with a more efficient model.
