1844 Town Hall

North Hampton, NH

Exterior Conditions Assessment Report

February 2018

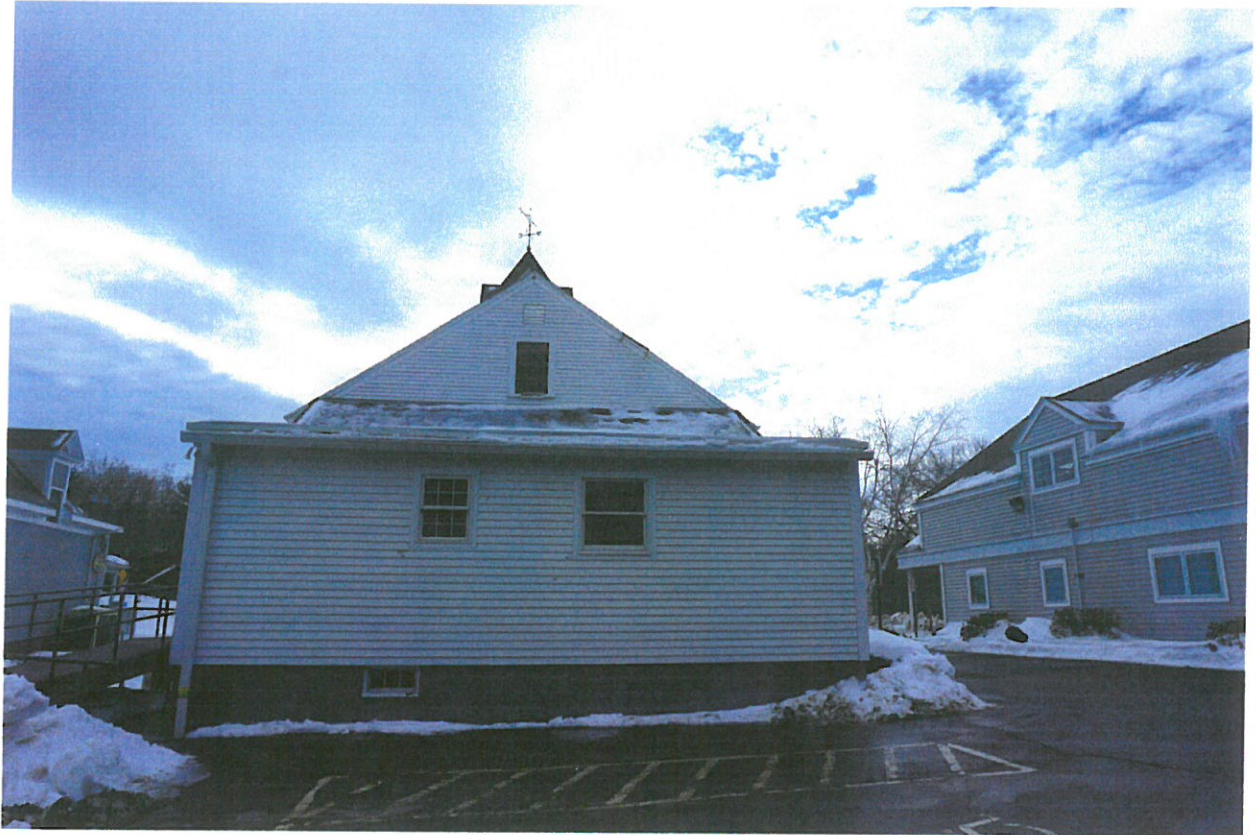
North Façade Roof/ Findings and Recommendations

1. The upper rakes on the roof gable are loose and gapping.

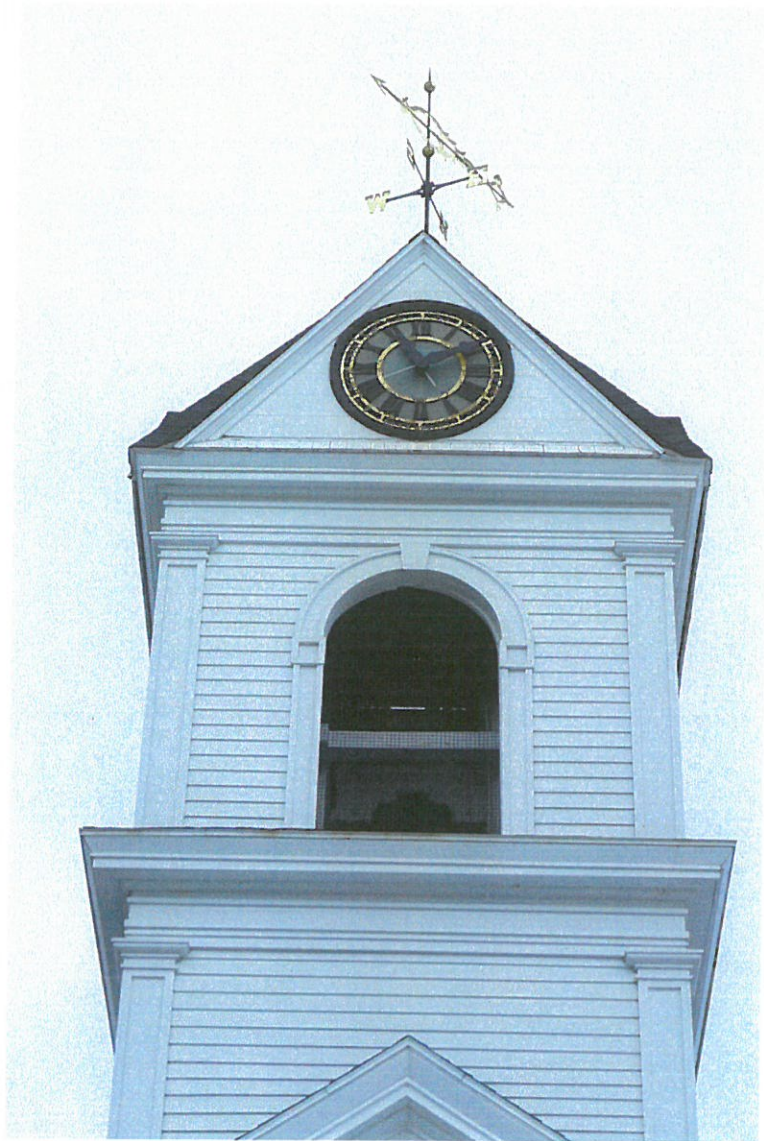
Steeple

Due to its height, I did not get directly in front of the steeple's four facades though I did inspect all facades with binoculars and feel confident in my discoveries. I also climbed out the shuttle door in the steeple onto the metal ladder and looked at the north side.
